McKenney Library Adaptive Reuse Study

Petersburg African American History, Cultural Center, and Archives

May 1st, 2024

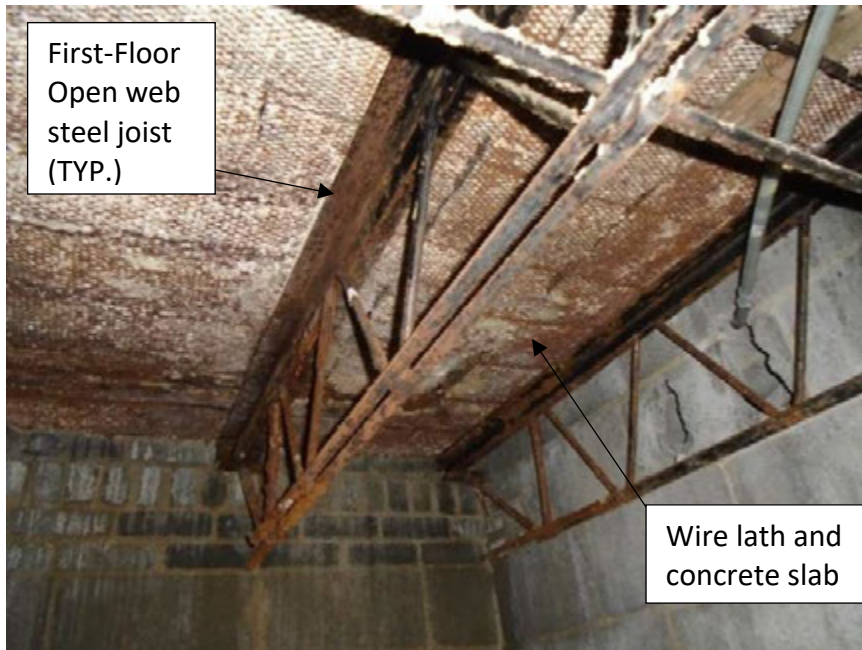
Photograph 3: Open web joists with significant corrosion. Source of damage is a roof leak. Install W12x14 beams adjacent to affected joist. We recommend shoring the floor prior to the renovation work to protect the public.

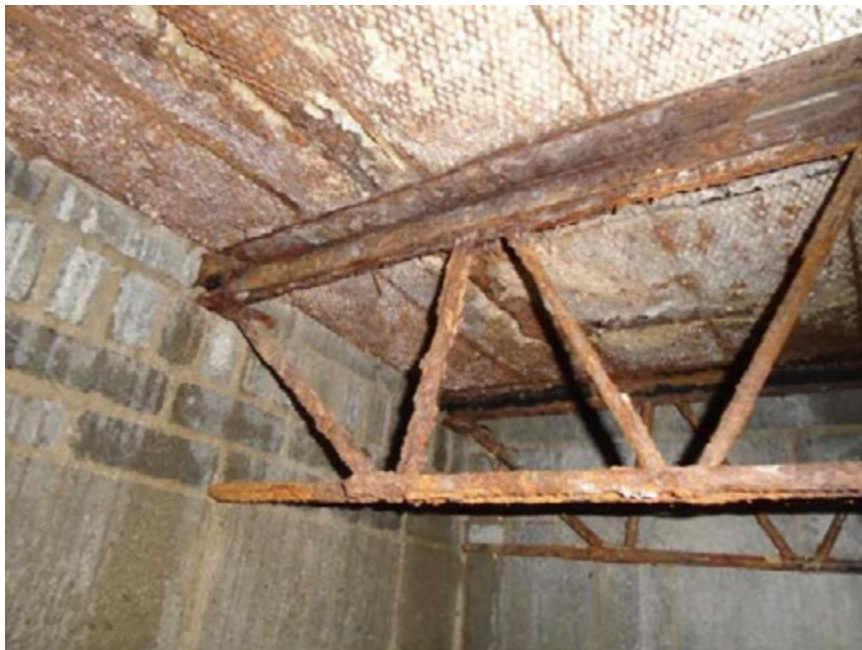
Photograph 4: A close-up of open web joists with significant corrosion. Install W12x14 beams to adjacent affected joist. We recommend shoring the floor prior to the renovation work to protect the public.

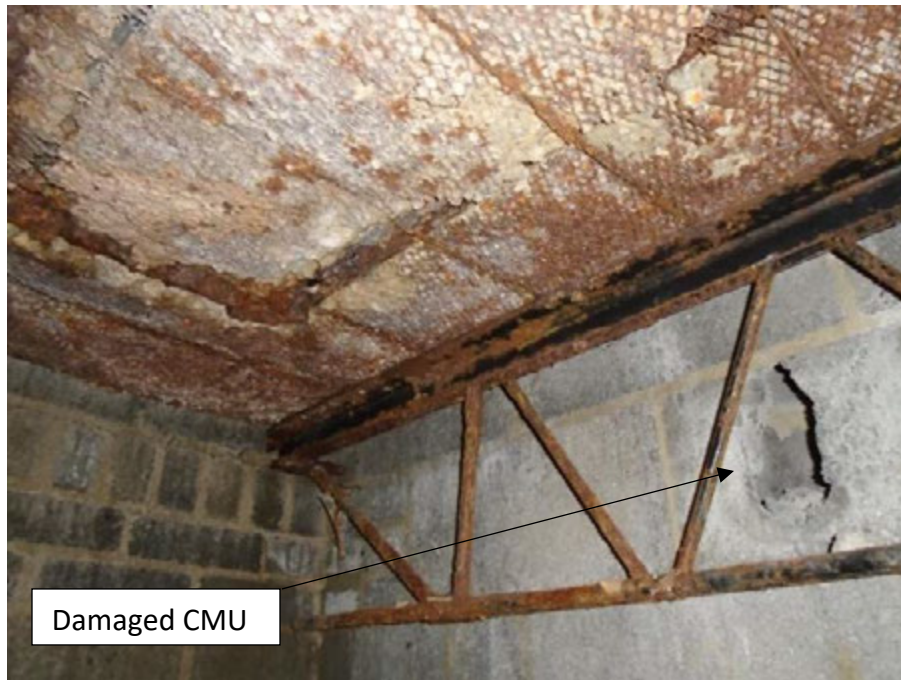
Photograph 5: A close-up of open web joist with significant corrosion. CMU is also damaged. Square off area of damage and mortar in a new face shell.

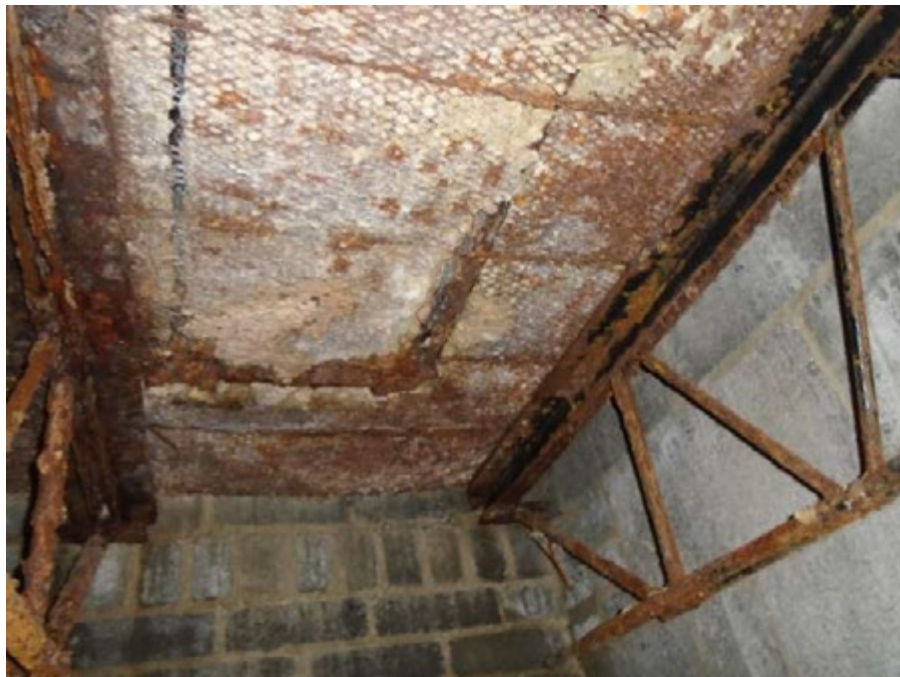
Photograph 6: A close-up of open web joists with significant corrosion. Install W12x14 beams adjacent to affected joist. We recommend shoring the floor prior to the renovation work to protect the public.

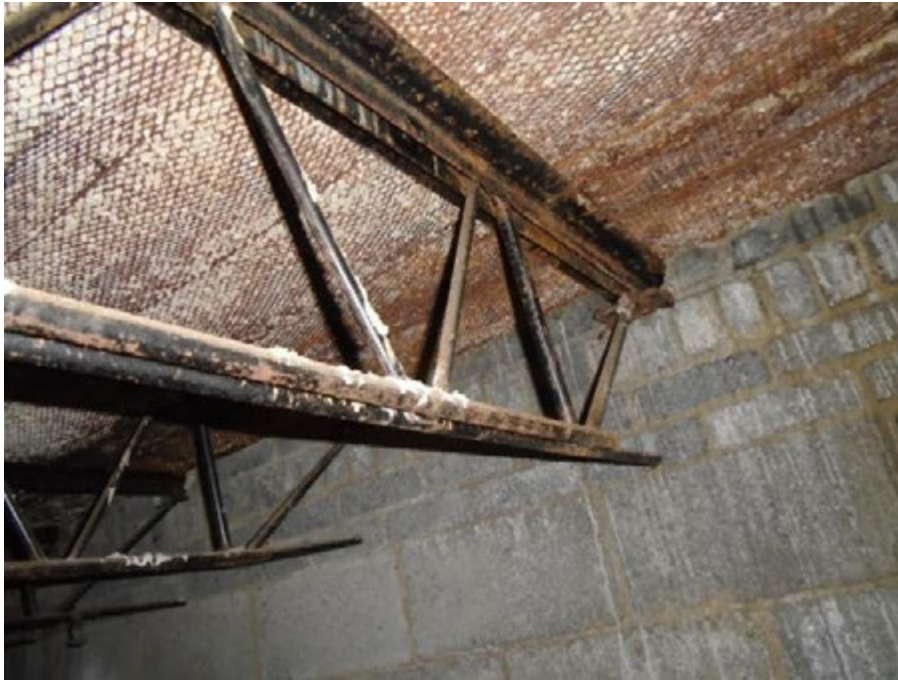
Photograph 7: A close-up of open web joists with moderate corrosion.

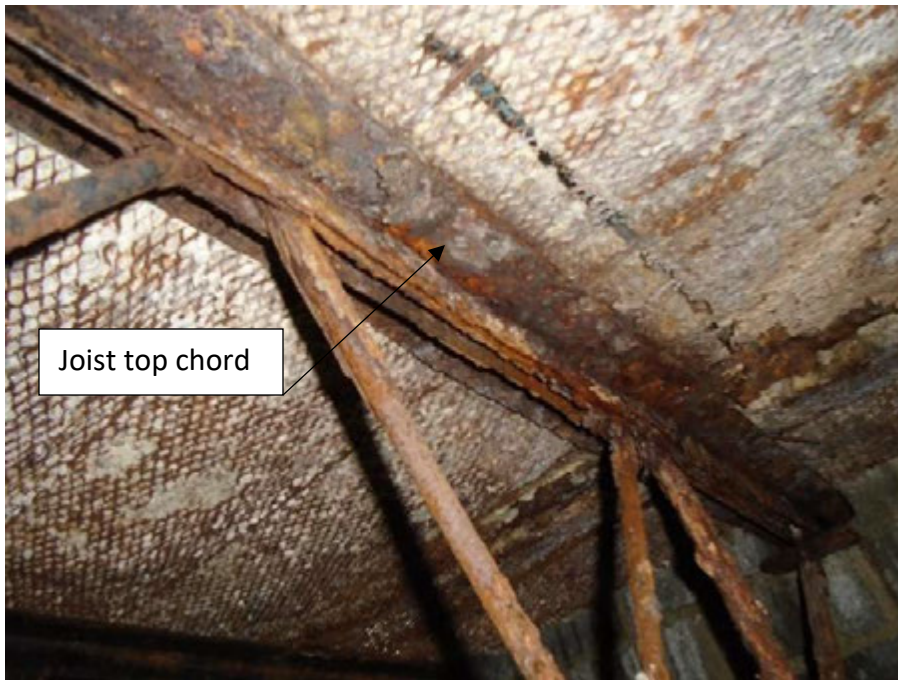
Photograph 8: A close-up of open web joist top chord with significant corrosion. Top chord is 75% deteriorated. This is a safety hazard and requires reinforcement. Install W12x14 beams adjacent to affected joist. We recommend shoring the floor prior to the renovation work to protect the public.

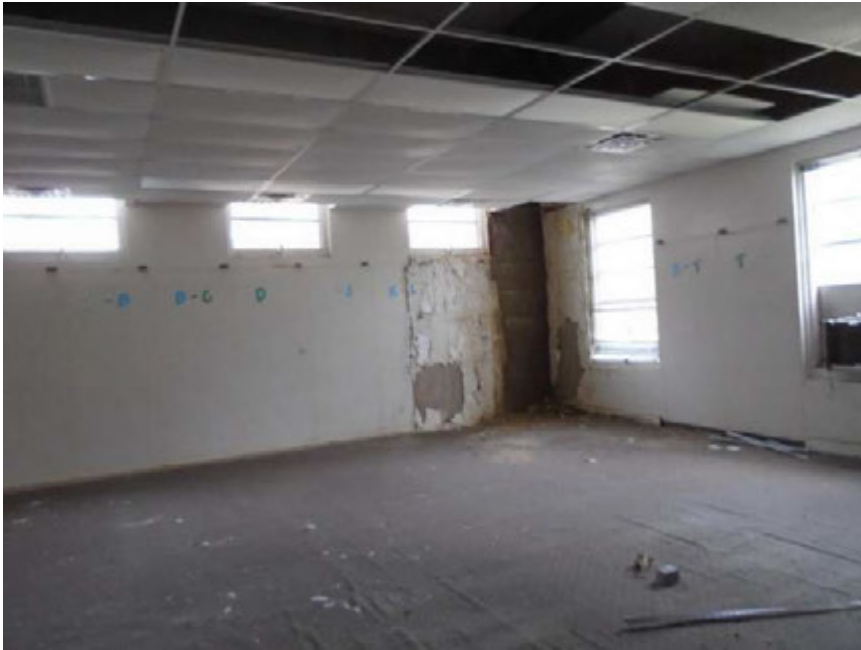
Photograph 9: Overall view of first floor with moisture damage along exterior walls.

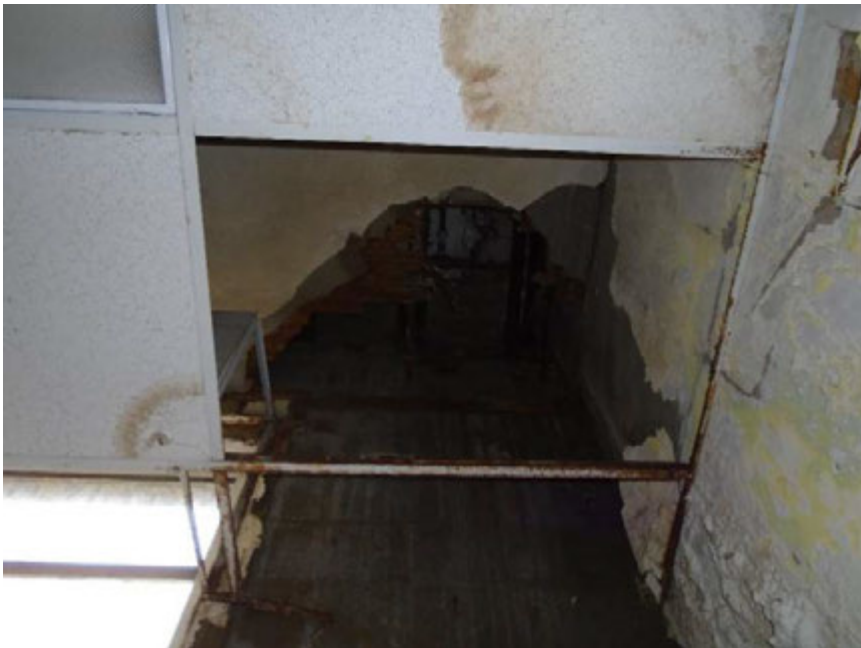
Photograph 10: A close-up of second floor open web joist with corrosion.

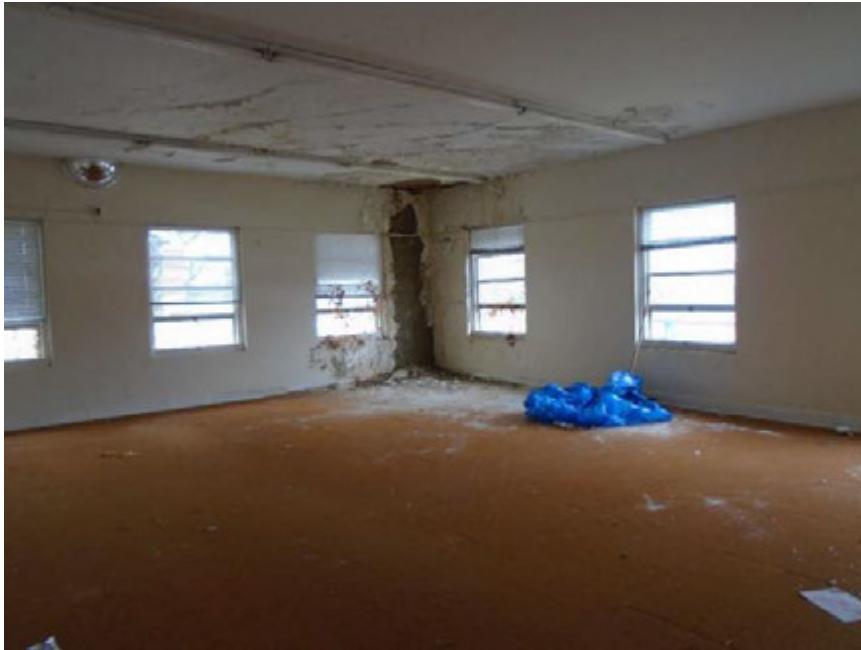
Photograph 11: Overall view of second floor with moisture damage along exterior wall.

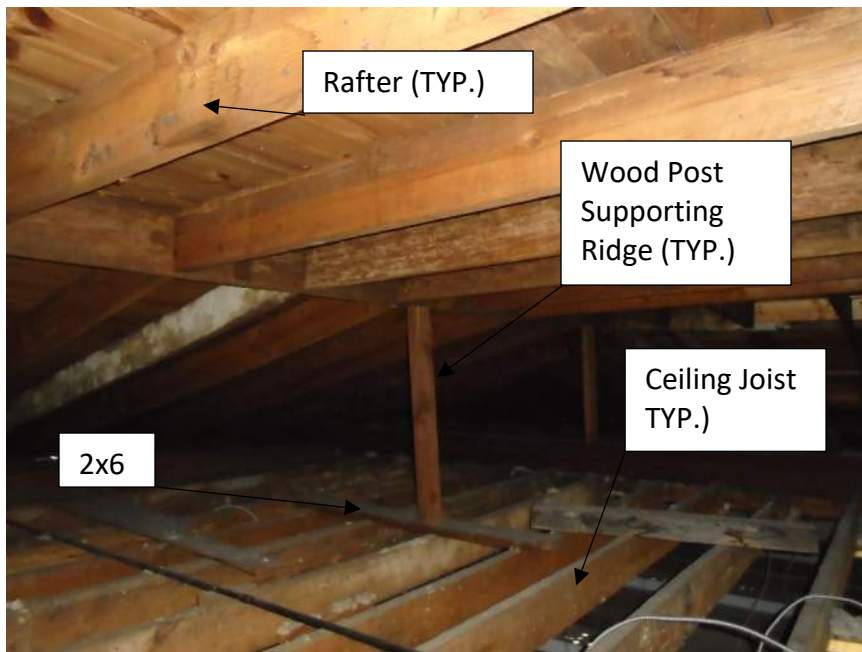
Photograph 12: A close-up of wood posts supporting ridge beam bearing on 2x6 supported on ceiling joists. Reinforce ceiling joists for loads by adding 2x8 ceiling joist along the existing ceiling joist fastened to existing ceiling joist.

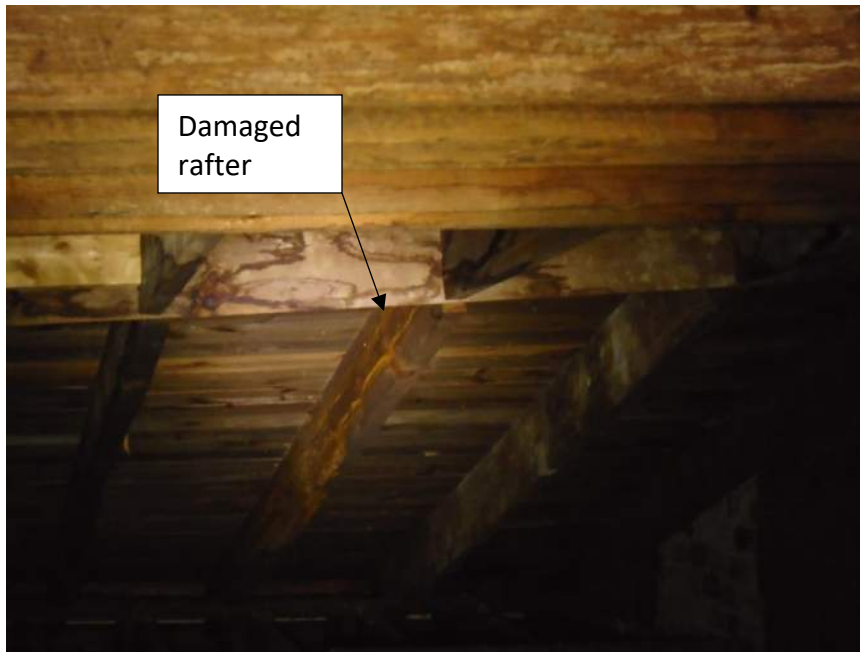
Photograph 13: A close-up of damaged roof rafter. Sister by adding 2x8 rafter along the damaged rafter fastened to the existing damaged rafter.

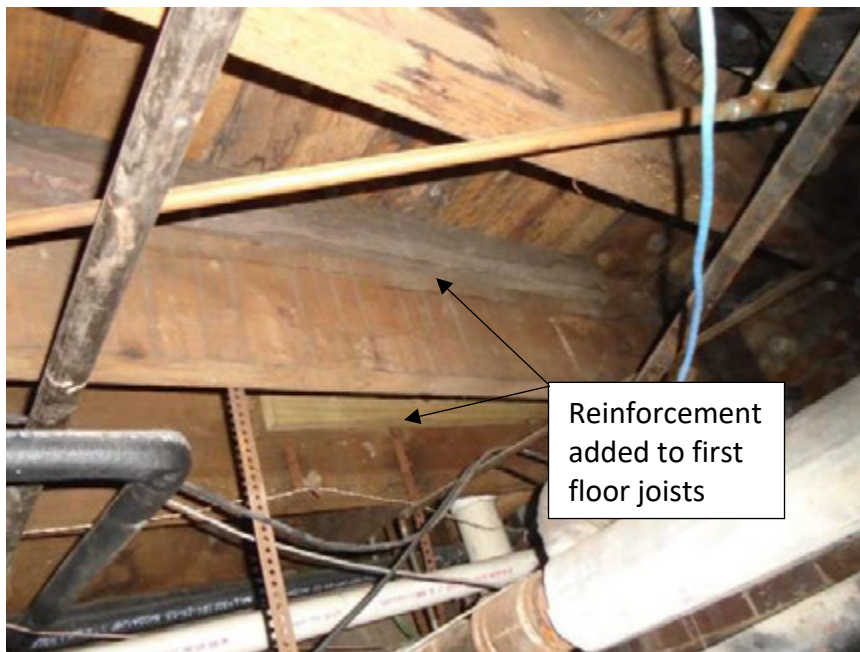
Photograph 14: A close-up of reinforced floor joists where joists is split. Sister by adding 2x12 floor joist along the damaged joist fastened to existing damaged joist.

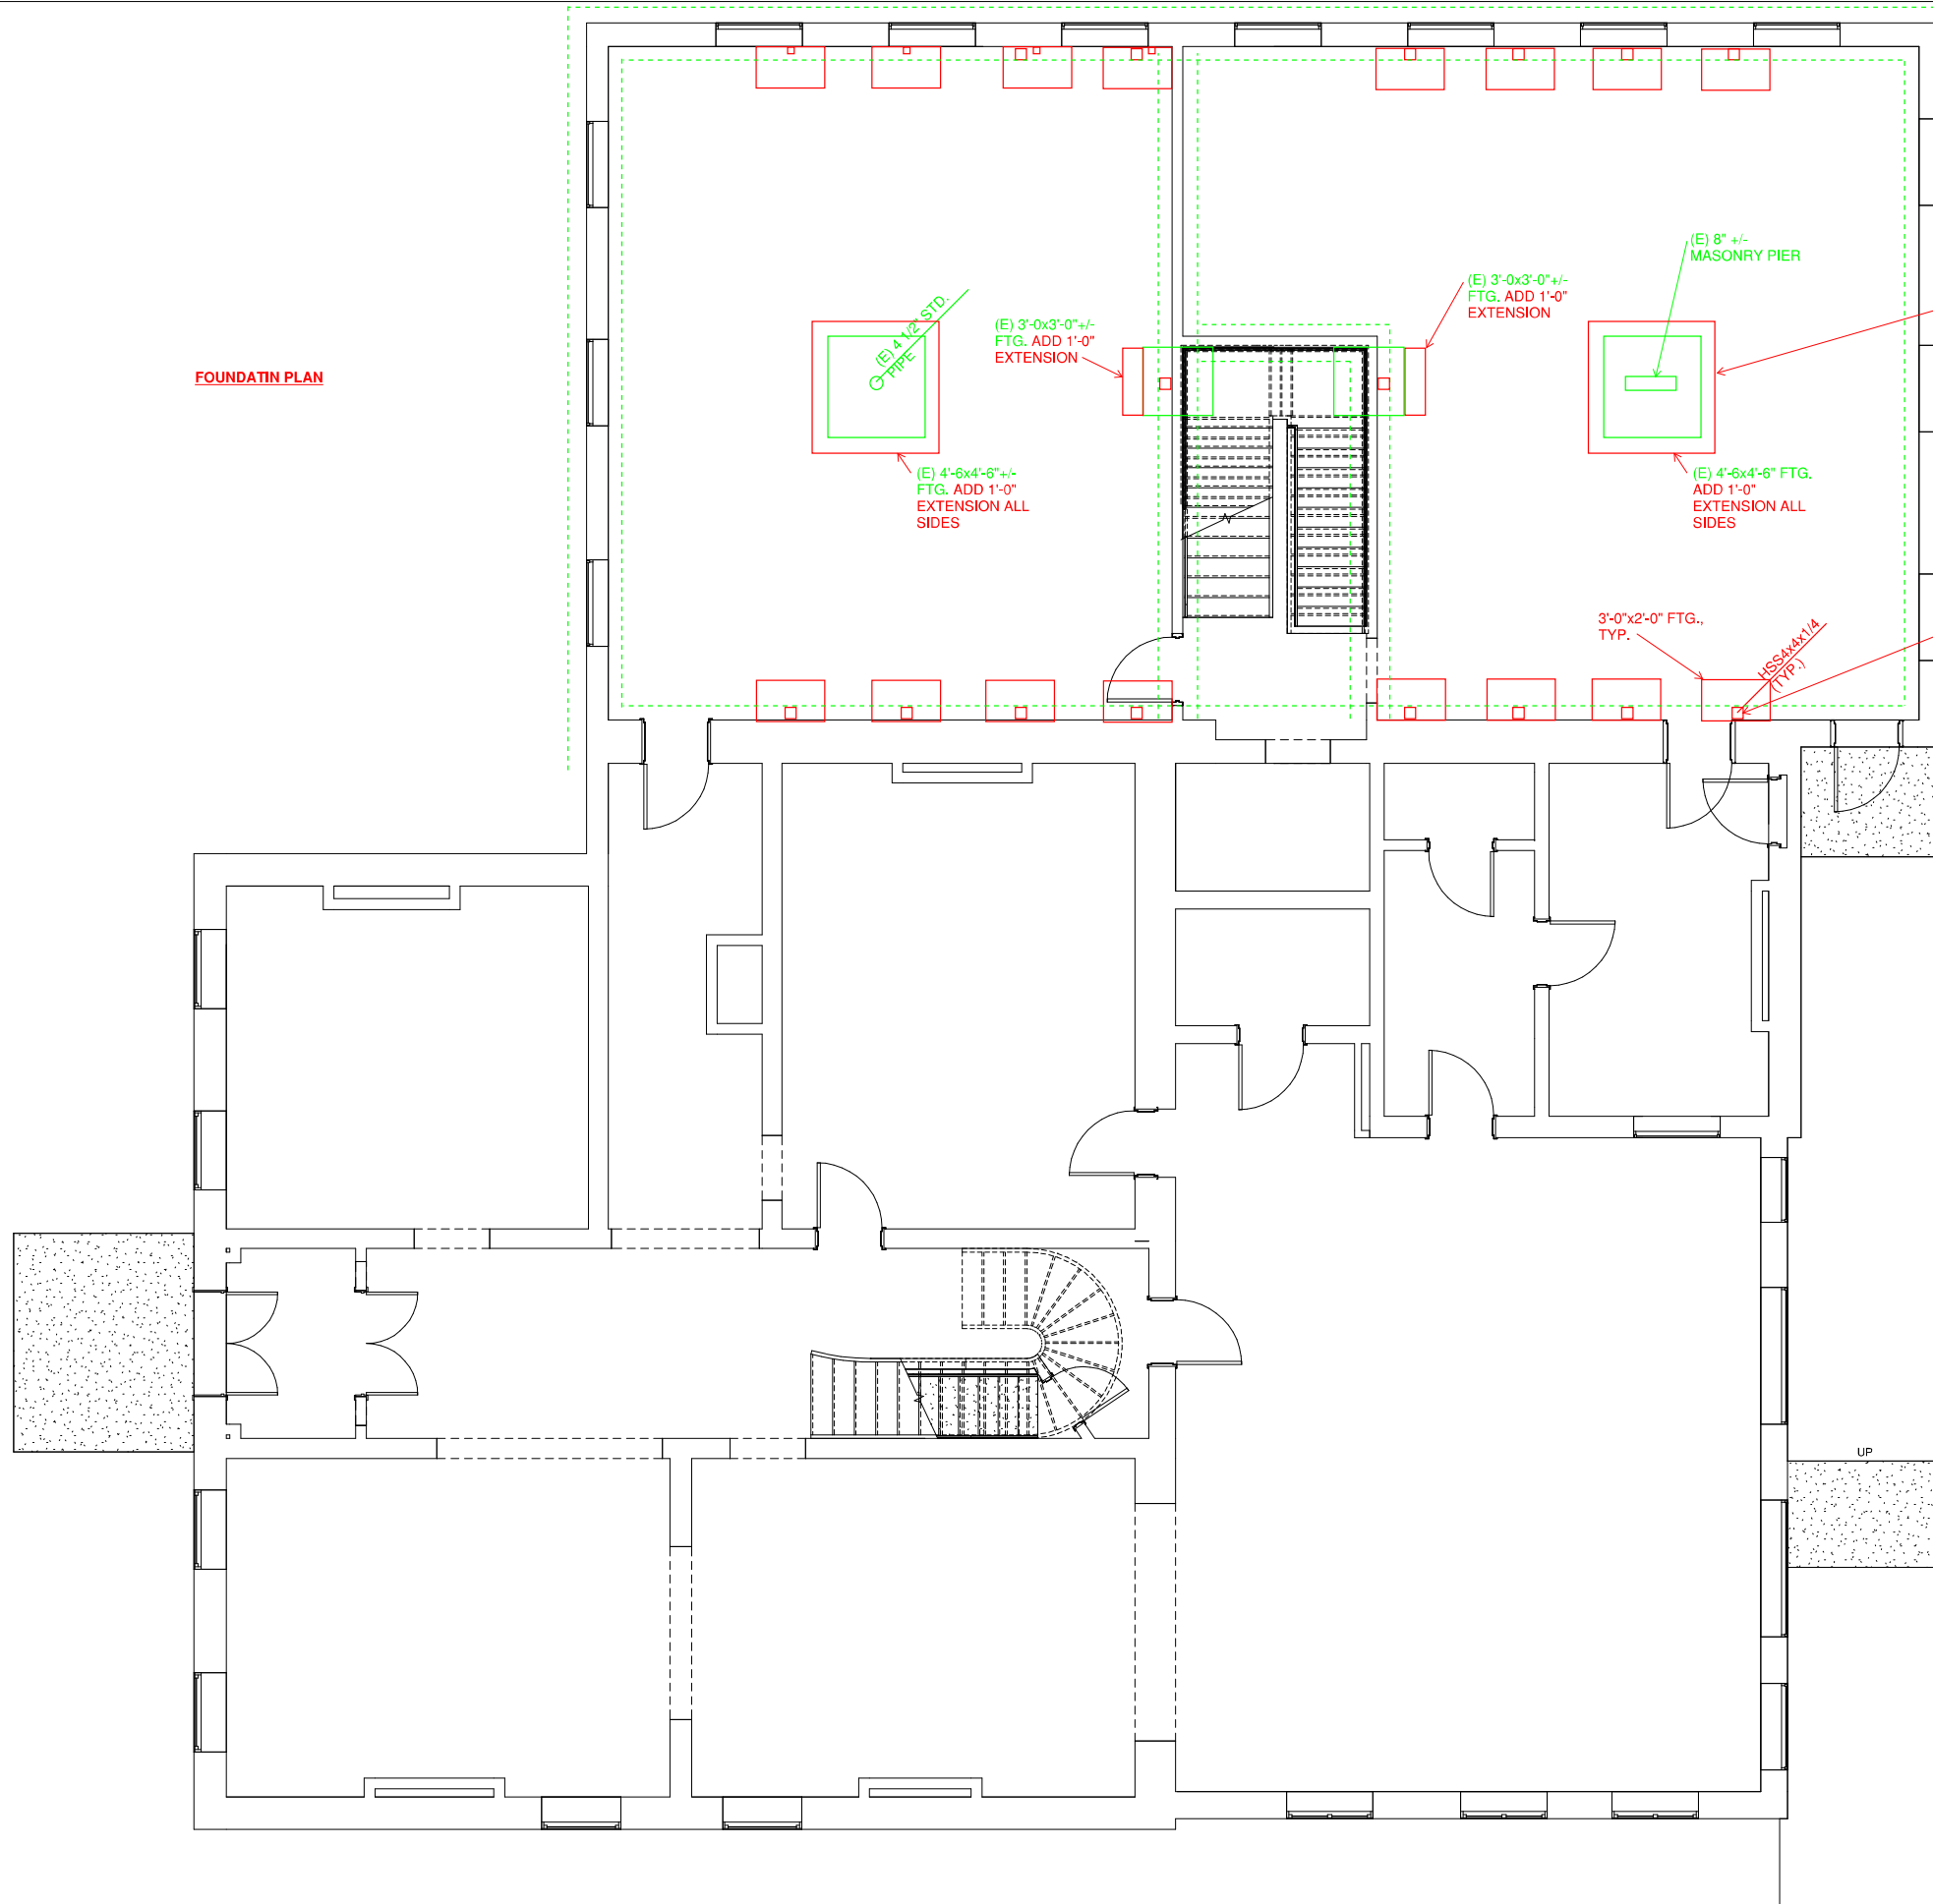
FOUNDATIN PLAN

EXISTING FOOTINGS ARE NOT ADEQUATE FOR ADDITIONAL WEIGHT FROM STORAGE SYSTEM. THEREFORE, EXISTING FOOTING REQUIRES ENLARGEMENT TO HANDLE INCREASE LOADS.

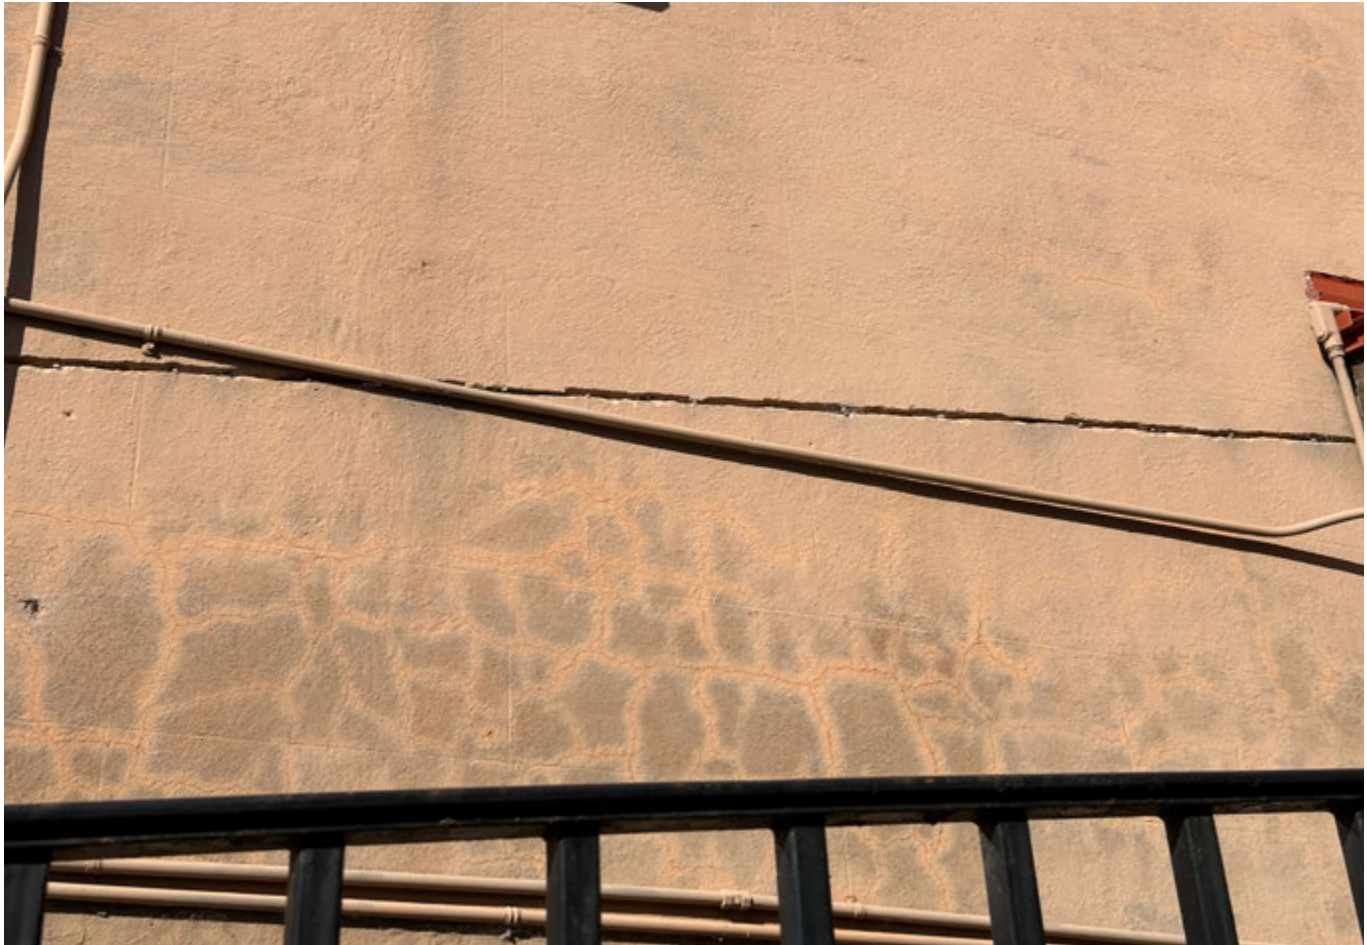
PHOTO: 8 E1 — East Elevation

The stucco on the original home is in fair condition; however, there is extensive micro cracking in the surface. The stucco still appears to be bonded to the brick, and there are no apparent signs of spalling. Scaffolding should be installed around the outside of the building when repairs begin. The exterior stucco should be tested by lightly tapping on the surface with a plastic mallet. If the stucco has separated from the brick below, the tapping will sound hollow. Loose or delaminated sections of stucco should be replaced. The extent of replacement is unknown, but it is recommended to allow for approximately 500 square feet of stucco patching. The

- Remove any unstable stucco
- Remove and patch existing stucco with new stucco to match existing. Allow approximately 500 square feet of stucco patching.
- Test existing stucco to determine composition.
- Custom mix new stucco to match the composition of existing stucco.
- Apply lime putty wash over existing stucco to fill in small cracks.
- Paint stucco after repairs.

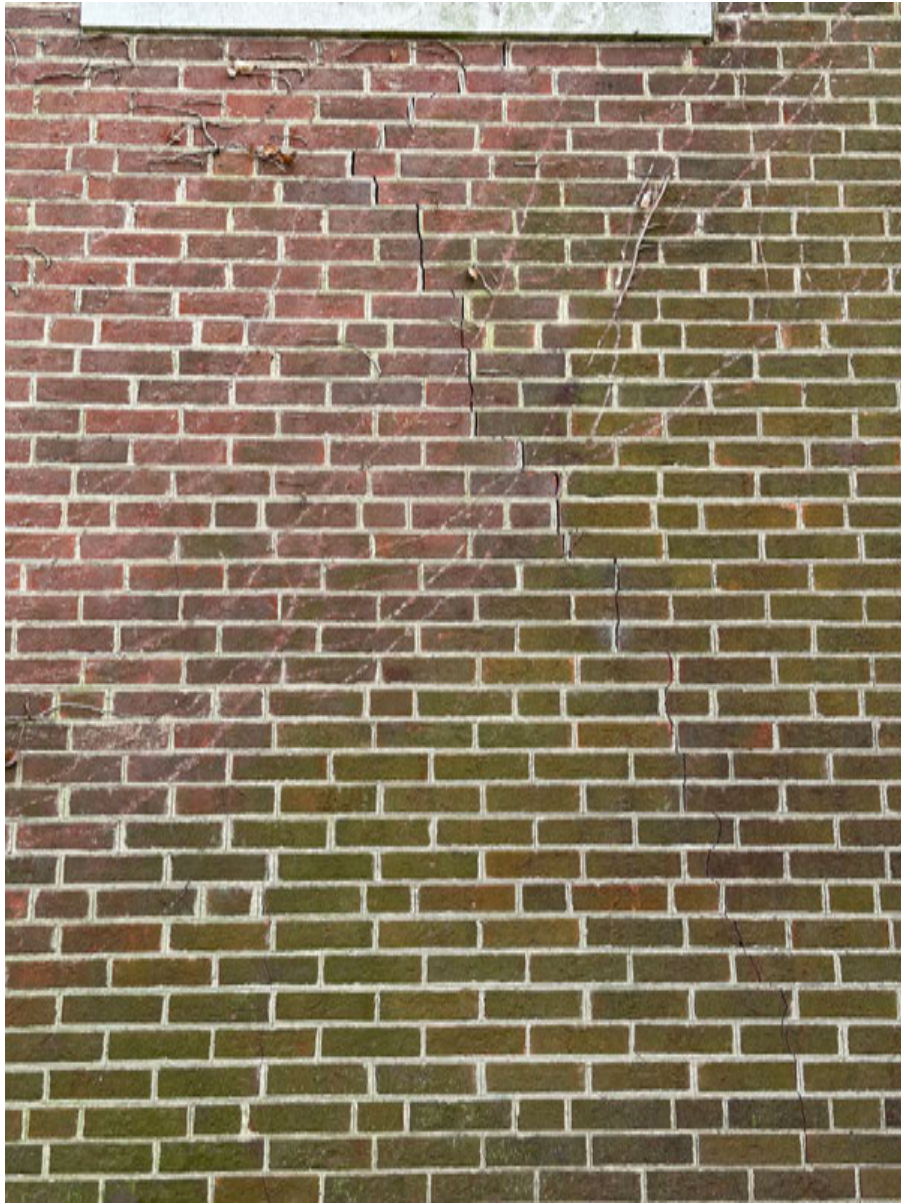
PHOTO: 10 N5 — North Elevation

All the walls are in fair condition; however, repointing may be needed in limited areas on the 1950s expansion. There are some cracks forming on both the original building and the expansion. On the North wall of the 1950's expansion, a vertical crack runs up the center of the wall. That crack appears to be caused by normal thermal expansion and contraction of the building. A masonry control joint should be cut in the existing brick wall near the crack running vertically at the jambs of the existing windows. The existing masonry crack should be repaired.

- Repair cracking in wall
- Add expansion joint near cracking area

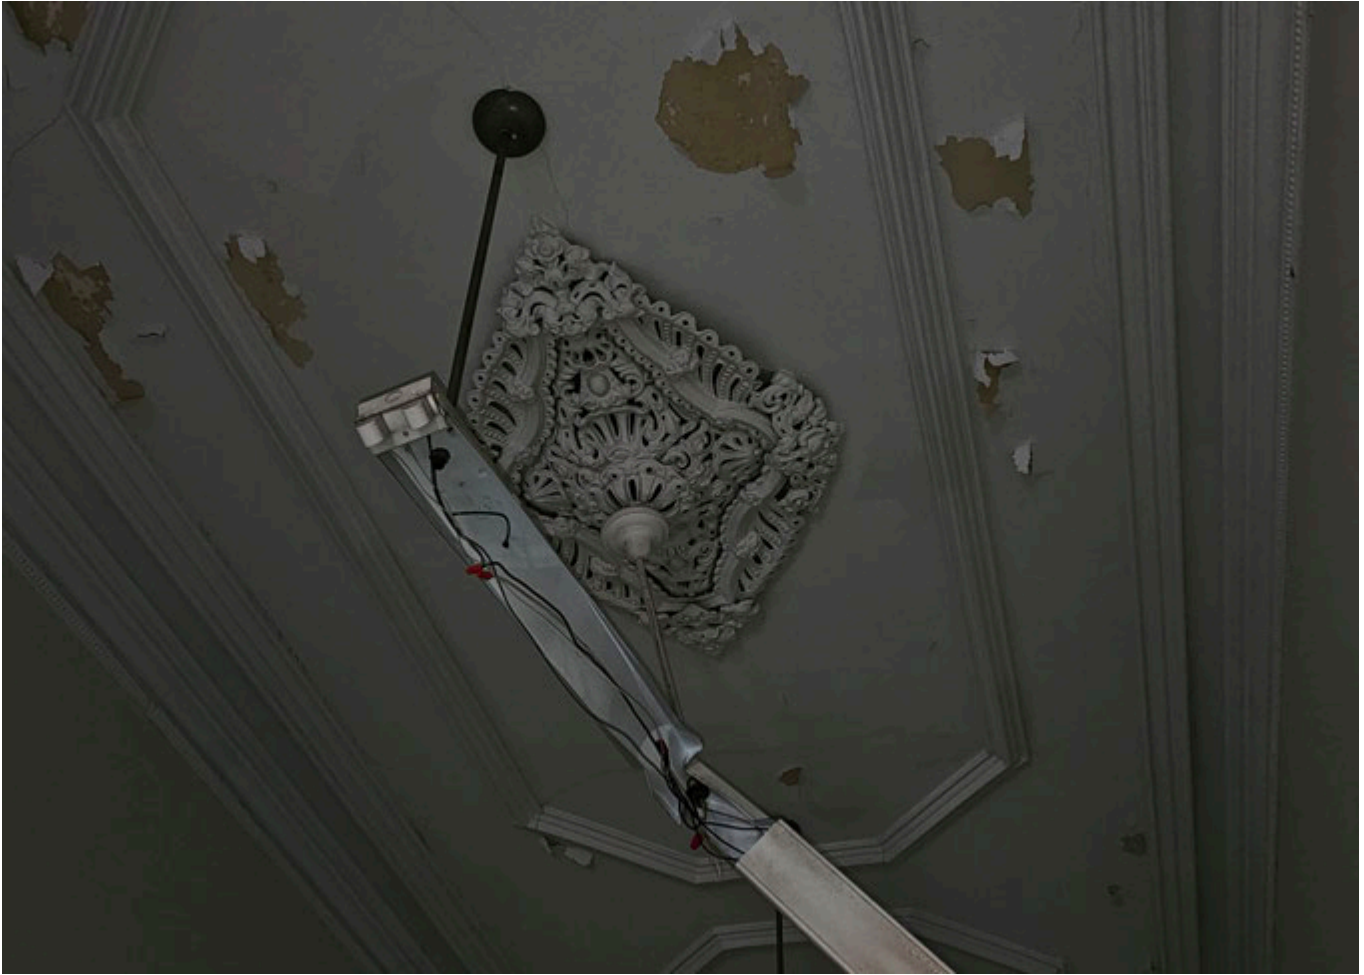
HISTORIC CEILING

The original home has high plaster ceilings with ornamental plaster medallions and moldings. Those ceilings are damaged in several areas. The ceilings should be repaired to match the original historic construction.

- Repair ceilings to match original historic construction
- Install required fire sprinkler system for the project
- Conceal sprinkler heads and piping
- Cut channels in existing plaster ceilings for sprinkler piping installation
- Repair plaster to match original historic condition after installation of sprinkler piping and heads
