McKenney Library Adaptive Reuse Study

Petersburg African American History, Cultural Center, and Archives

May 1st, 2024

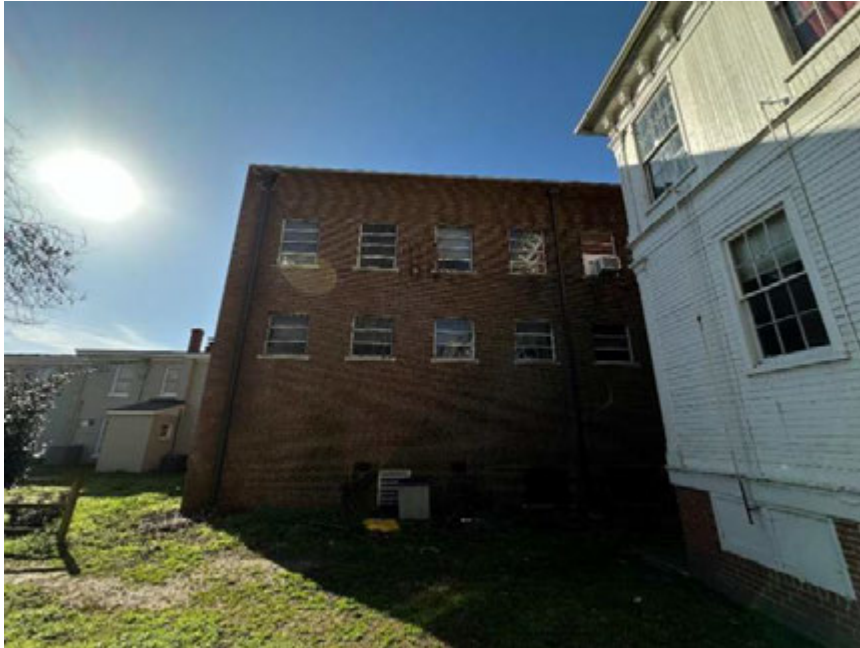
In addition to the cracks above the windows, we observed a vertical crack located at the middle of the wall. This crack is likely due to a lack of masonry control joints. Vertical control joints are incorporated into brick masonry construction to handle the expansion characteristics of clay masonry products. Bricks made of clay expand due to temperature and moisture changes. Clay products have an affinity for water and grow significantly (horizontally and vertically) over a period of time. Control joints filled with sealant allow for movement of brick without causing damage. We recommend cutting in vertical control joints and repair veneer damage.

Photograph 15: Overall view of left (North) elevation. No control joints observed. Cut in masonry control joints.

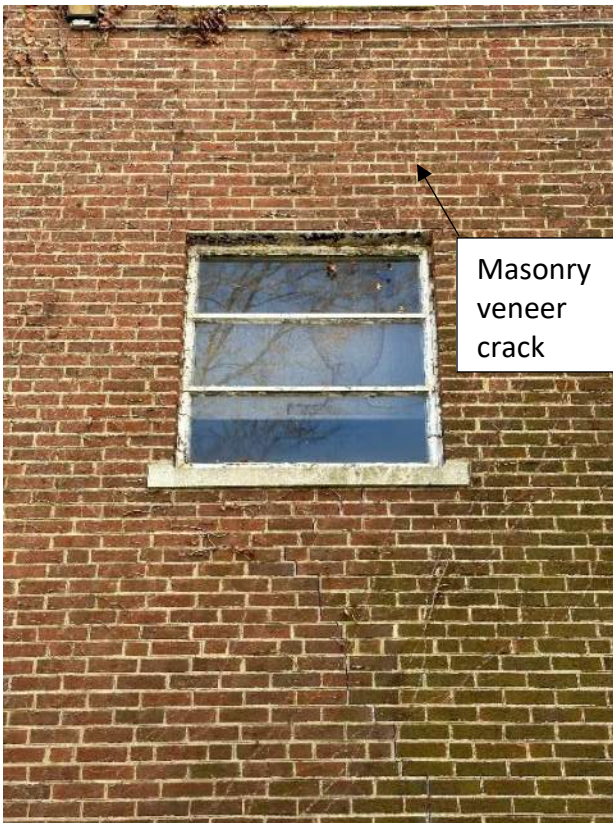
Photograph 17: A close-up of masonry veneer cracks. Cracks are the result of non-existent masonry control joints. Install masonry control joints.

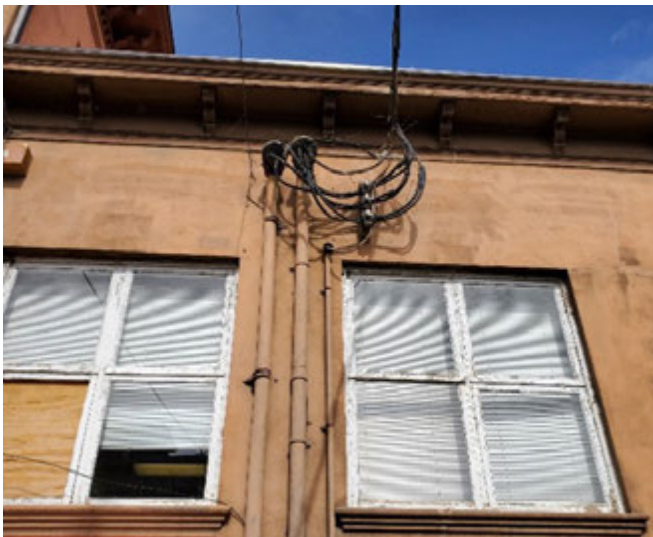
The existing electric service to the McKenney Library is 120/208V, 3-phase and is supplied from transformers mounted on a Dominion Energy power pole located along Marshall Street on the south side of the building. The power company secondary service conductors run overhead from the pole to two (2) surface mounted service heads located on the south exterior wall of the library just above the first floor windows. Dominion current transformers (CTs) are actually mounted on the exterior wall just to the right of the surface heads and are exposed. The Dominion overhead secondary conductors are routed through the CTs before entering the service heads. The two (2) service heads are connected to two (2) exposed conduits that run down the side of the building and enter the facility just to the right of the existing basement entry door. There is a third service head and exposed conduit, smaller than the others, that carries the signal wiring from the CTs down to the power company meter that is also mounted on the exterior wall and accessible from grade level.

Elec Photo #1: Overhead Service Drop & Exposed CTs

The recommendation however, is to replace the entire electric service, including replacing the overhead secondary service drop from the Dominion power pole and the exposed wall-mounted CTs with an underground service drop from the pole and a CT cabinet. The CT cabinet would be mounted on the exterior south wall of the building just to the right of the stair into the basement. The main electrical closet will be directly behind the CT cabinet inside the building. The power company meter and meter signal wiring would also be replaced. This recommendation is based on the age of the existing service, the current aesthetics with the exposed service heads and service conduits, and Dominion requirements to replace exposed CTs whenever there is any significant service work undertaken that they need to be involved in. Also, even though all of the existing exposed incoming service wiring is insulated, it is also concerning from a safety standpoint how close the secondary service conductors and exposed CTs are to the top of the first floor windows and roof line.

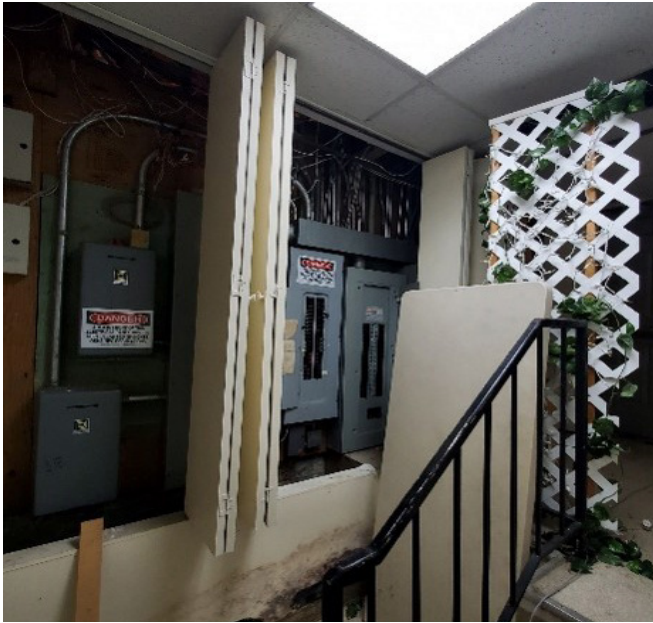
On the low side of the vestibule, there is actually a short wall along the front of the closet. Top of this wall is at the same height as the high side of the vestibule. Someone accessing the electrical equipment on the low side has to reach over this short wall. While all existing equipment is installed above the level of the wall, the existence of the short wall itself is still an NEC violation, which requires clearance in front of electric equipment of this type to extend down to grade, floor, or platform level.

Elec Photo #2: Existing Main Electrical Closet

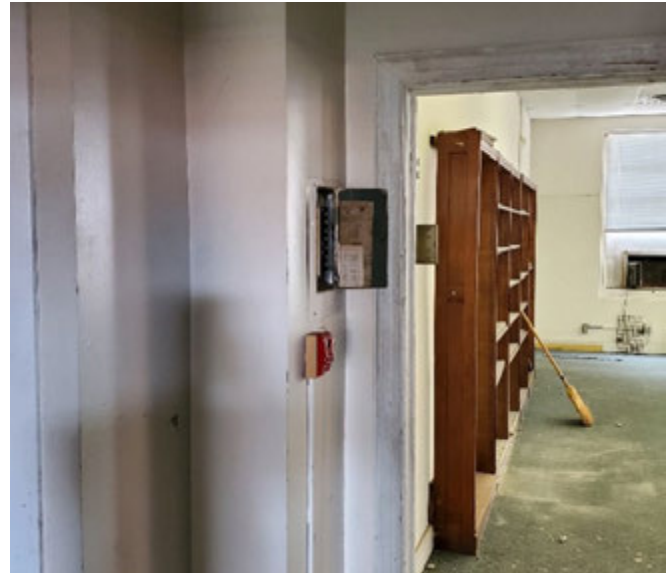
The only other existing panelboard that was found in the building was a small 16 circuit 1-phase, 120/240V, 125 amp Federal Pacific load center located recessed in the wall of the 1st floor elevator lobby. It appears older than any of the panels in the main electrical closet. It is unclear where it is supplied from, although most likely it is from Panel 36.

Elec Photo #3: Load Center Recessed in Elevator Lobby Wall

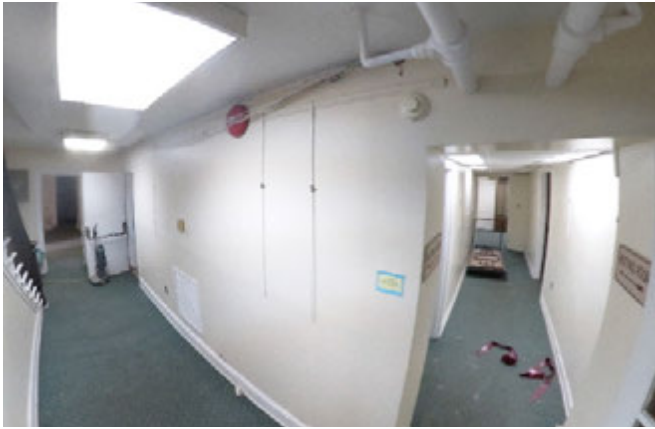
It appears that conduit and MC cable have been used for running pretty much all line voltage circuitry leaving the branch panelboards. However, there is a significant amount of low voltage wiring for communication and safety/security systems such as telephone, data, and fire alarm, that was run exposed and it cannot be ruled out that there isn't some exposed line voltage wiring mixed in with the low voltage wiring. Unsurprisingly considering the original building was constructed in 1859 and the addition was built in 1958, much of the circuitry was installed after construction and therefore, exposed surface mounted conduit, exposed MC cable, and surface raceway is installed in many areas. Many of the facility's general use receptacles were also installed in this manner. Particularly, surface mounted receptacles were added in numerous locations to power window mounted air conditioning units. We even noticed surface mounted receptacles installed on floors in certain spaces. It was also noted that some of the existing receptacles are not provided with terminals for ground pins

Elec Photo #4: Exposed cabling in Corridor

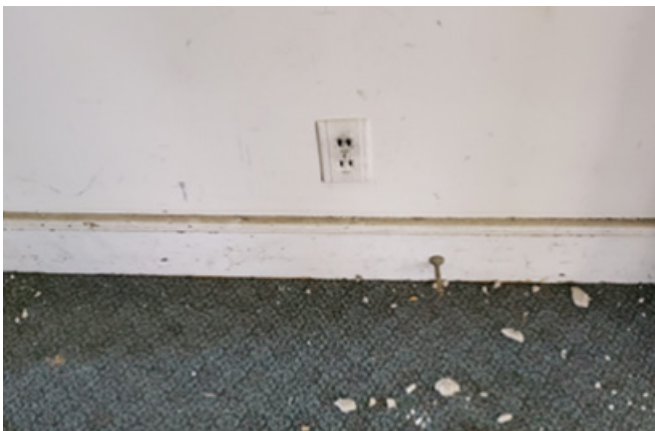
Elec Photo #5: Receptacle, No Ground

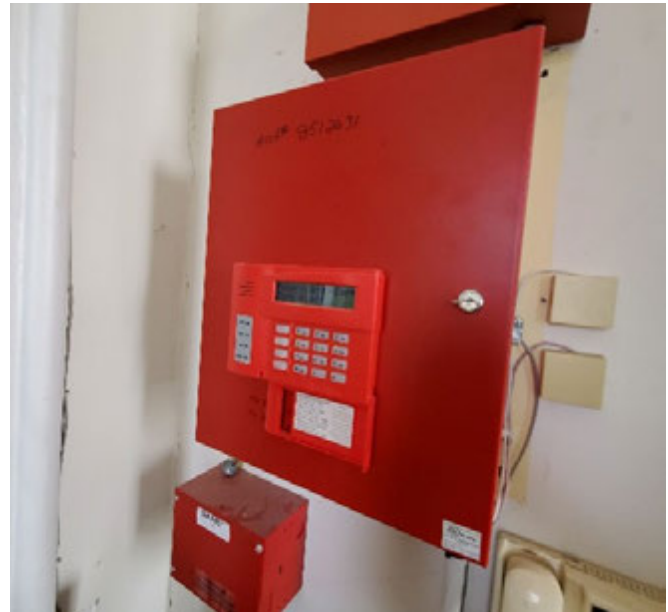
Elec Photo #8: Existing Combo Fire/Security Panel

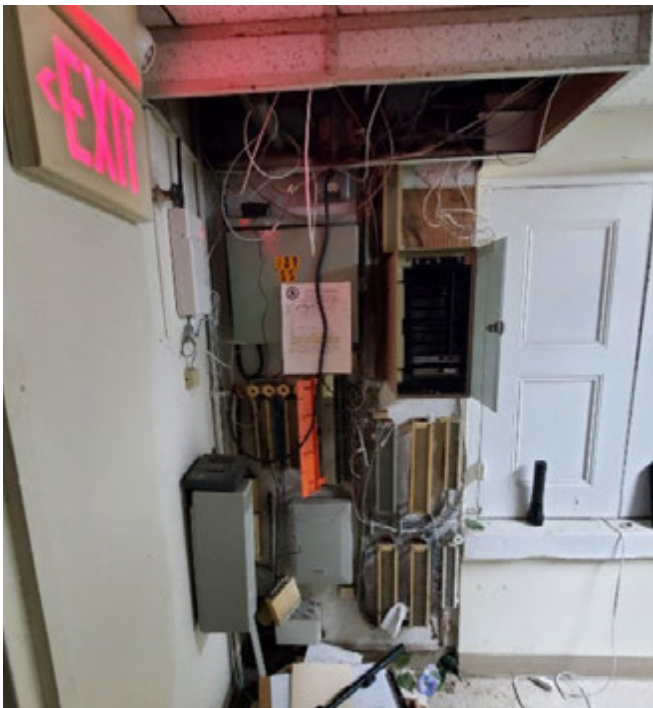
through the entry door from the exterior. Basically, the telecom backboard is right across from the main electrical closet. Mounted on the backboard is the Verizon demarcation equipment, numerous wiring blocks, and the library's Nortel Norstar telephone switch. Outlets for telecommunications, including both telephone and data outlets, are provided throughout the building. Not surprisingly, these outlets are pretty much all installed via surface raceway. It appears the data system headend equipment may have been located in a room in the basement on the northwest corner of the original 1859 building, as there is a large bundle of low voltage cabling hanging out of the ceiling in the corner of that room. In the floor plans for the proposed renovation, this is the space labeled Exhibit 015. It appears however, that any data equipment that may have been installed there at one point has been removed. Some similar type cables hanging loose from the ceiling were also found on the other end of the basement in Storage Room 027.

Elec Photo #9: Existing Telecom Backboard & Headend Equipment

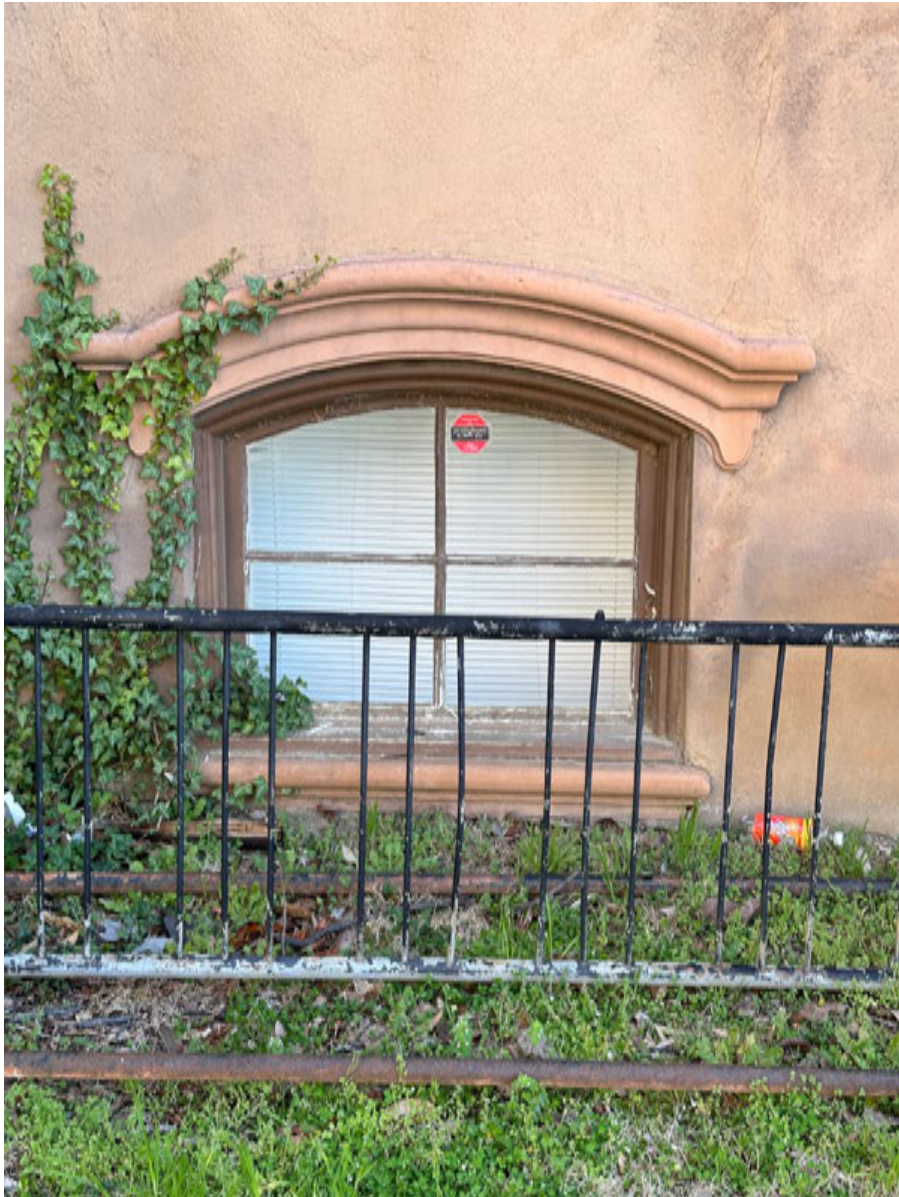
PHOTO: 1 W1 — West Elevation

REMARKS:
Typical basement wood window

- Remove vines encroaching on the window

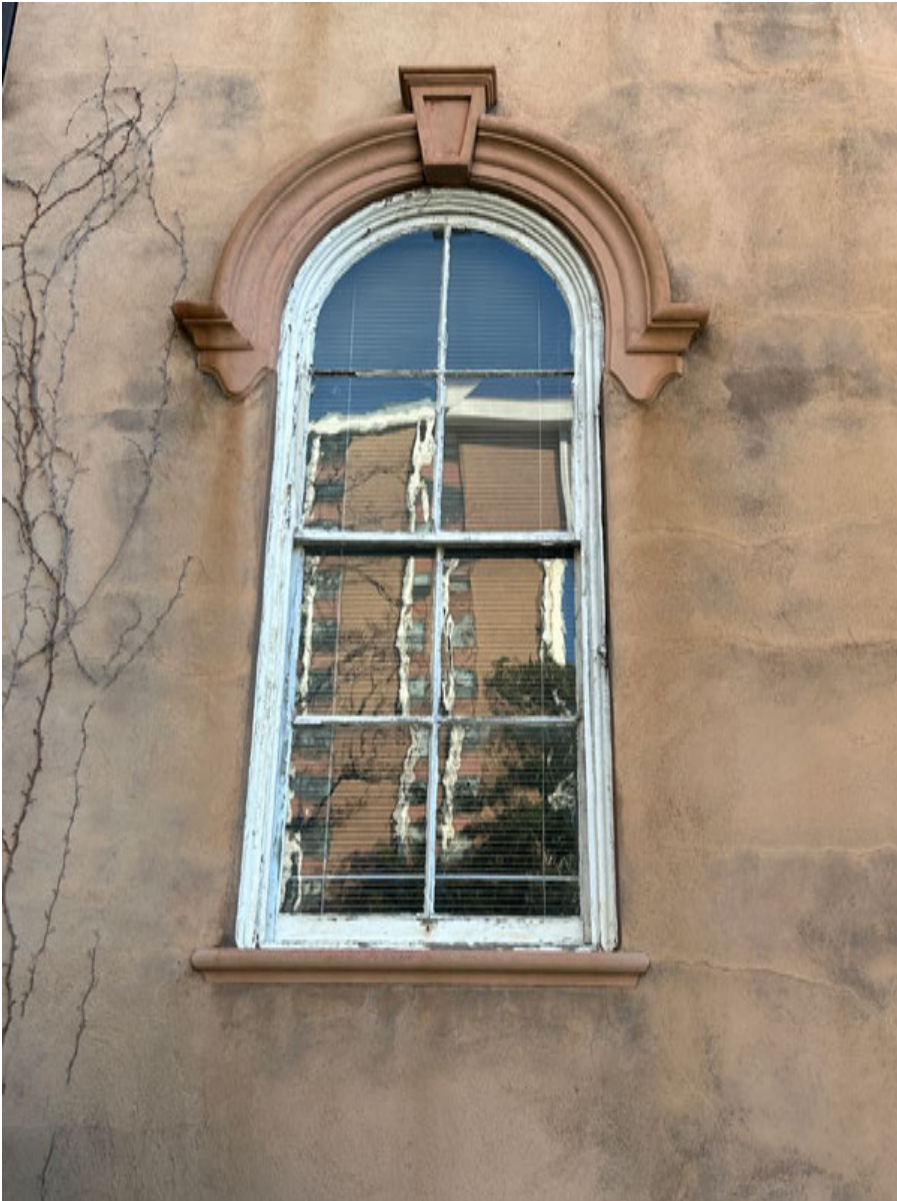
PHOTO: 1 W2 — West Elevation

REMARKS:
Typical first floor wood window.

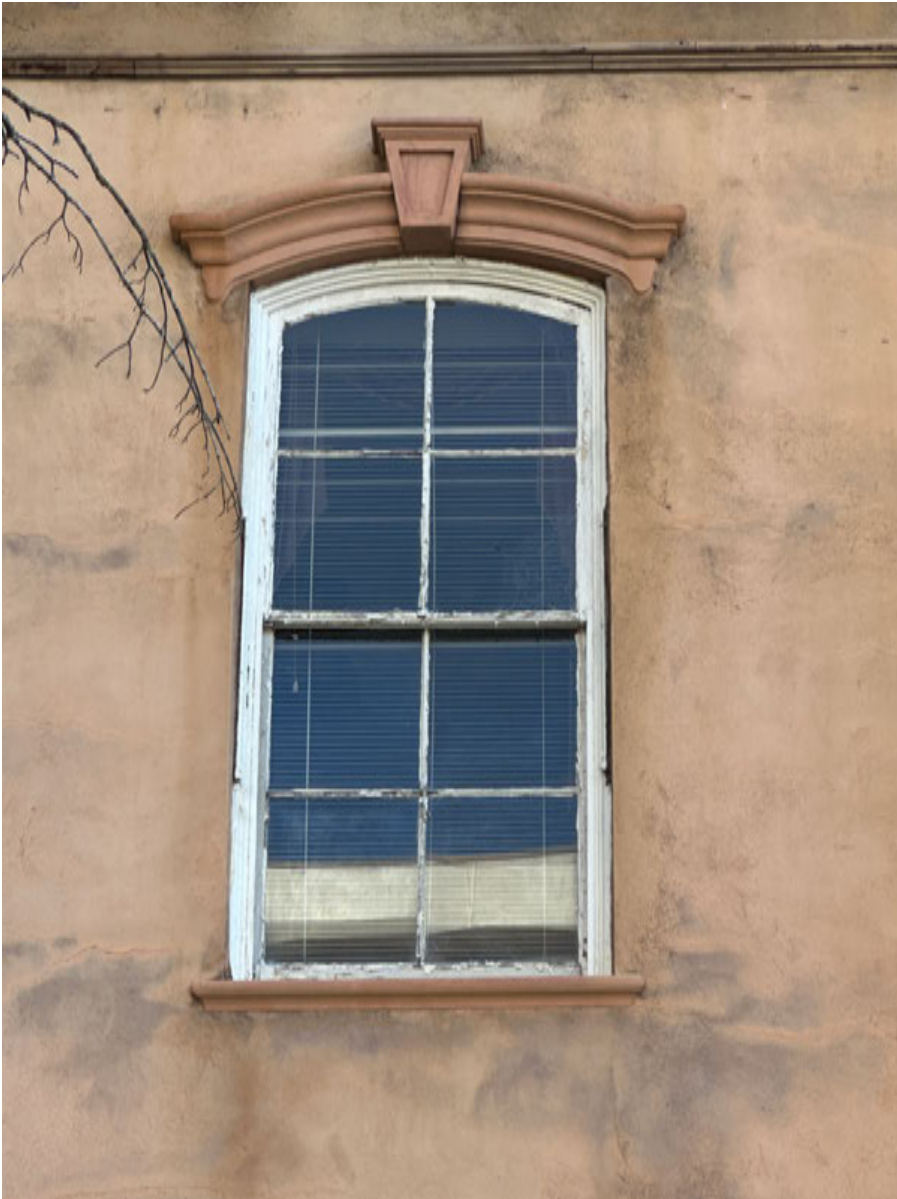
PHOTO: 1 W3 — West Elevation

REMARKS:
Typical second floor wood window.

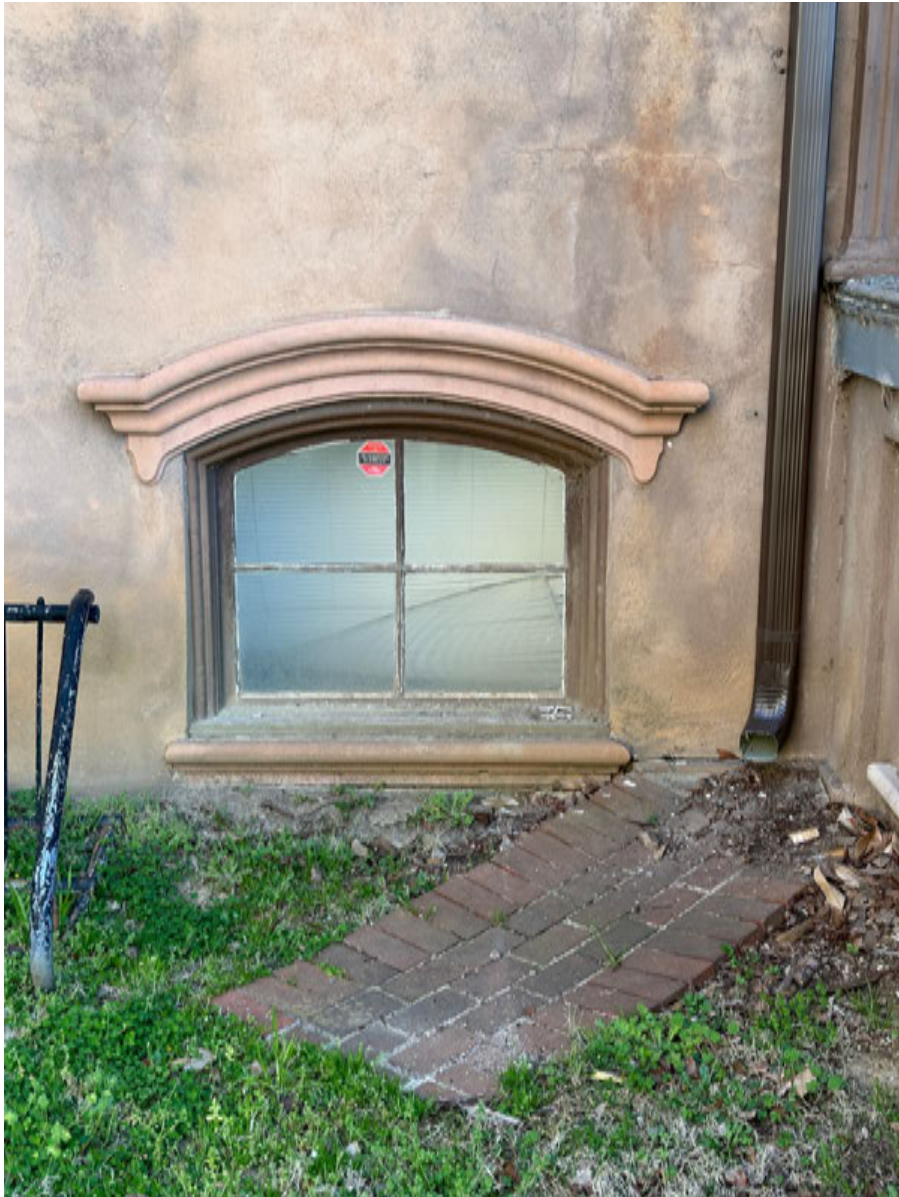
PHOTO: 1 W4 — West Elevation

REMARKS:
Typical basement wood window and drainage notes.

- Replace down spouts with historically correct round painted down spouts
- Waterproof outside of foundation wall see report for additional information
- Connect down spouts below grade and pipe from foundation
- Provide positive slope of grade away from building

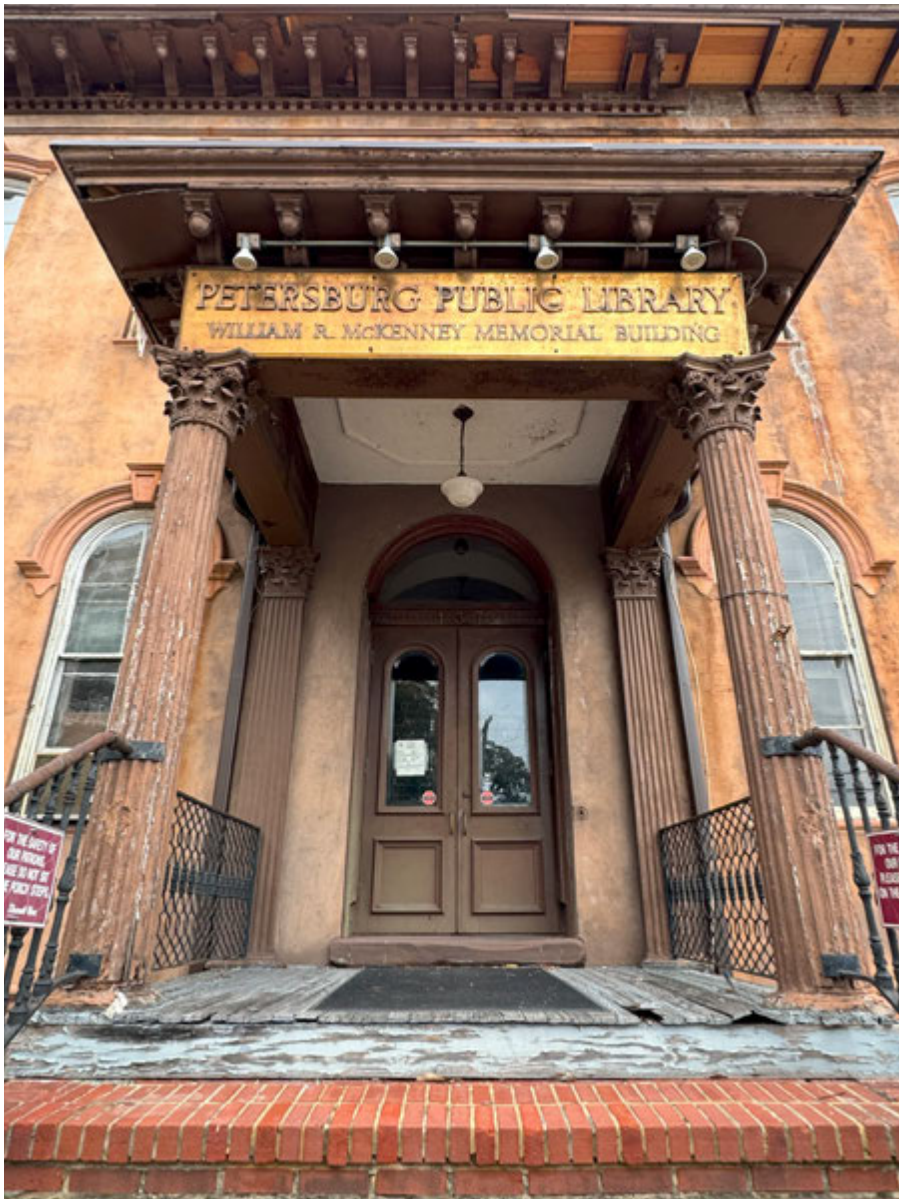
PHOTO: 1 W8 — West Elevation

REMARKS:
Front entrance door.

- Temporarily support porch roof.
- Remove railings and refinish at paint shop. Remove paint, prime and paint with high performance epoxy paint system
- Remove porch columns and take to shop for repairs.

- Repair small deteriorated wood areas and decorated pieces with epoxy wood consolidator solution and epoxy wood patches.
- Remove and replace larger sections of rotten wood with new rot resistant wood to match original.

- Repair and replace all rotten soffit materials and deteriorated decorative corbels with new rot resistant wood to match the original historic construction.

- Remove all loose and peeling paint.
- Prime surfaces with an oil base primer and two finish coats of paint.
- Remove floor construction and non original brick steps.

- Repair and rebuild brick walls below porch and install new stucco coating.
- Reframe wood porch floor structure and install waterproof membrane above new plywood decking.

- Install new sleepers above waterproofing and install floating 5/4 tongue and groove wood flooring

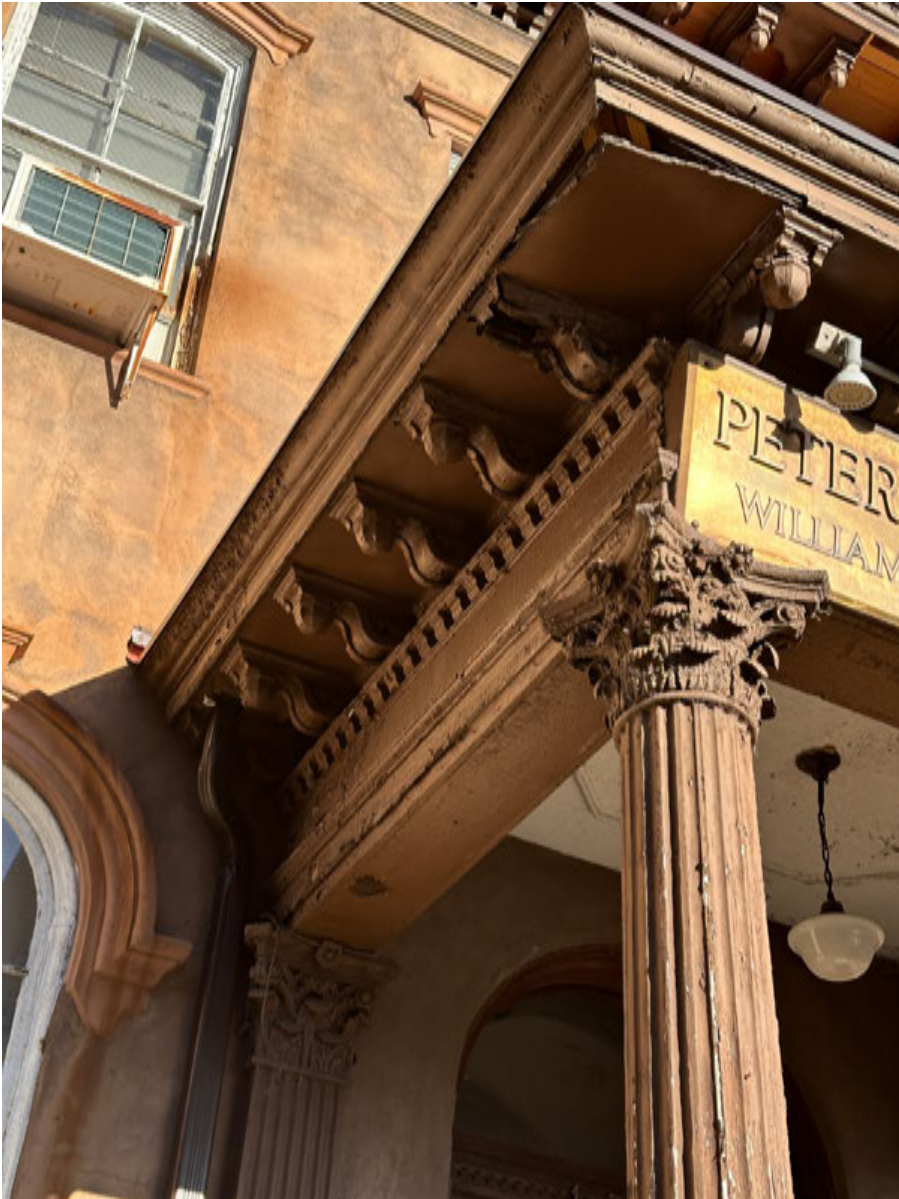
PHOTO: 1 W10 — West Elevation

REMARKS:
Front porch beam and column capital.

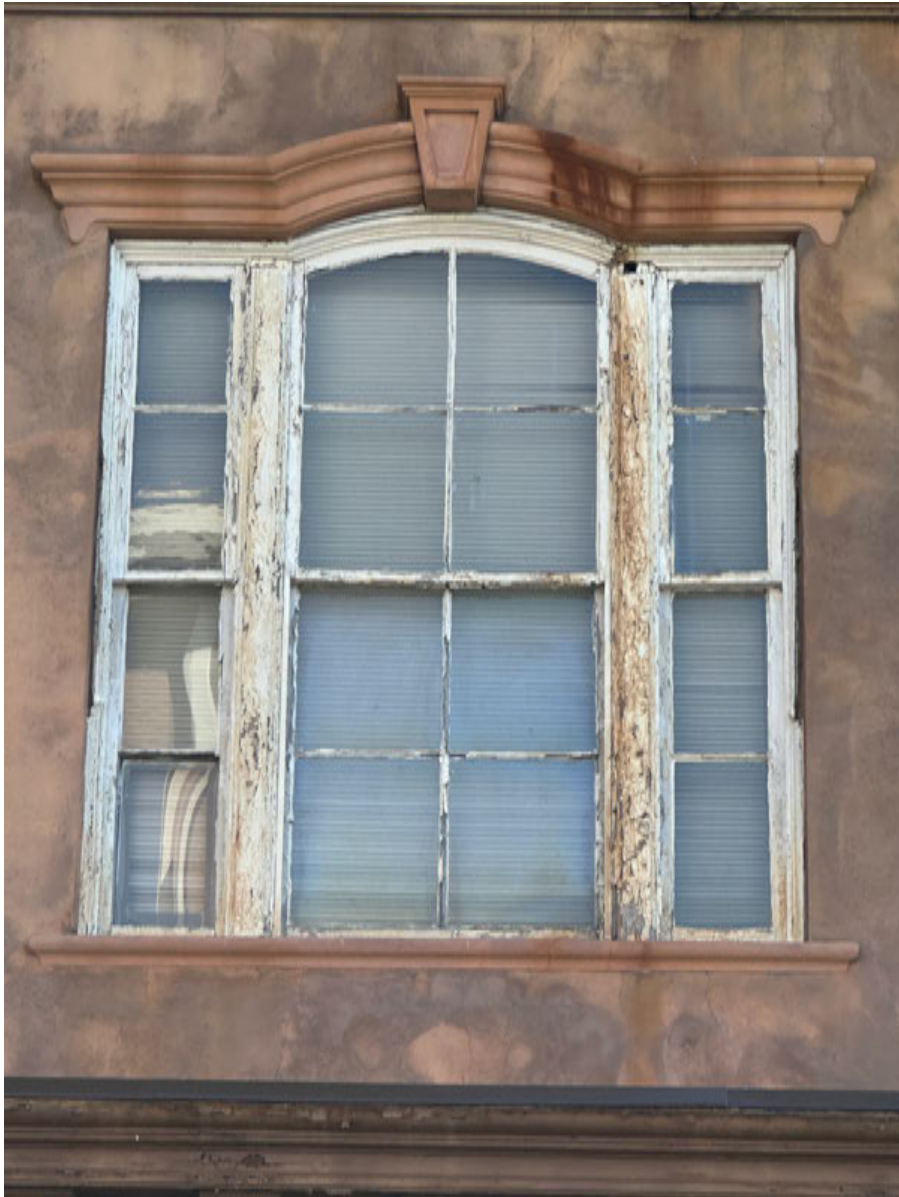
PHOTO: 1 W12 — West Elevation

REMARKS:
Front Windows.

- Clean stains from stone window surround and wall.
- Remove rotten wood at mullion and replace with rot resistant wood.
- Prime and paint with two finish coats.

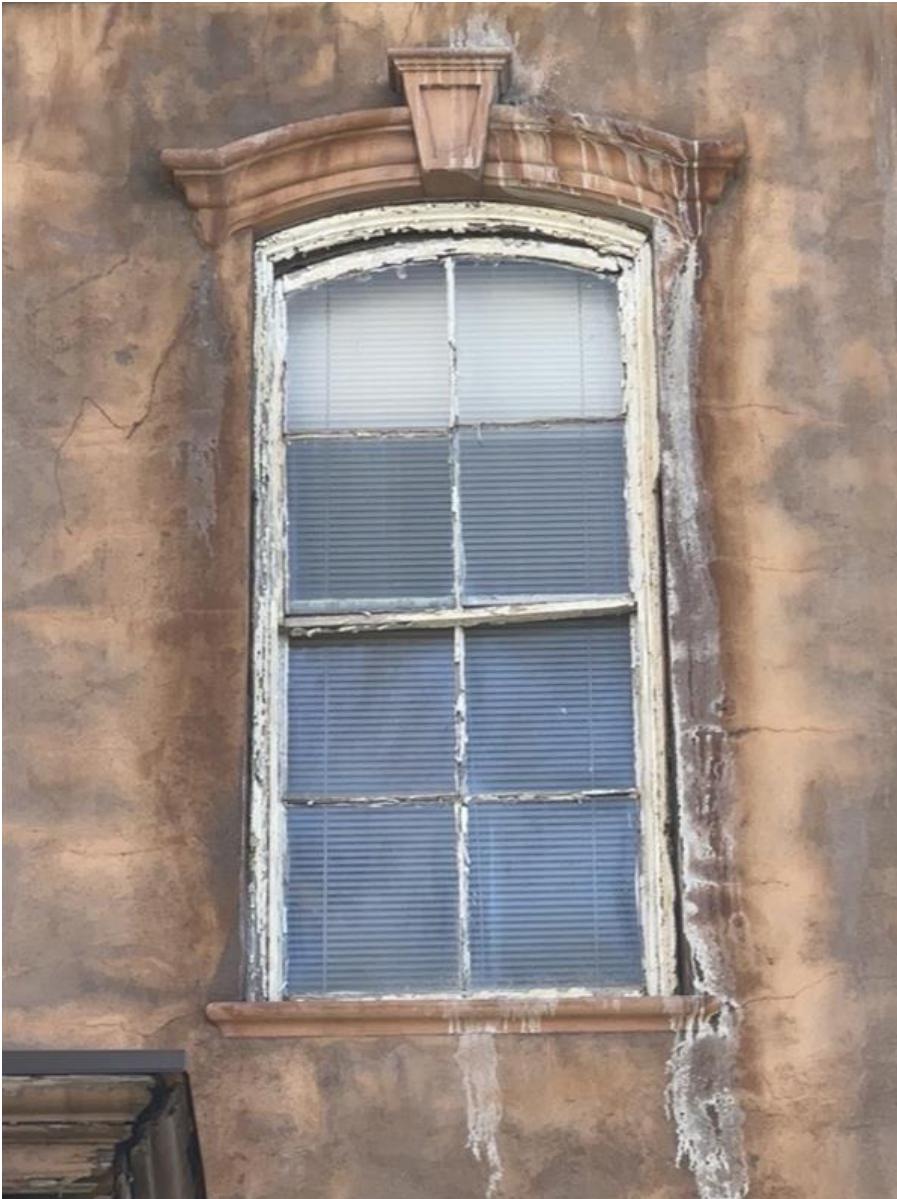
PHOTO: 1 W13 — West Elevation

- Check rail joint has failed and sash is racked and sagging.
- Remove sash and repair and rebuild check rail to straighten and secure sash.
- Replace any rotten sash pieces with rot resistant wood.
- Verify condition of stucco adjacent to window. Remove any deteriorated and loose stucco and patch to match original condition.
- Clean stains from wall and window surround.

REMARKS:
Window repair.

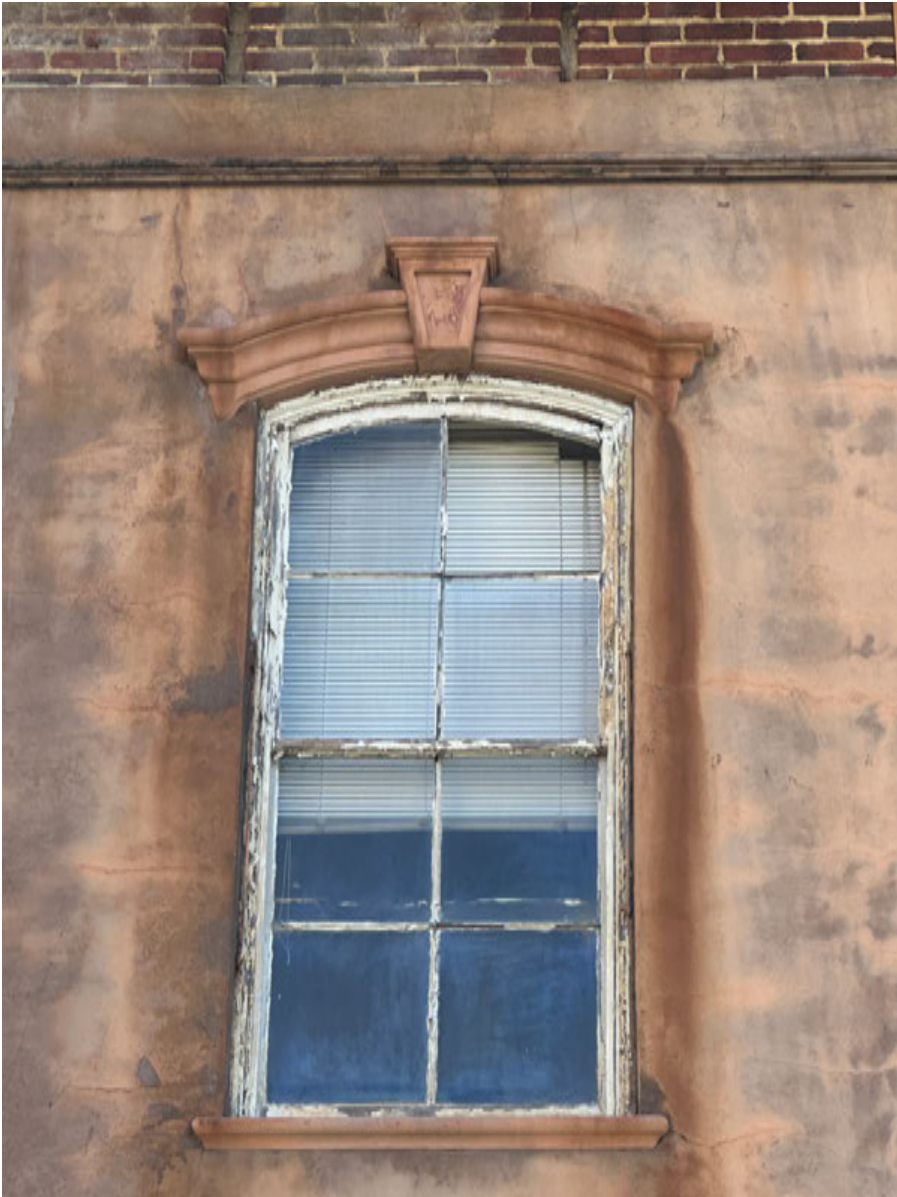
PHOTO: 1 W14 — West Elevation

REMARKS:
Window repair.

- Replace broken window panes

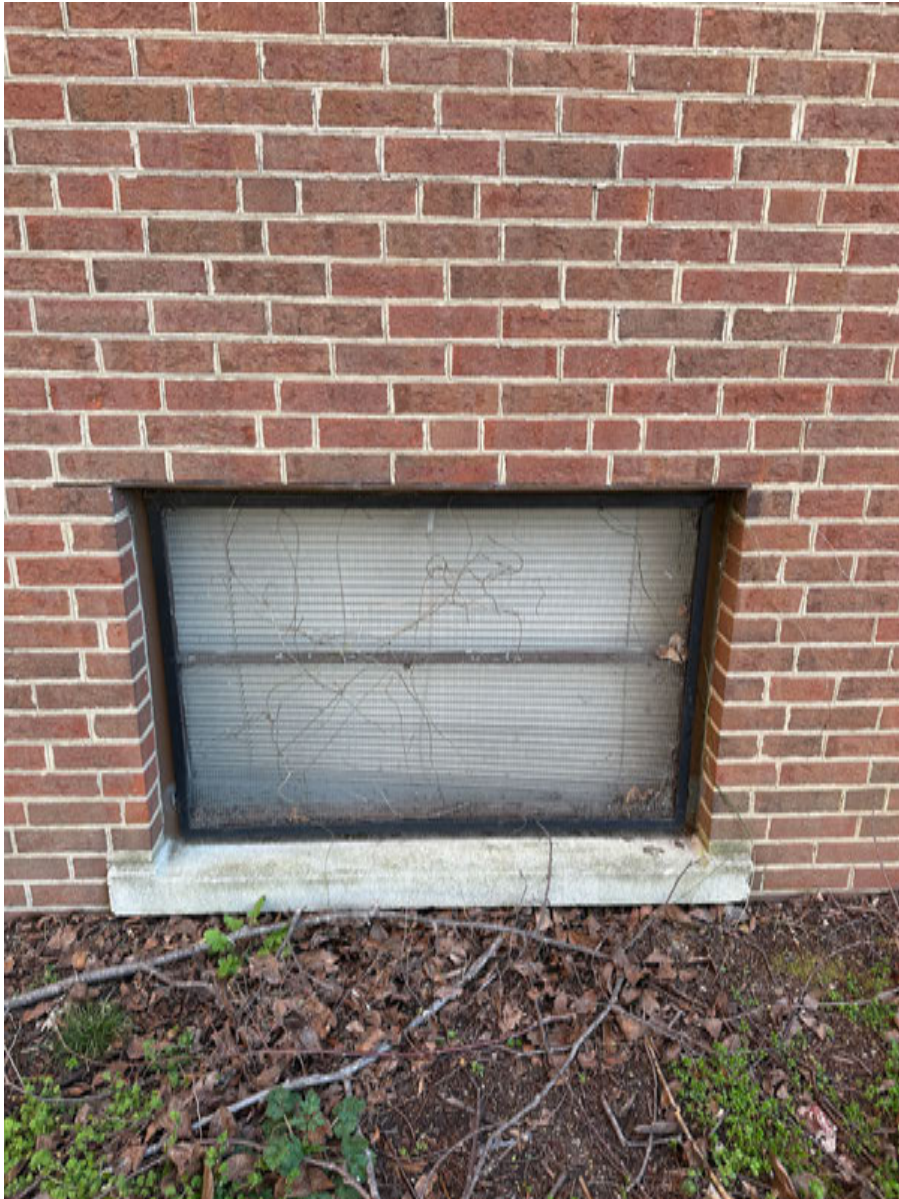
PHOTO: 2 W1 — West Elevation

REMARKS:
Basement window replacement.

- Replace window with aluminum storefront window.

- Remove paint and rust from lintel

- Clean brick facade and cast stone sills to remove stains.

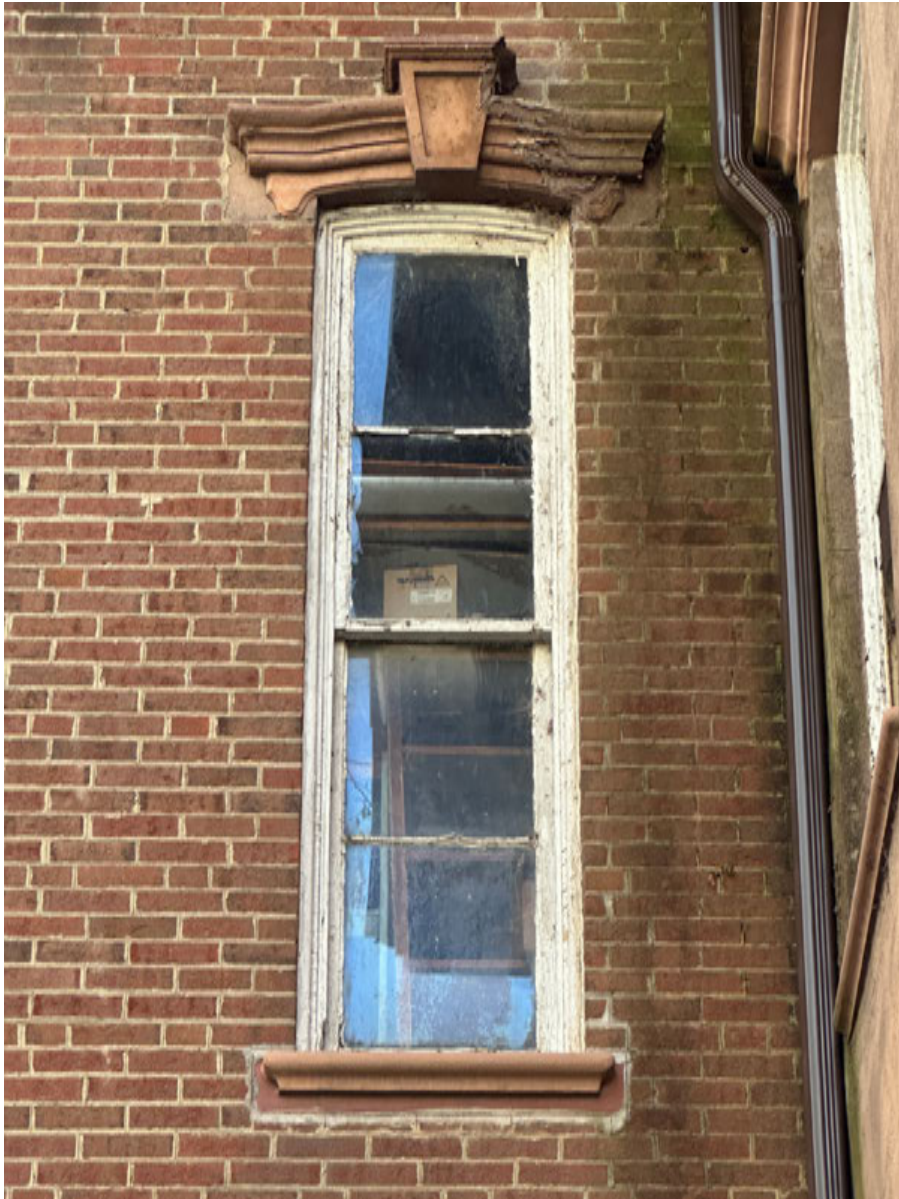
PHOTO: 2 W6 — West Elevation

REMARKS:
Window repairs.

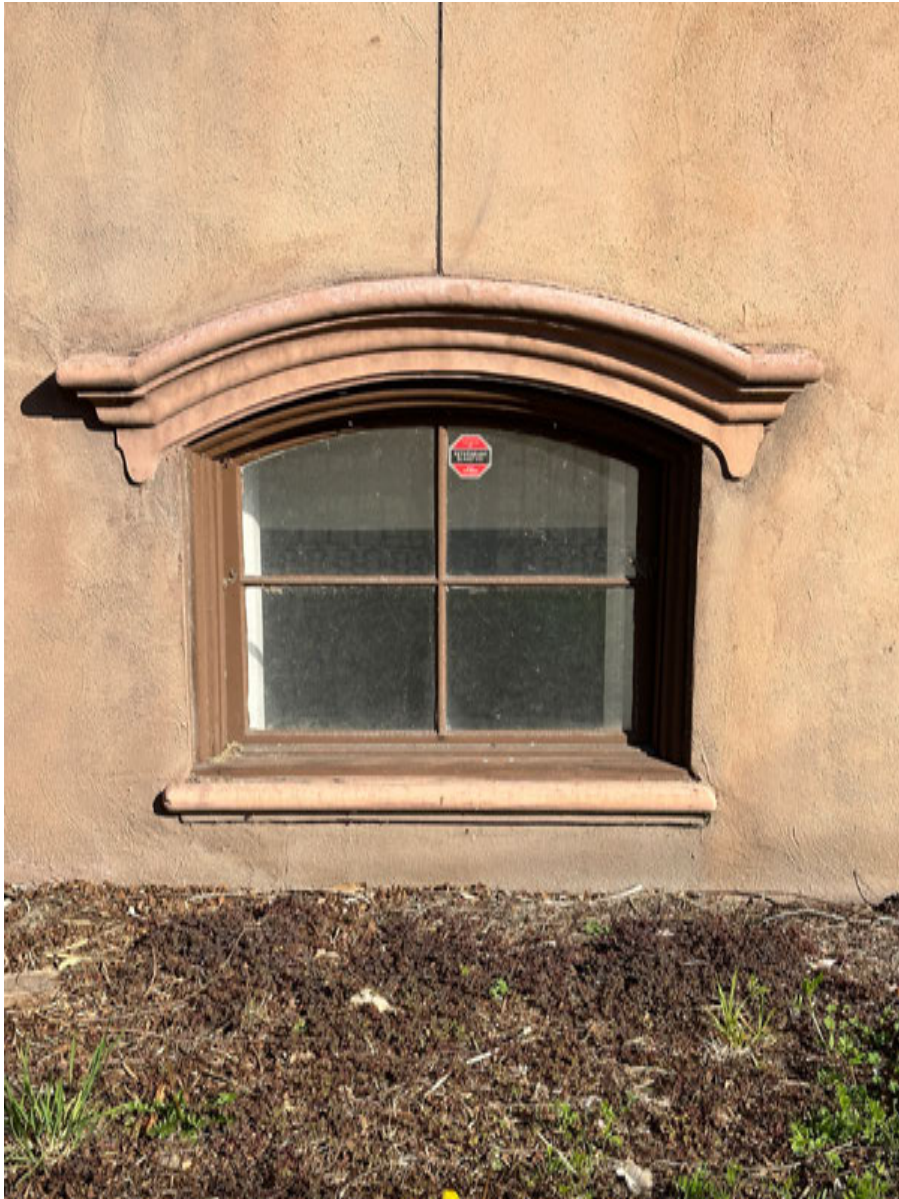
PHOTO: 5 S1 — South Elevation

REMARKS:
Window repairs.

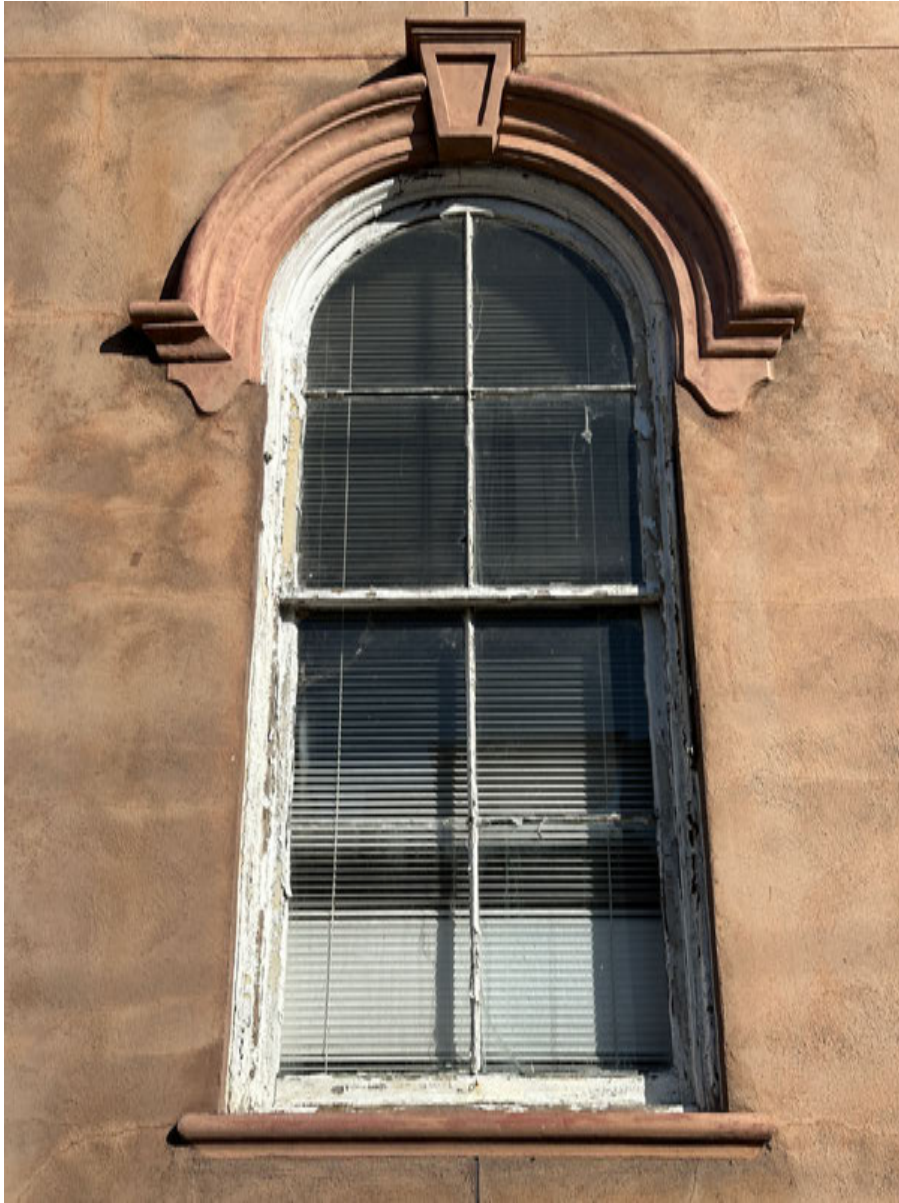
PHOTO: 5 S2 — South Elevation

REMARKS:
Window Repairs.

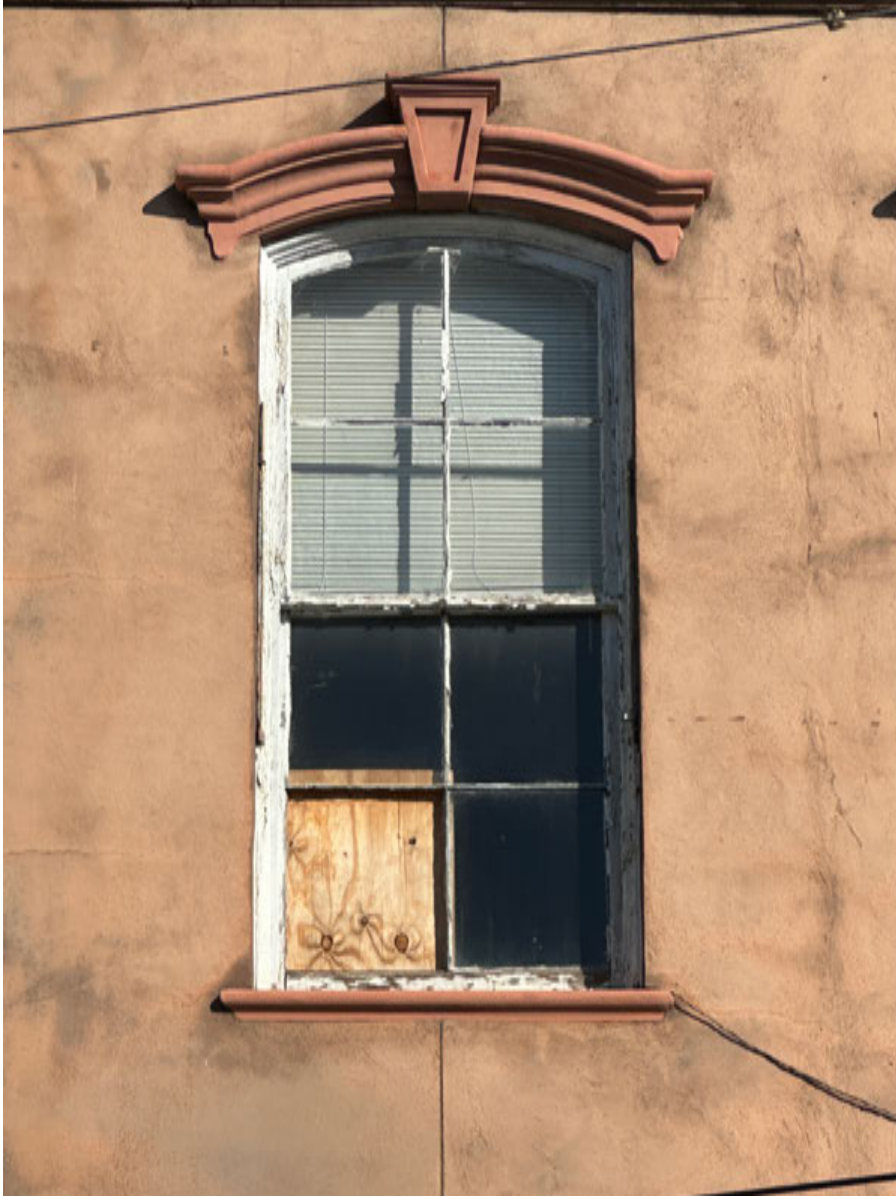
PHOTO: 5 S3 — South Elevation

REMARKS:
Window repairs.

- Replace window pane in bottom
sash

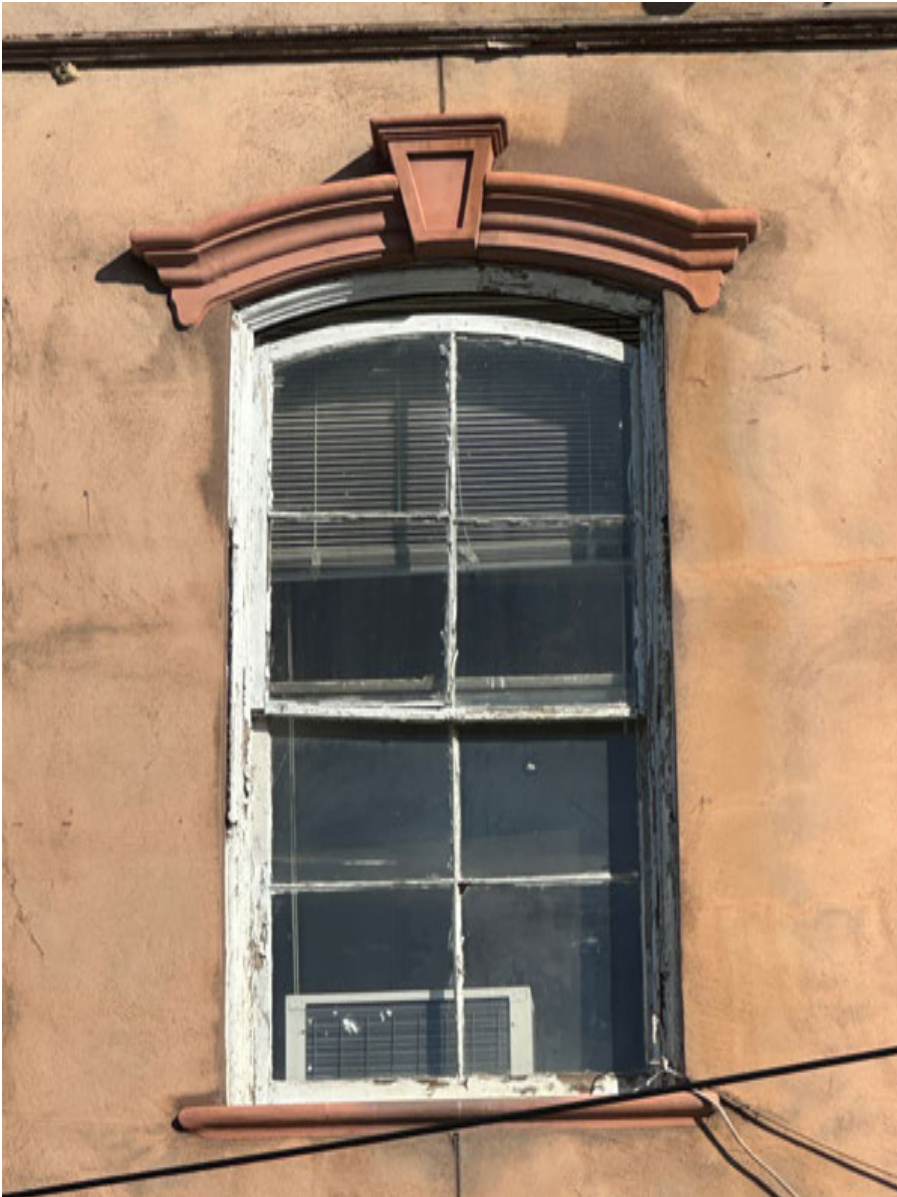
PHOTO: 5 S6 — South Elevation

- Check rail joint has failed and sash is racked and sagging.

REMARKS:
Window repairs.

- Remove sash and repair and re-build check rail to straighten and secure sash.

- Replace any rotten sash pieces with rot resistant wood.
