McKenney Library Adaptive Reuse Study

Petersburg African American History, Cultural Center, and Archives

May 1st, 2024

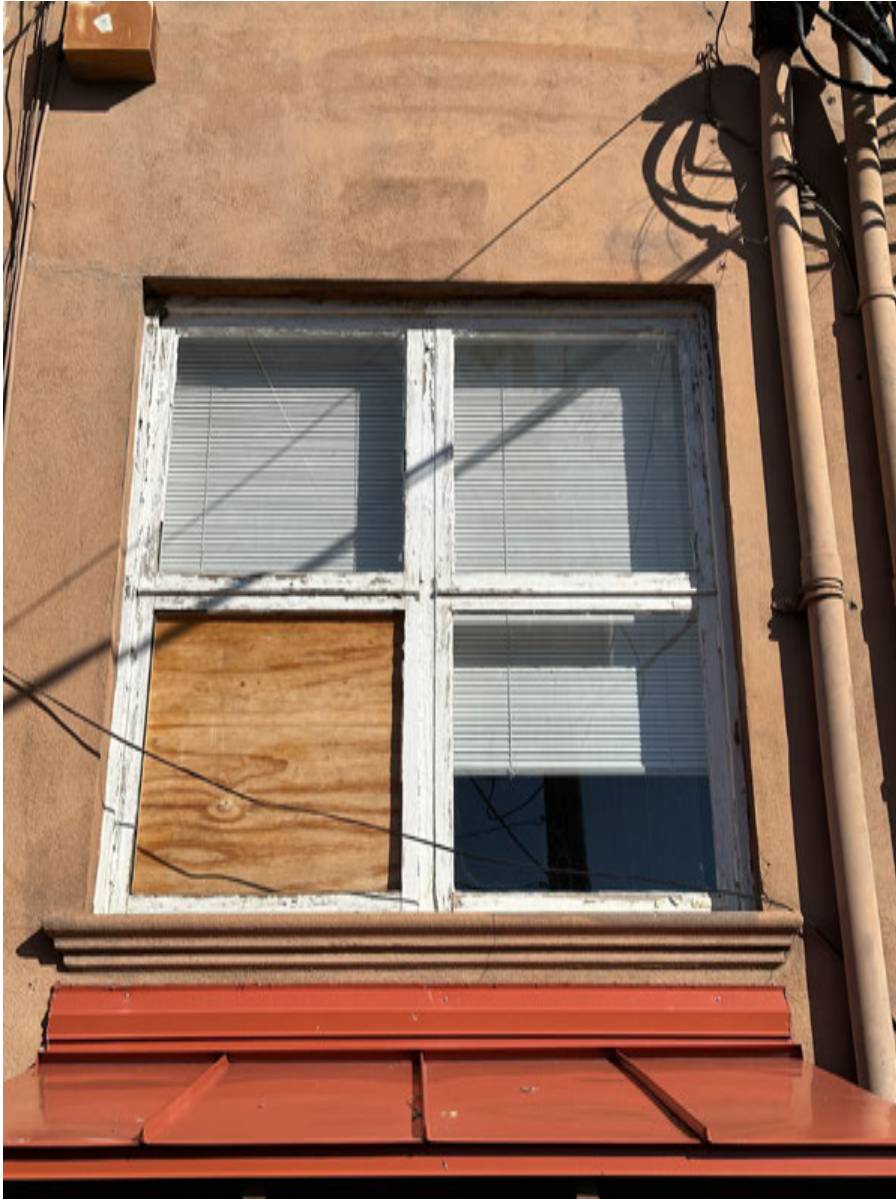
PHOTO: 5 S9 — South Elevation

REMARKS:
Window repairs.

- Replace missing window pane

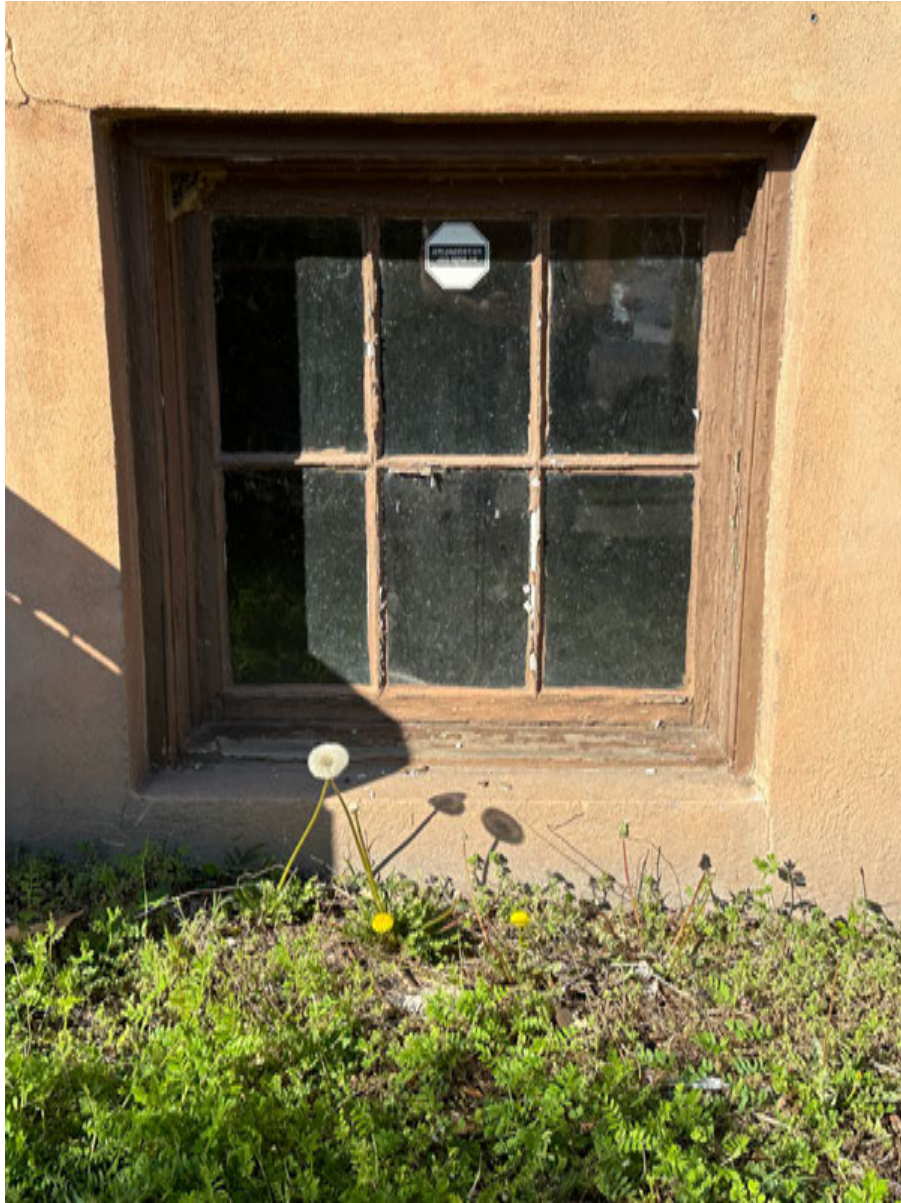
PHOTO: 5 S10 — South Elevation

REMARKS:
Window repairs.

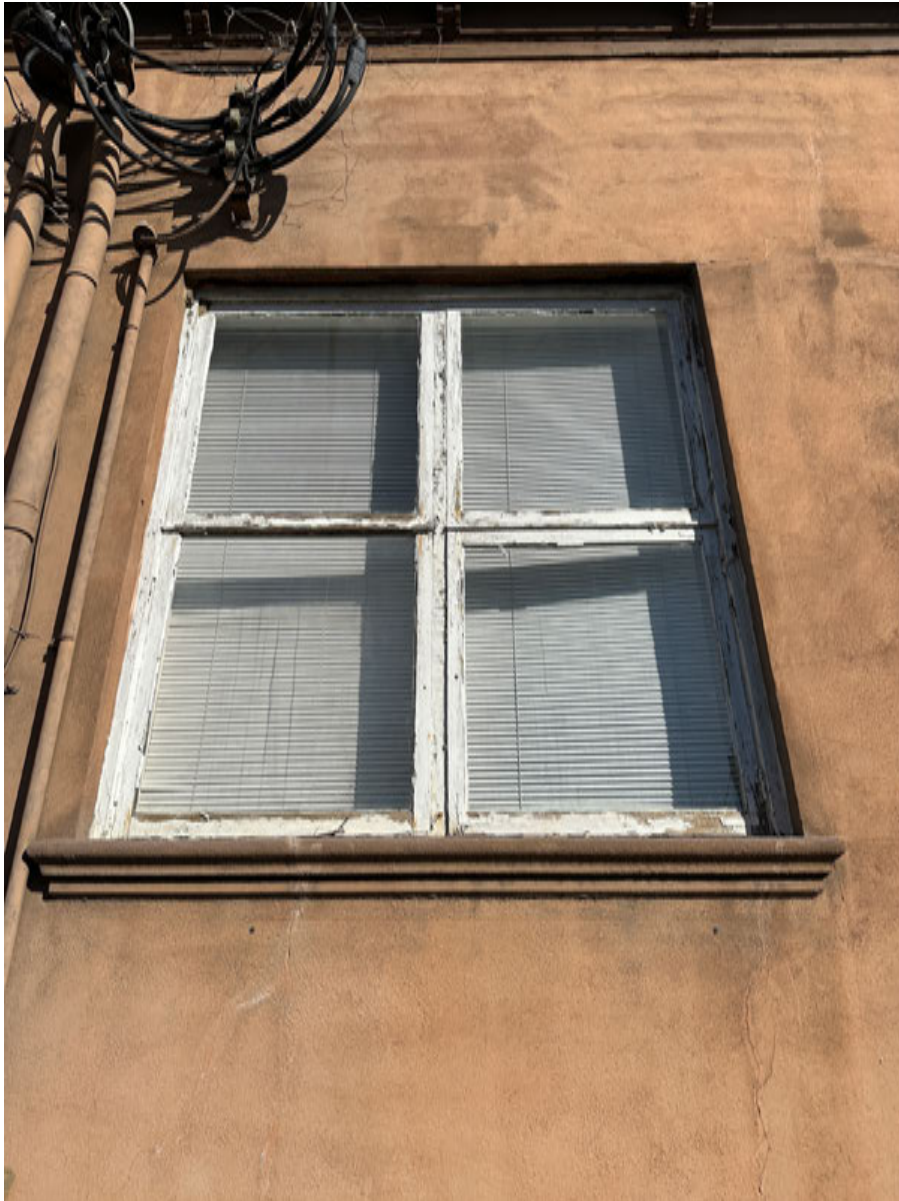
PHOTO: 5 S11 — South Elevation

REMARKS:
Window repairs.

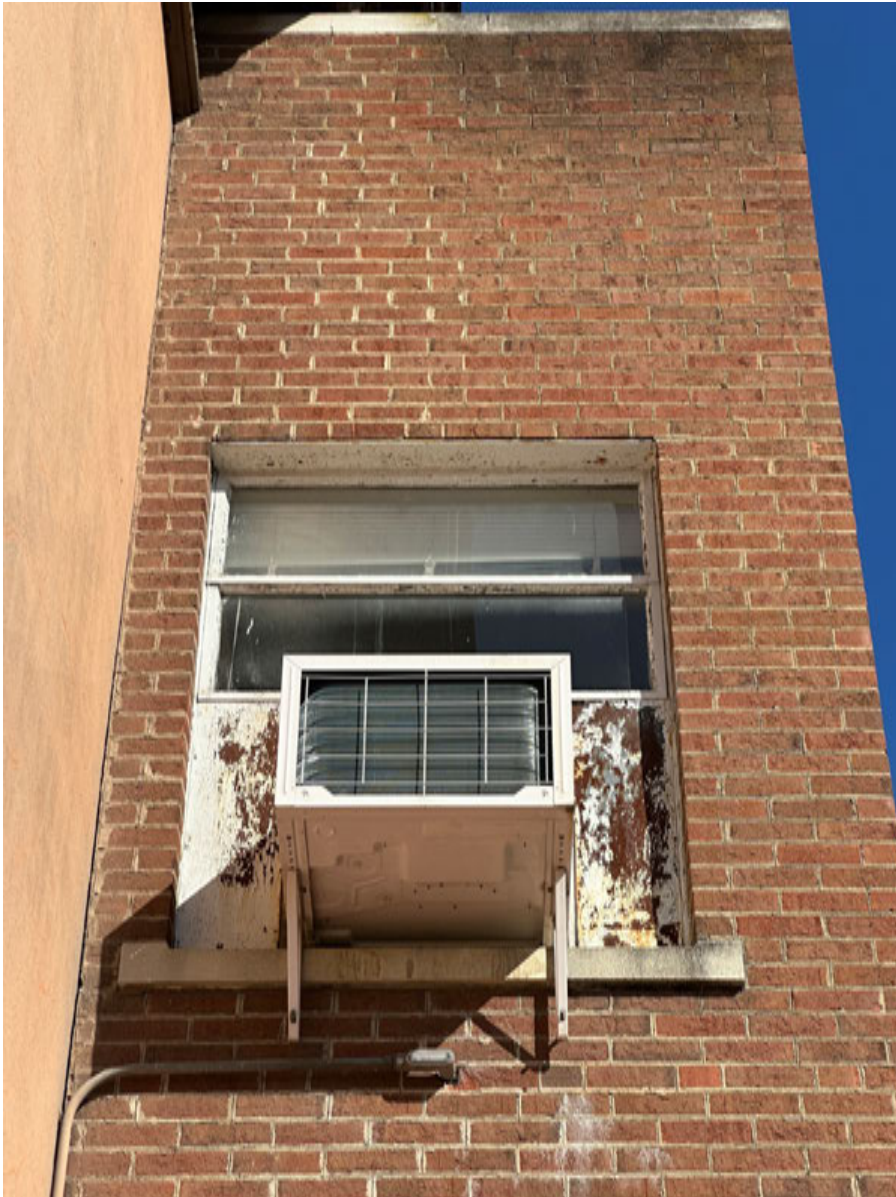
PHOTO: 6 S2 — South Elevation

REMARKS:
Window replacement.

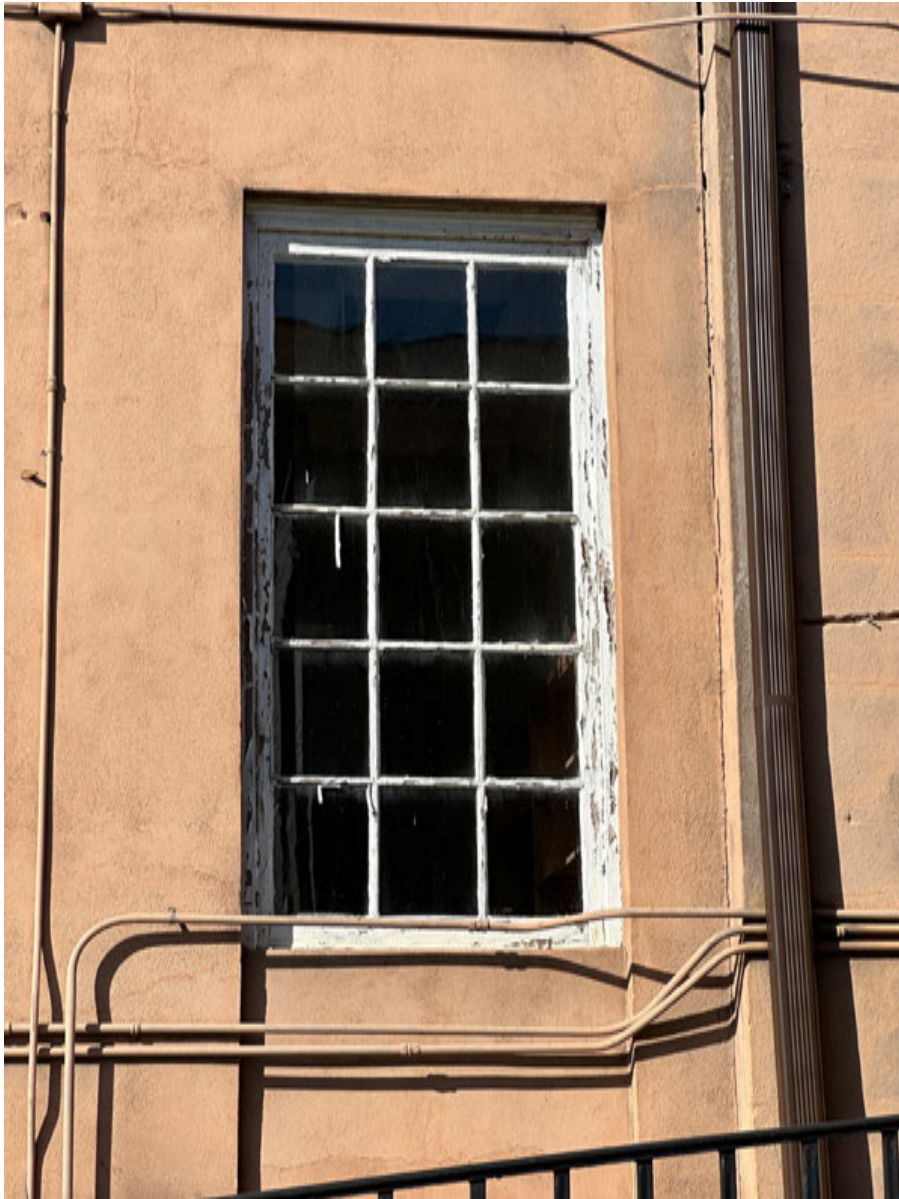
PHOTO: 7 E7 — East Elevation

REMARKS:
Window repairs.

- Replace down spouts with historically accurate round painted metal down spouts.

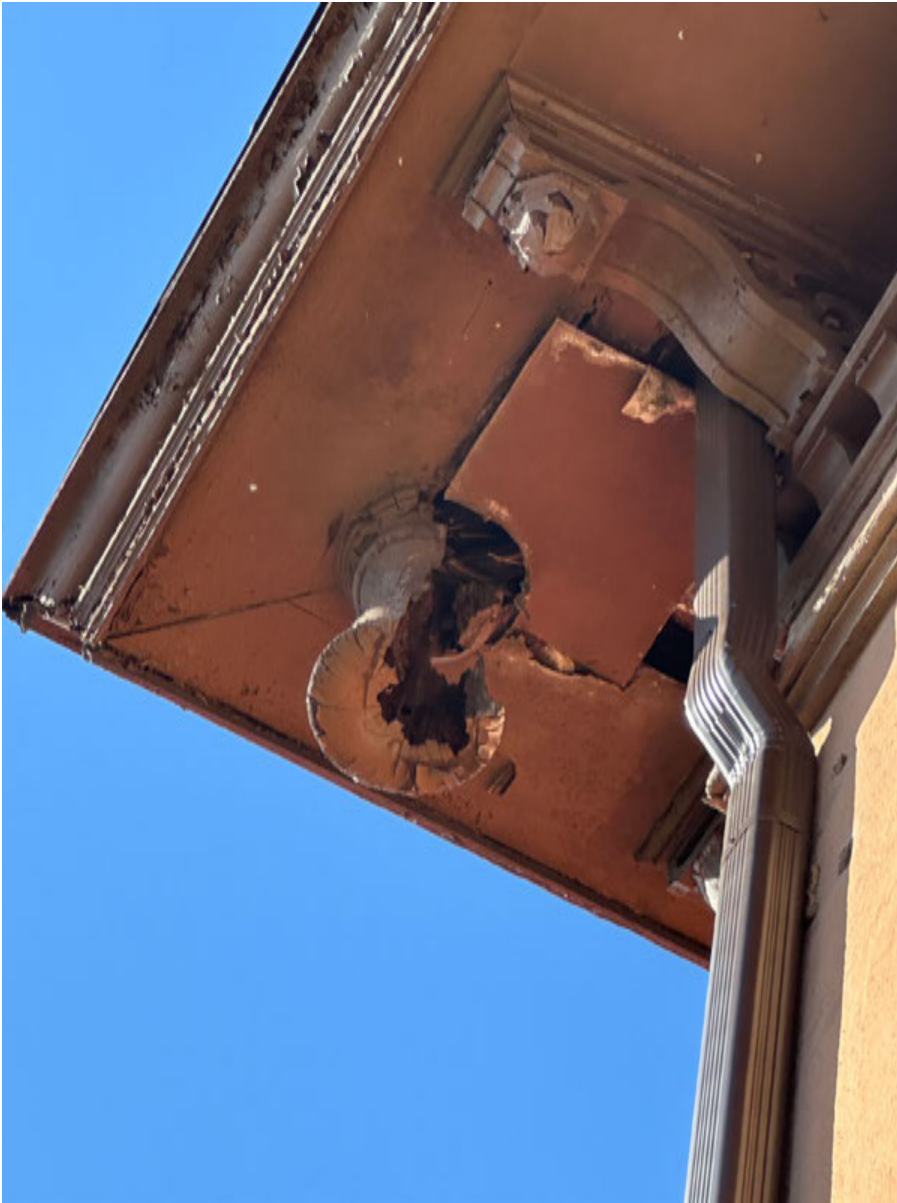
PHOTO: 8 E2 — East Elevation

REMARKS:
Soffit Repairs.

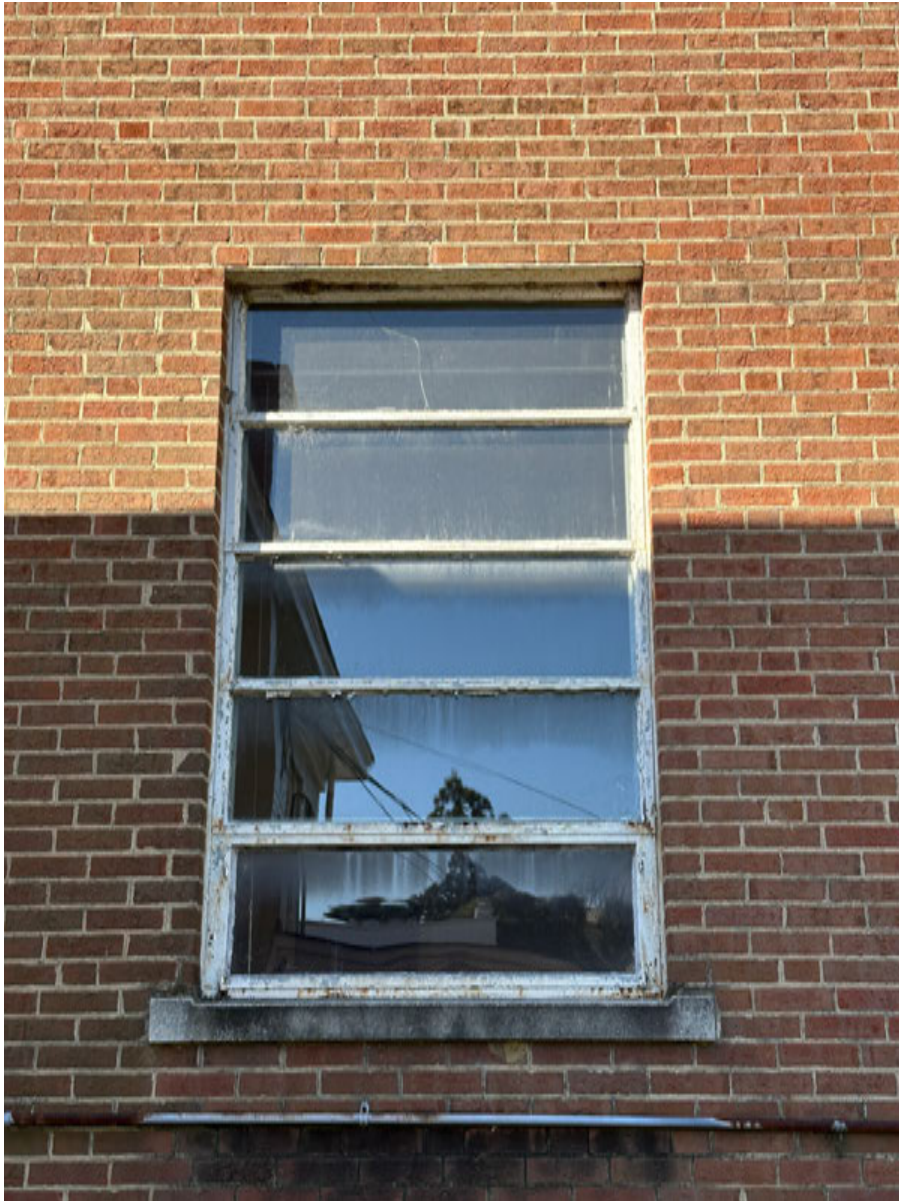
PHOTO: 9 E2 — East Elevation

REMARKS:
Windows infill.

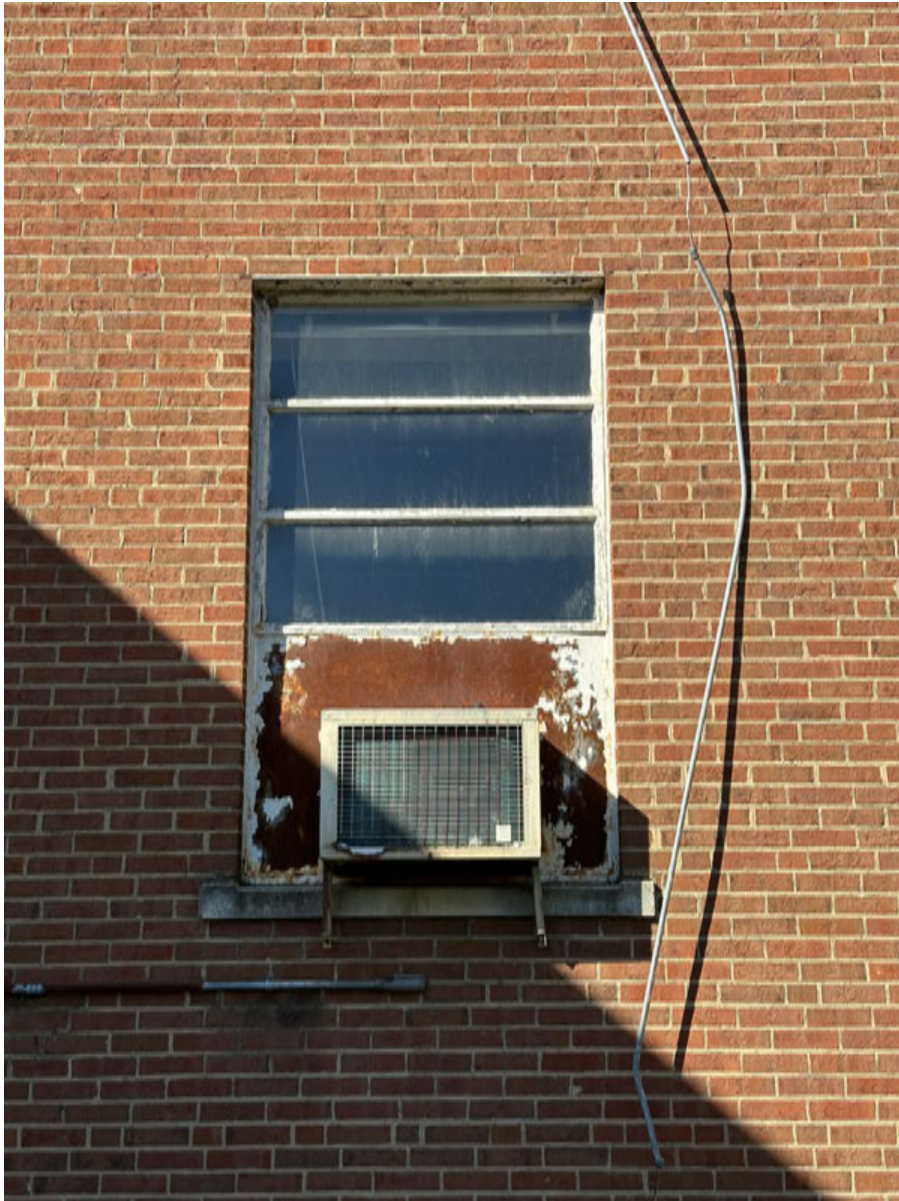
PHOTO: 9 E4 — East Elevation

REMARKS:
Window infill.

- Remove existing windows.
- Infill window opening with brick to create fire rated wall for protection from adjacent property.

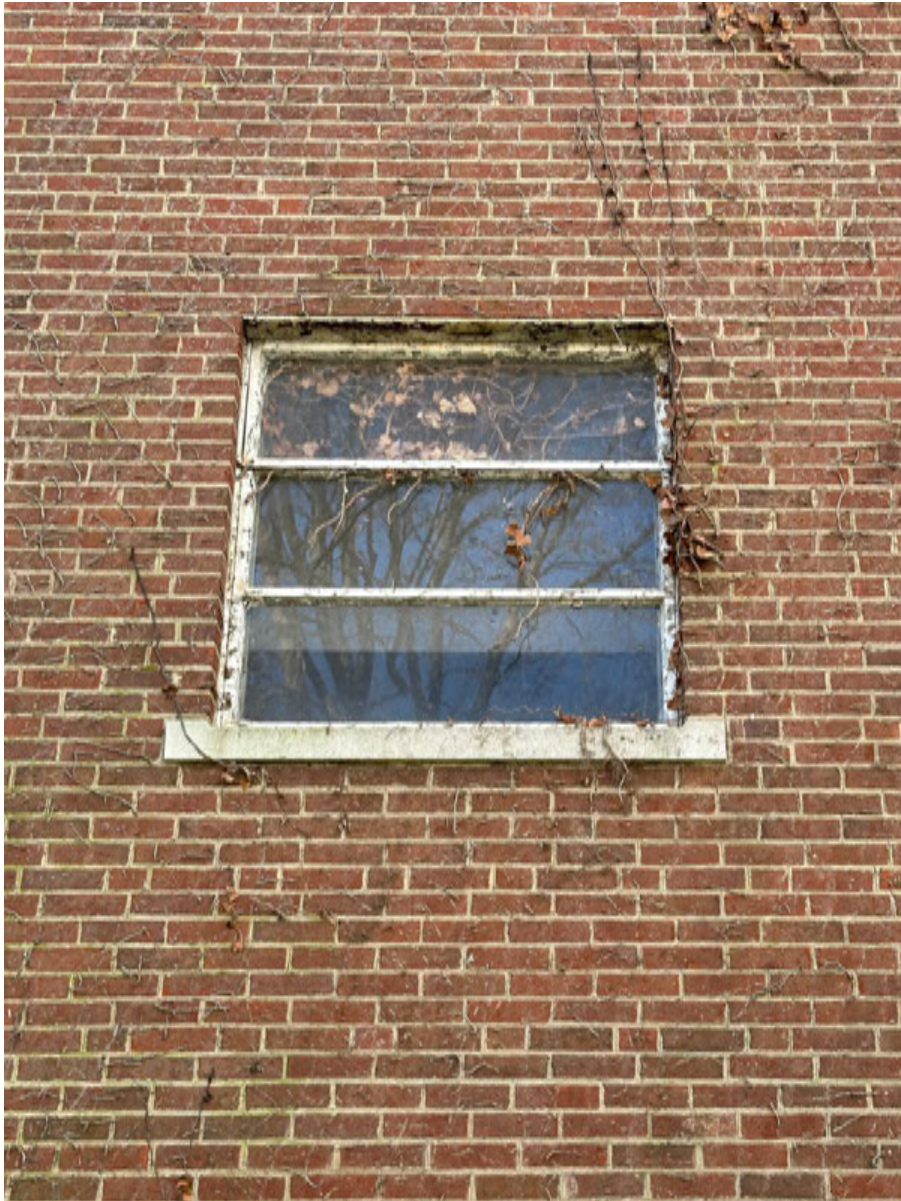
PHOTO: 10 N1 — North Elevation

REMARKS:
Window infill.

- See 9 E4 for typical notes.

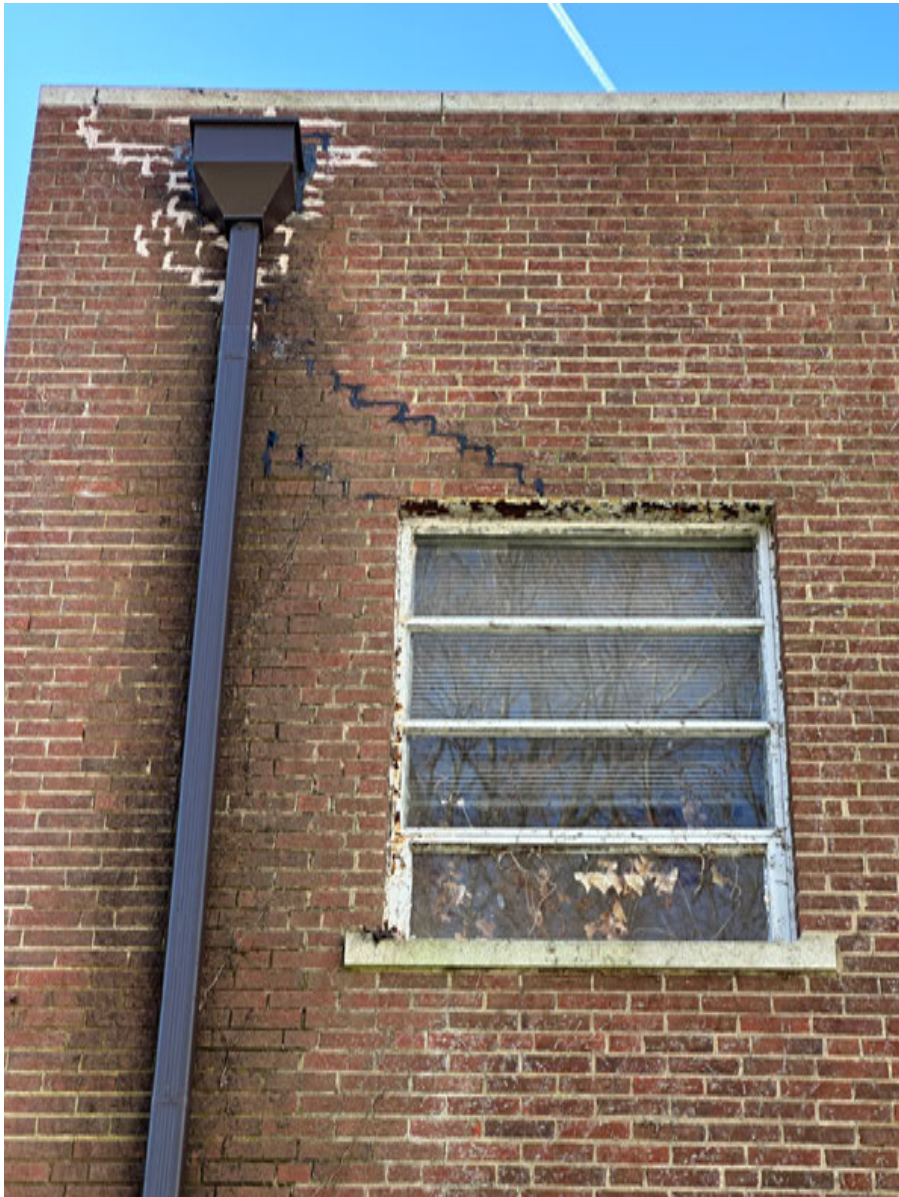
PHOTO: 10 N2 — North Elevation

REMARKS:
Window infill and masonry repairs.

- Remove sealant from brick.
- Remove deteriorated steel lintel angle and infill window opening with new brick.
- Rebuild loose brick areas.
- Repoint all joints.

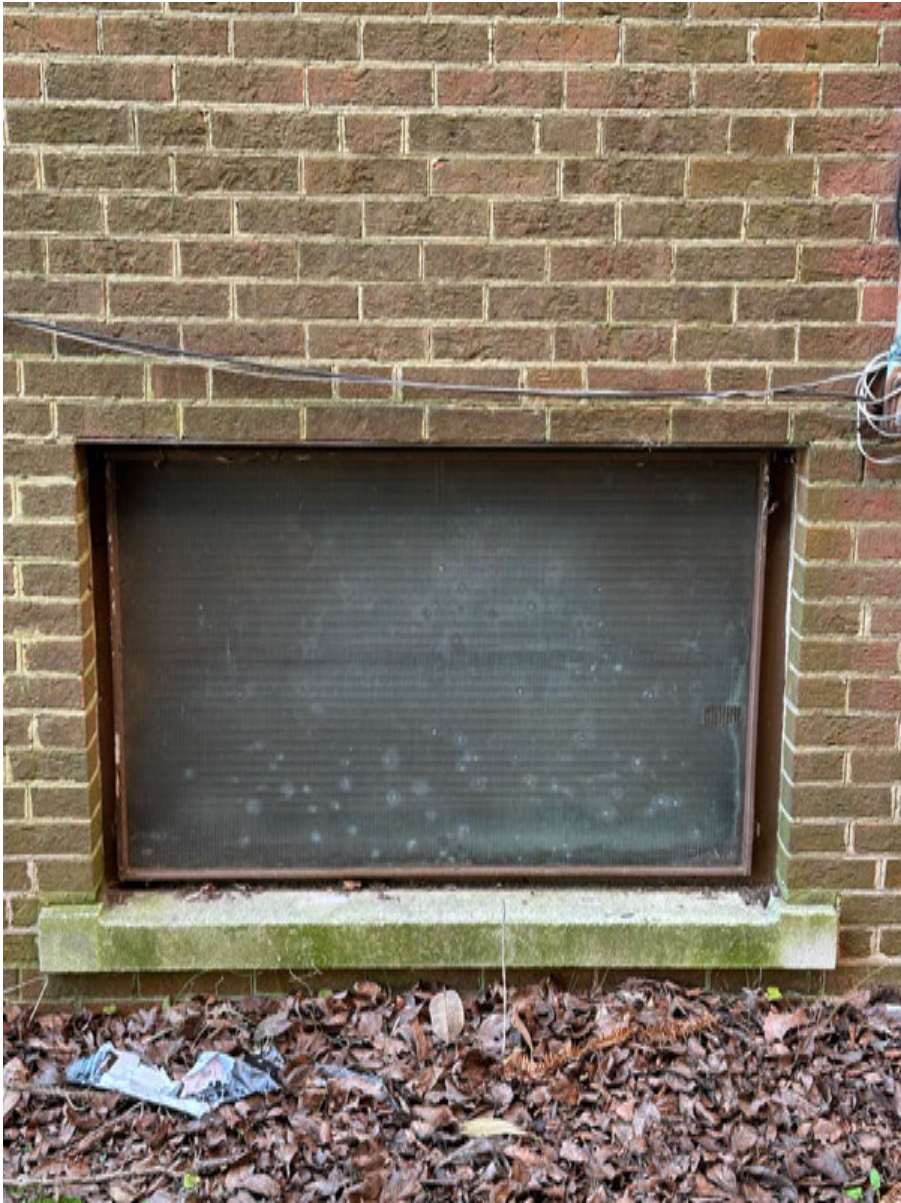
PHOTO: 11 N1 — North Elevation

REMARKS:
Window infill.

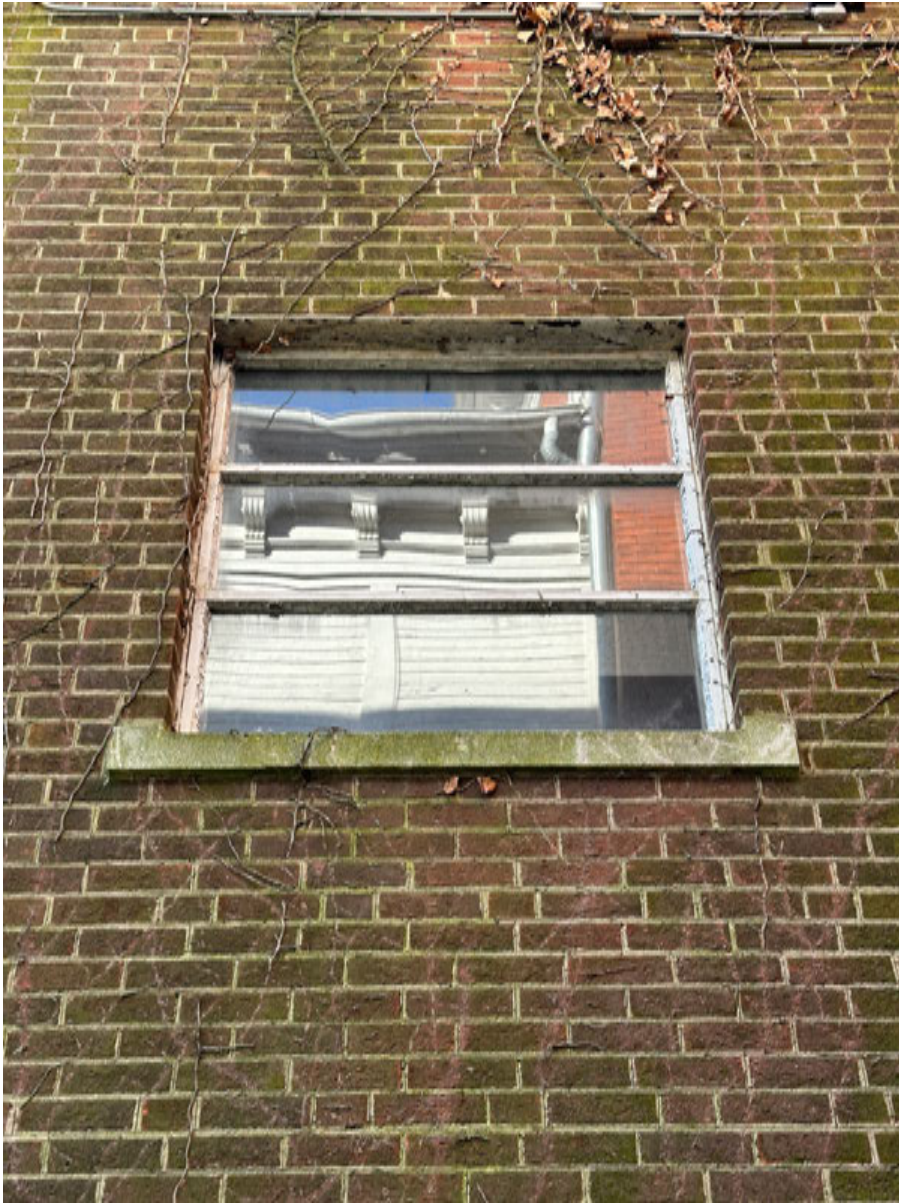
PHOTO: 11 N2 — North Elevation

REMARKS:
Window infill.

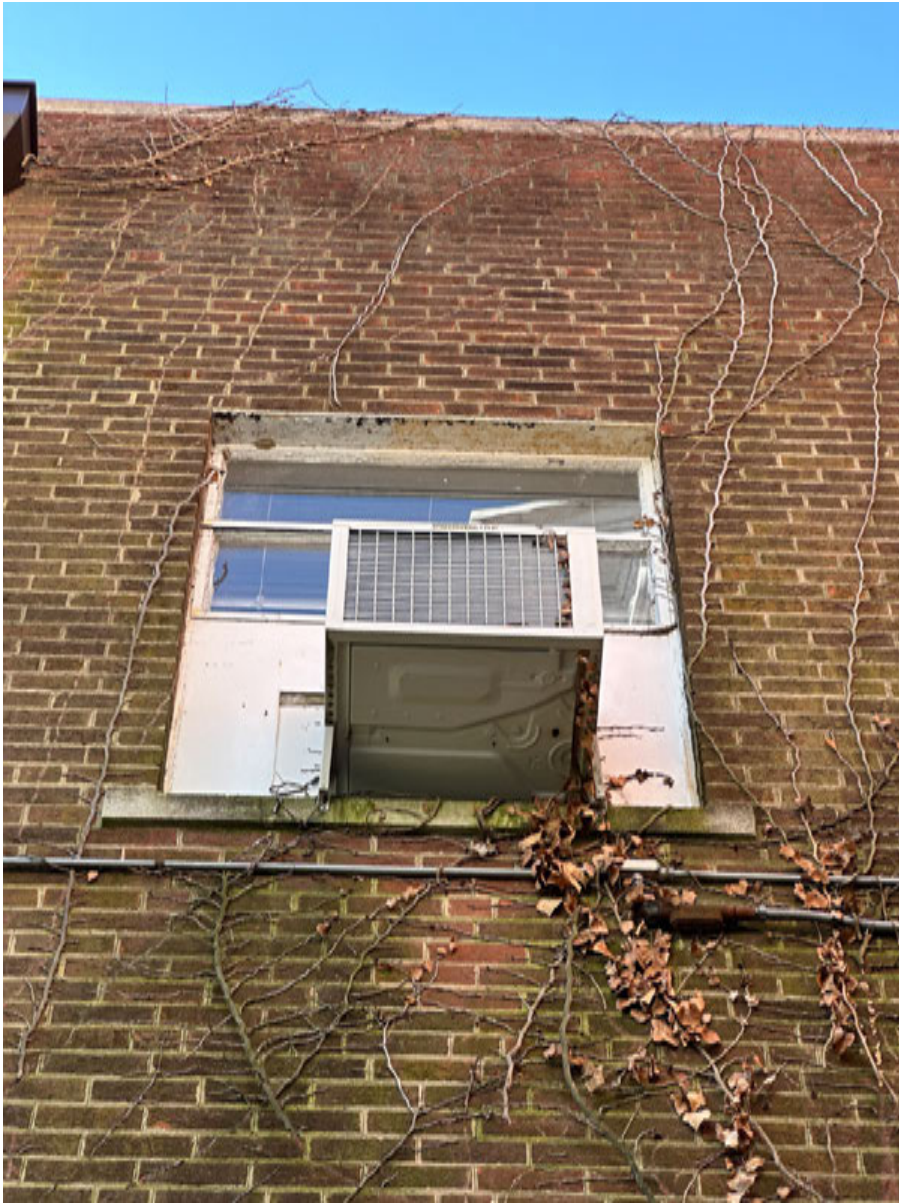
PHOTO: 11 N3 — North Elevation

REMARKS:
Window infill.

- Remove air conditioning unit, do not replace.

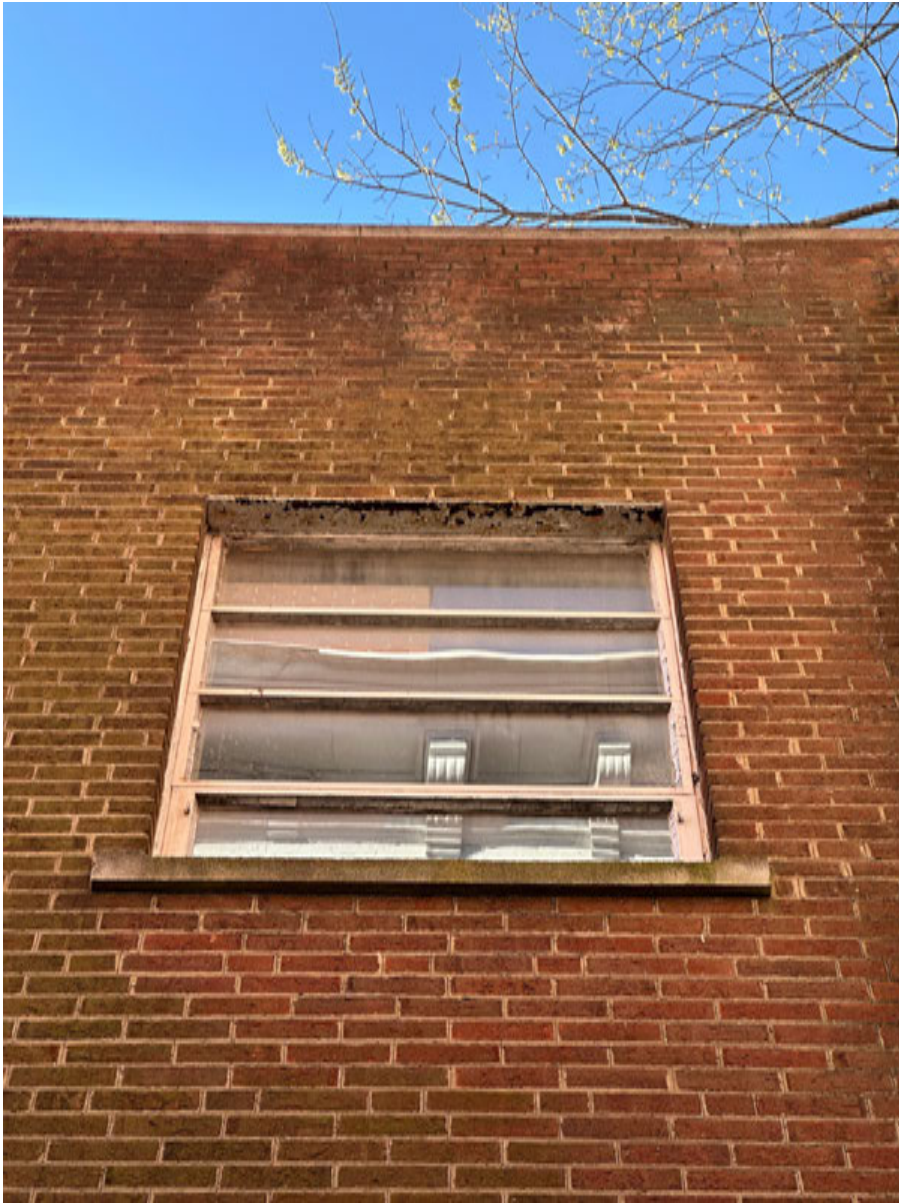
PHOTO: 11 N4 — North Elevation

REMARKS:
Window infill.

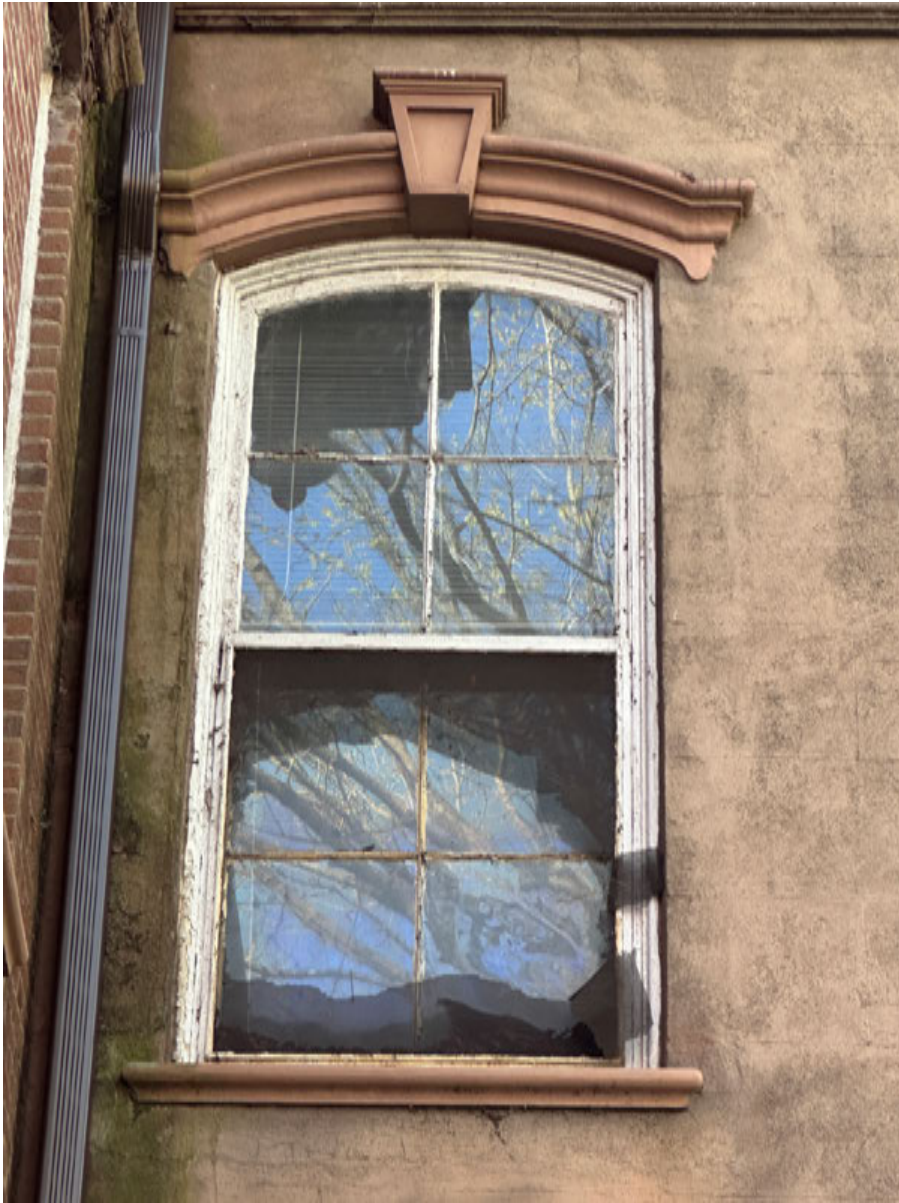
PHOTO: 12 N1 — North Elevation

REMARKS:
Window repair.

- Remove screen on lower sash
