McKenney Library Adaptive Reuse Study

Petersburg African American History, Cultural Center, and Archives

May 1st, 2024

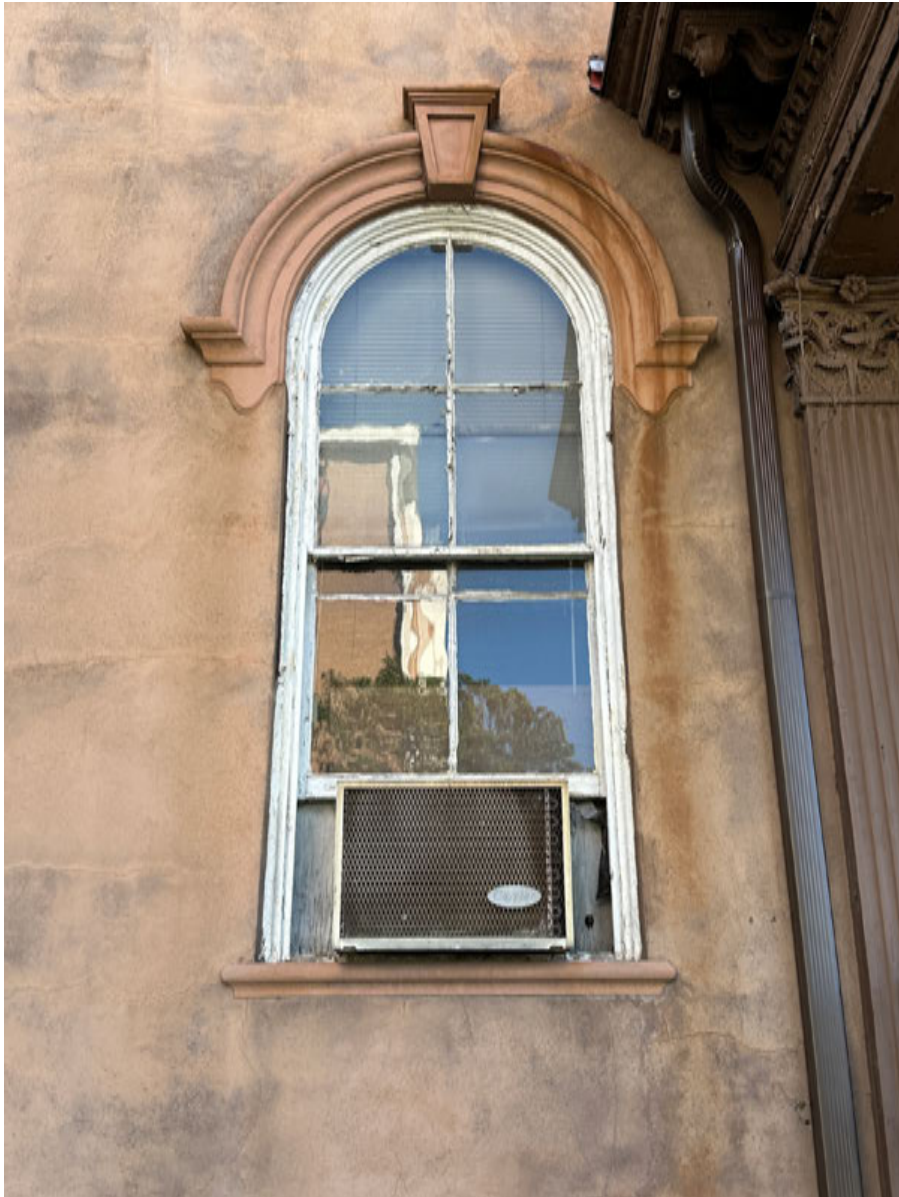
PHOTO: 1 W5 — West Elevation

REMARKS:
Window Notes.

- Remove window air unit
- Ensure bottom sash is not damaged by window unit
- Clean all stone surrounds around windows to remove stains
- Remove window air conditioning unit and enclosure, repair window frame.

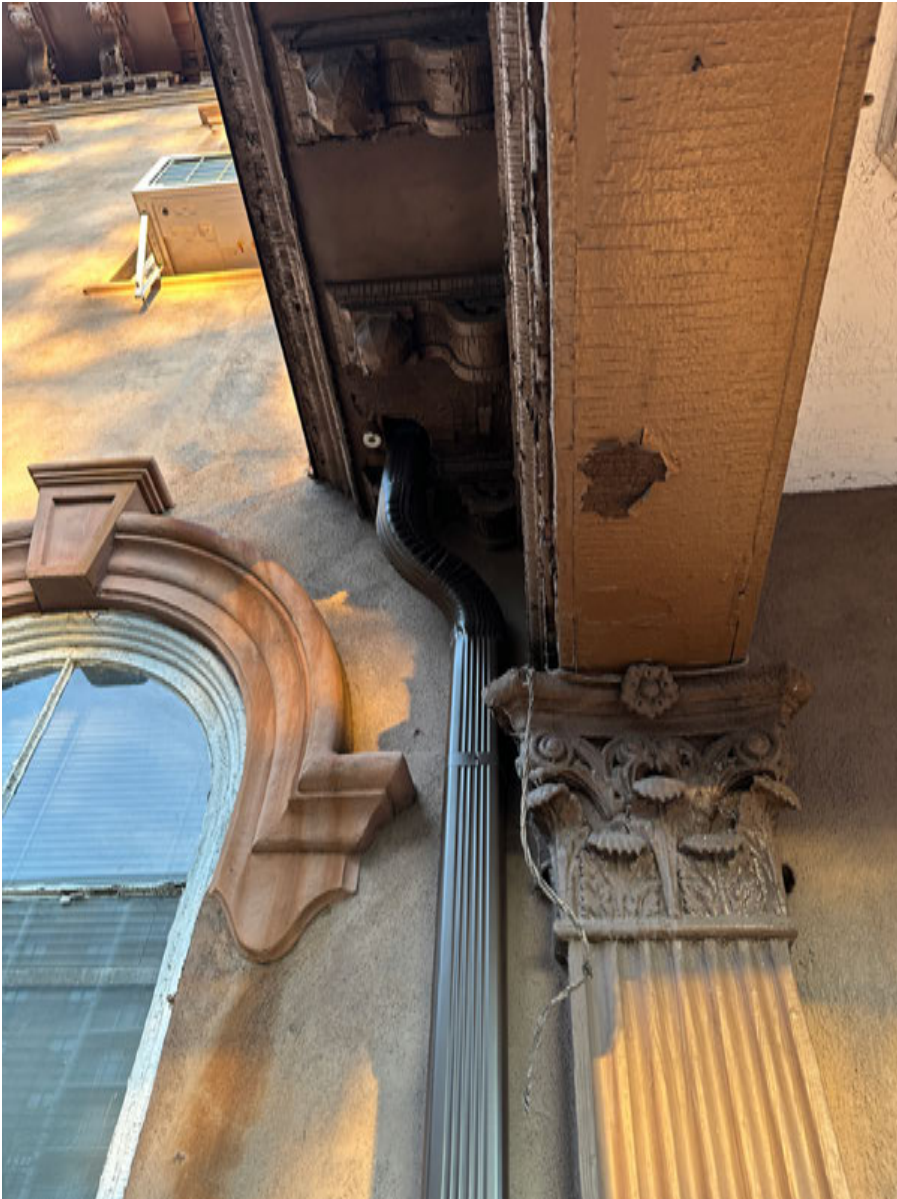
PHOTO: 1 W9 — West Elevation

REMARKS:
Front poch beam and column capital

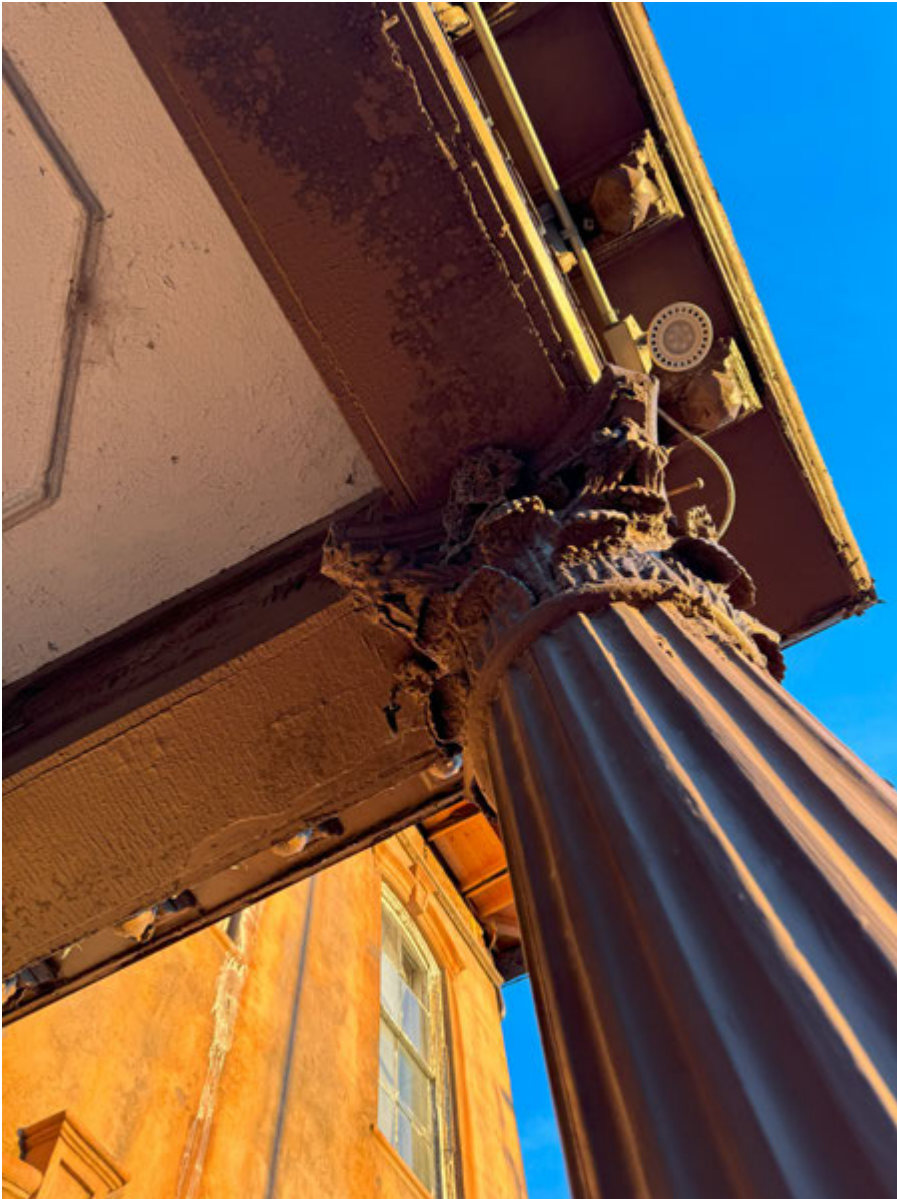
PHOTO: 1 W11 — West Elevation

REMARKS:
Front porch beam and column capital.

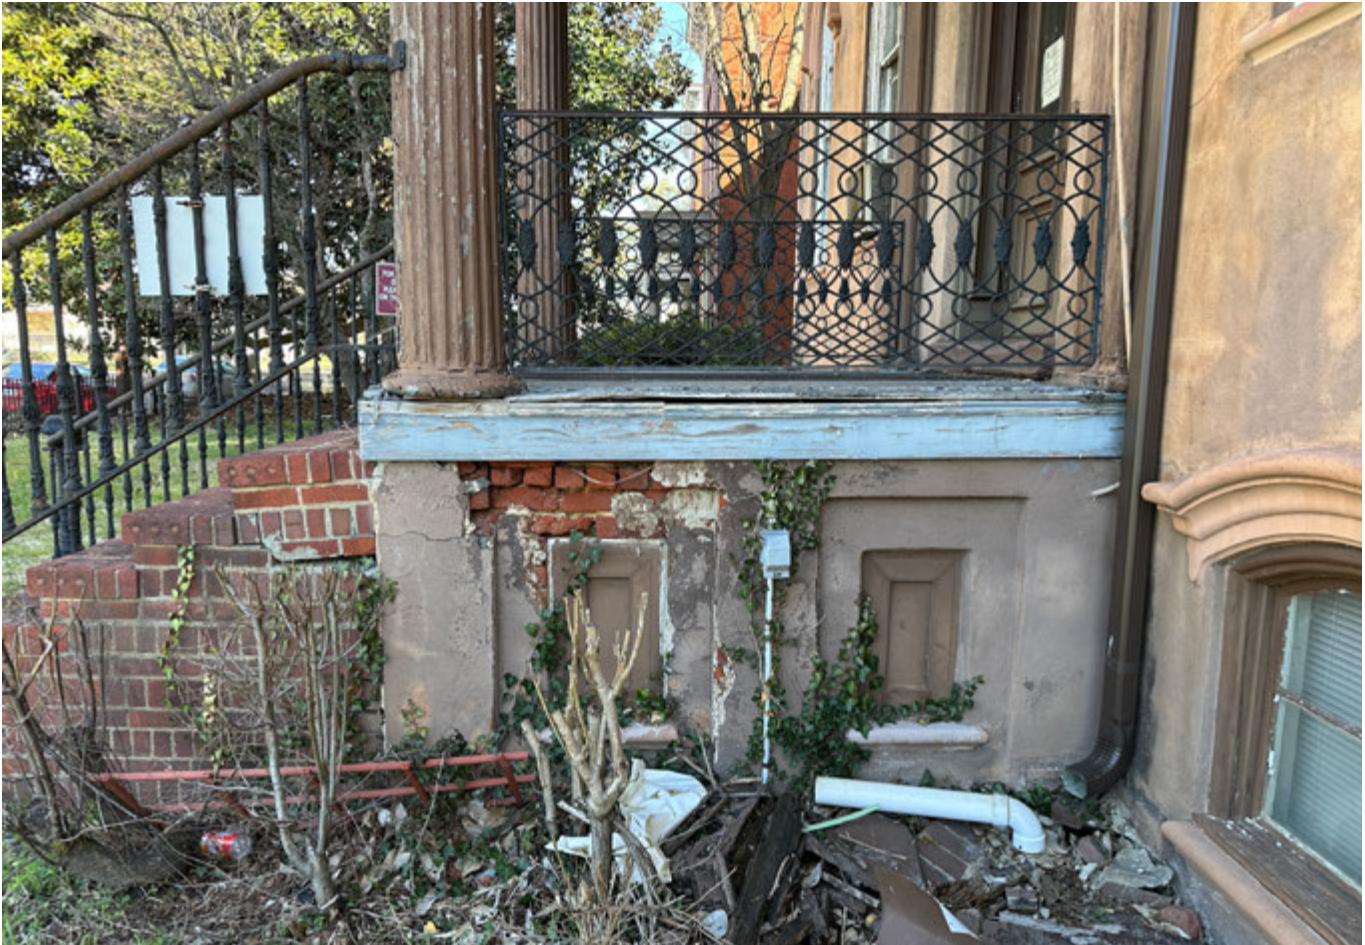
PHOTO: South Stair Elevation

REMARKS:
Front porch repairs.

Typical See I W8 for typical porch notes.

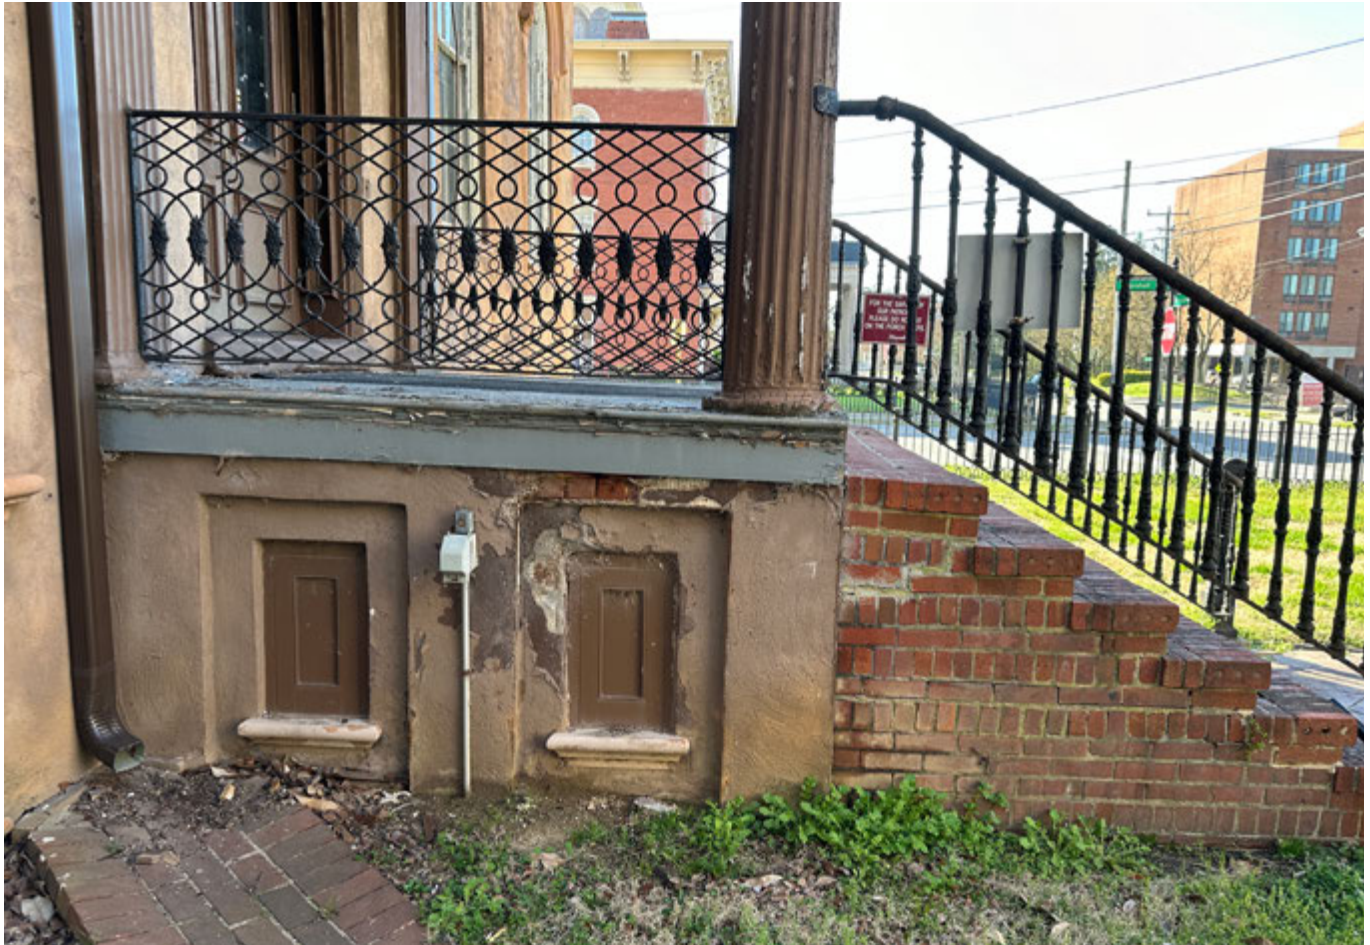
PHOTO: North Stair Elevation

REMARKS:
Front porch repairs.

See I W8 for typical porch notes

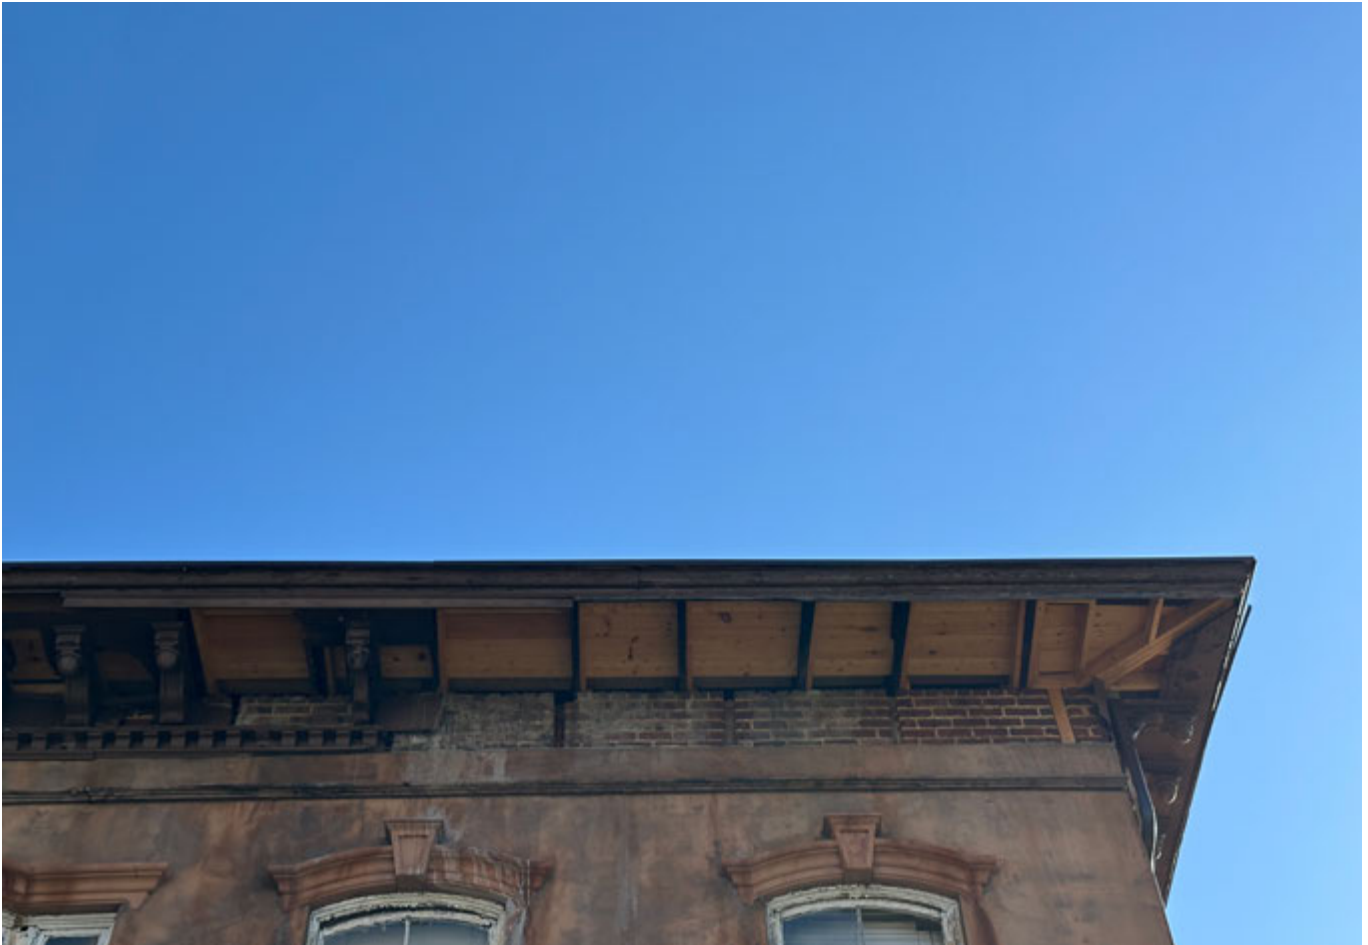
PHOTO: 1 W16 — West Elevation

REMARKS:
Soffit repair.

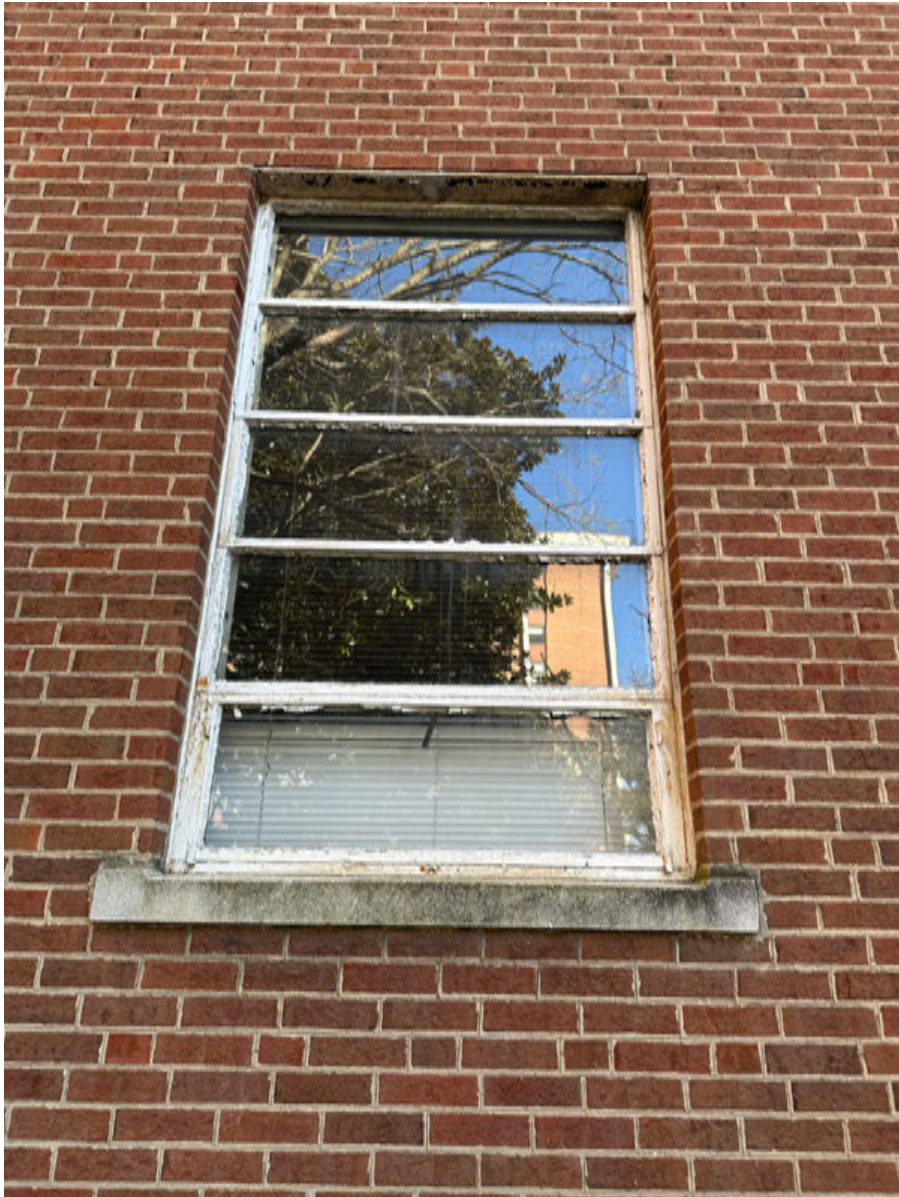
PHOTO: 2 W2 — West Elevation

REMARKS:
Repairs and window replacement.

- Clean brick facade and cast stone sills to remove stains.

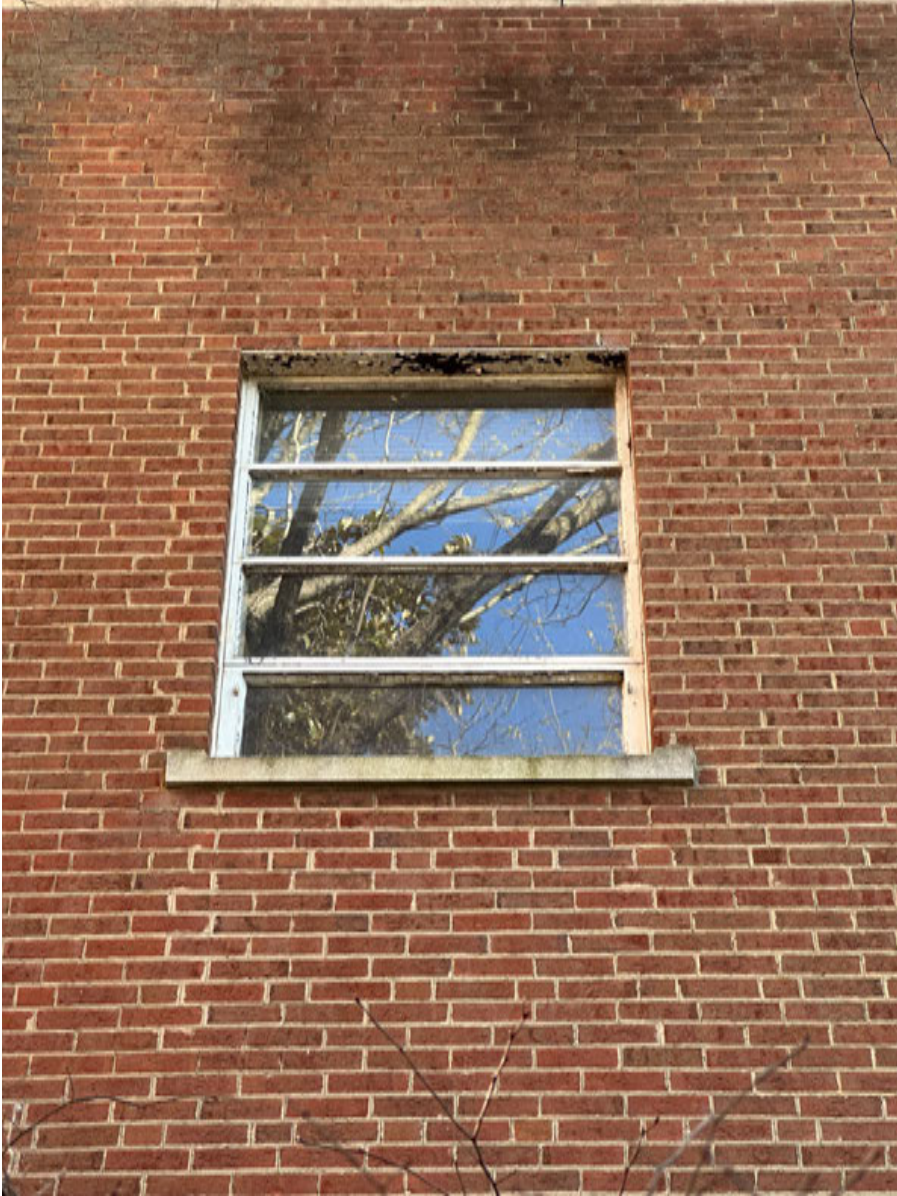
PHOTO: 2 W3 — West Elevation

REMARKS:
Repairs and window replacement.

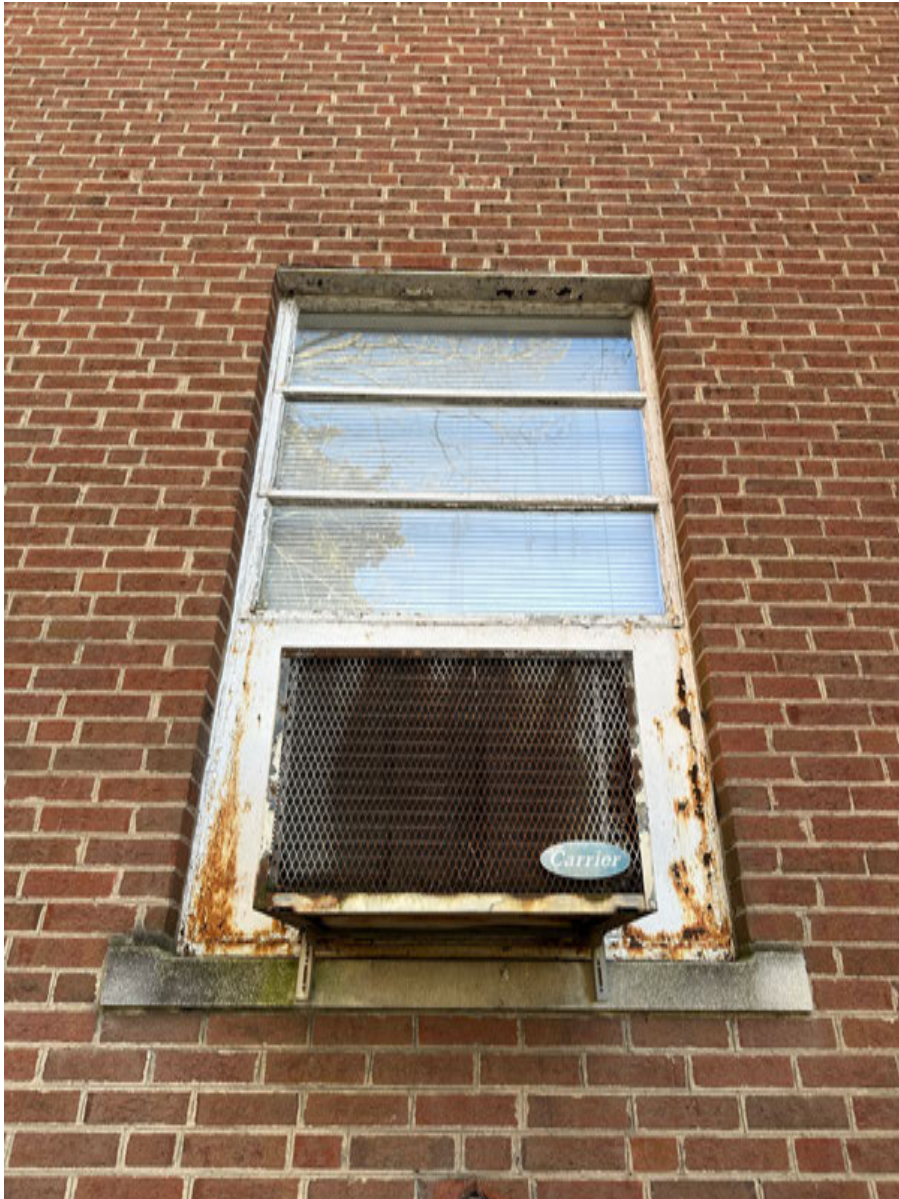
PHOTO: 2 W4 — West Elevation

REMARKS:
Repairs and window replacement.

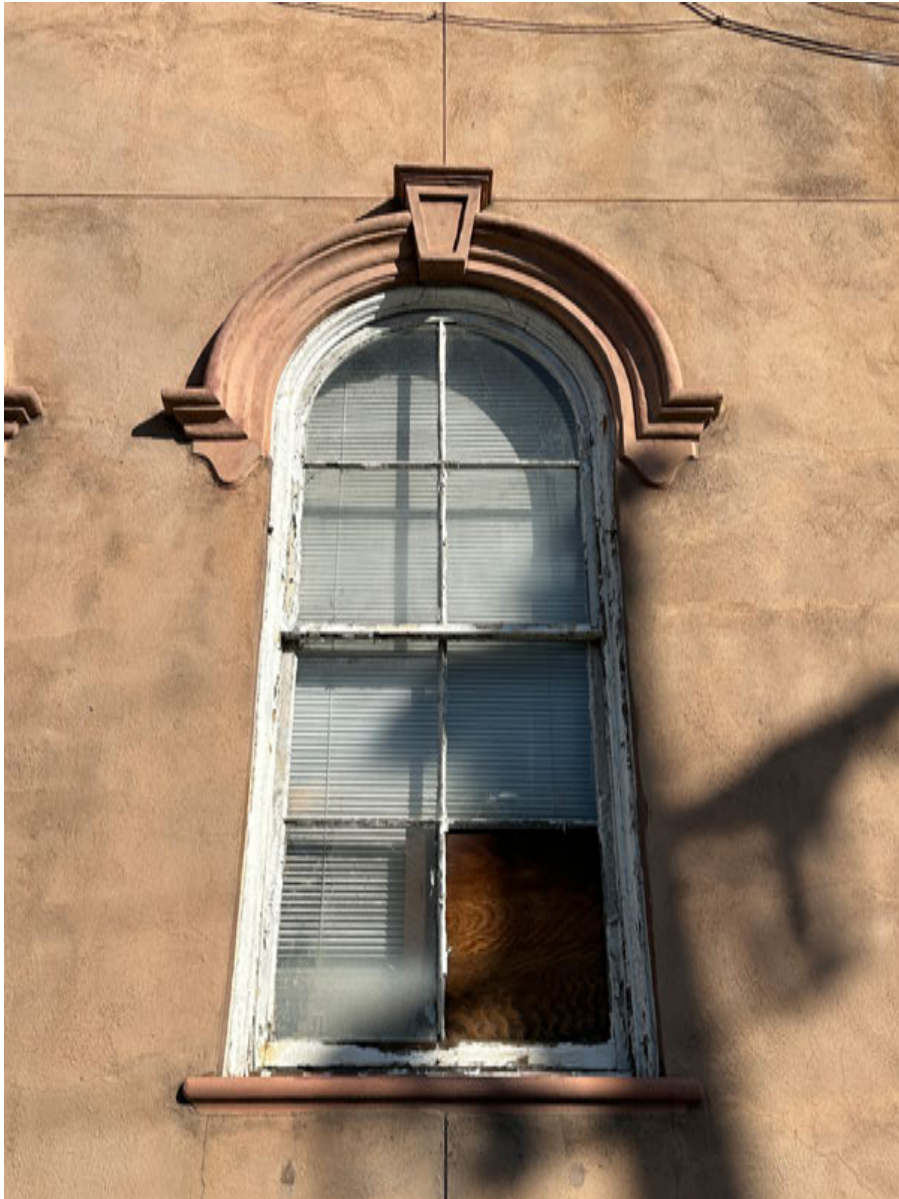
PHOTO: 5 S5 — South Elevation

REMARKS:
Window repairs.

- Replace window pane in bottom
sash

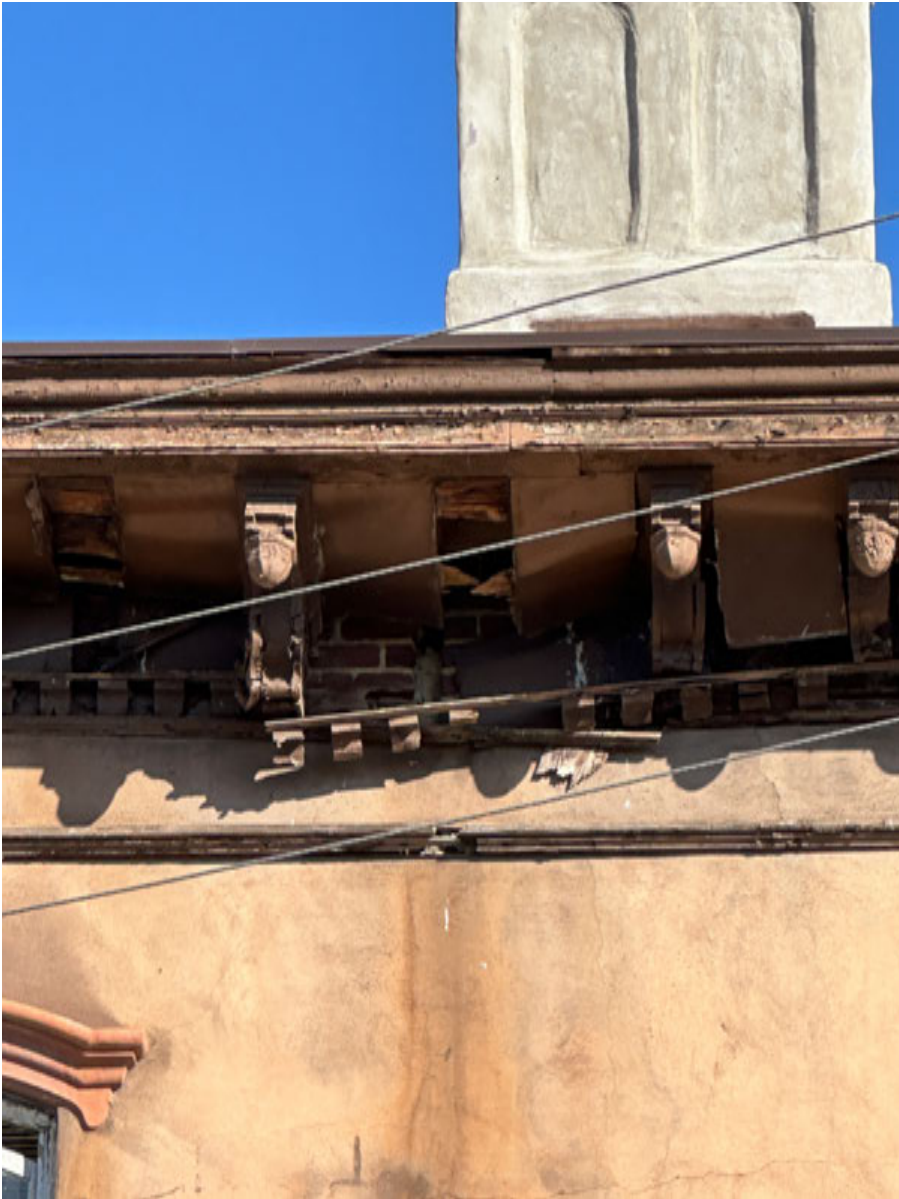
PHOTO: 5 S7 — South Elevation

REMARKS:
Soffit repairs.

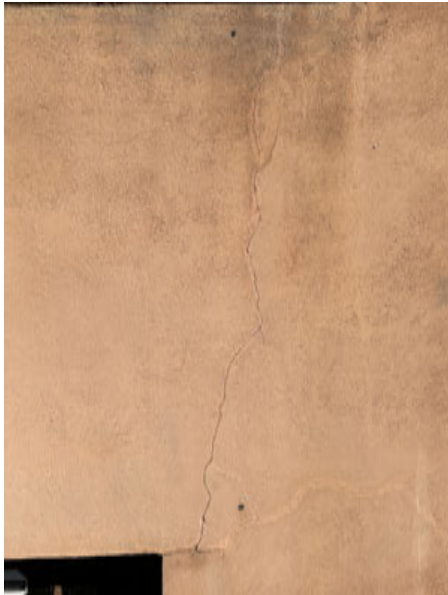
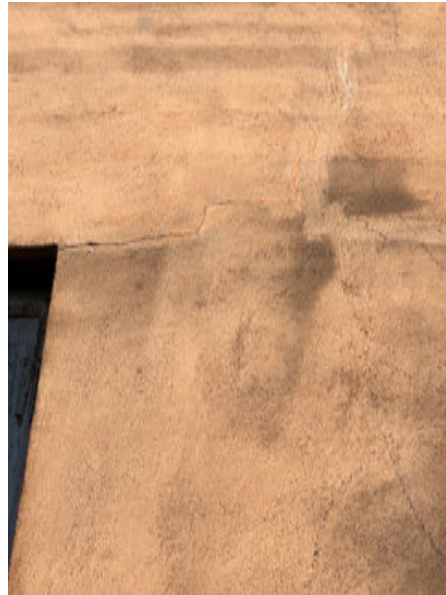
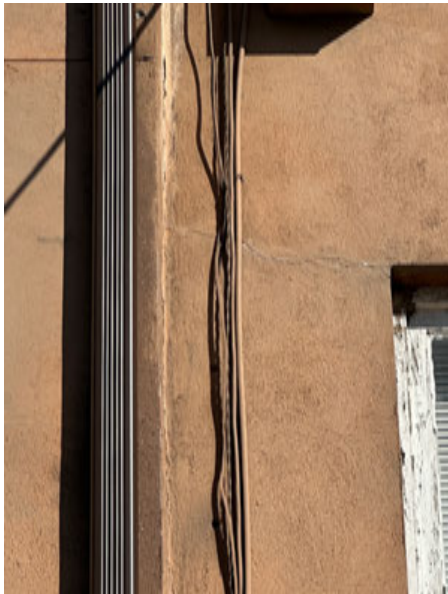
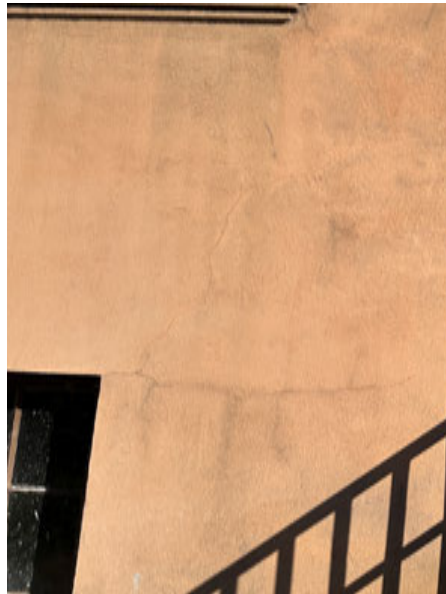
PHOTOS: South Facade Cracks

REMARKS:
Stucco repairs.

- Test stucco for damage and detachment from underlayers
- Remove any unstable stucco
- Remove and patch existing stucco with new stucco to match existing. Allow approximately 500 square feet of stucco patching
- Test existing stucco to determine composition. Custom mix new stucco to match the composition of existing stucco.
- Apply lime putty wash over existing stucco to fill in small cracks.
- Paint stucco after repairs.

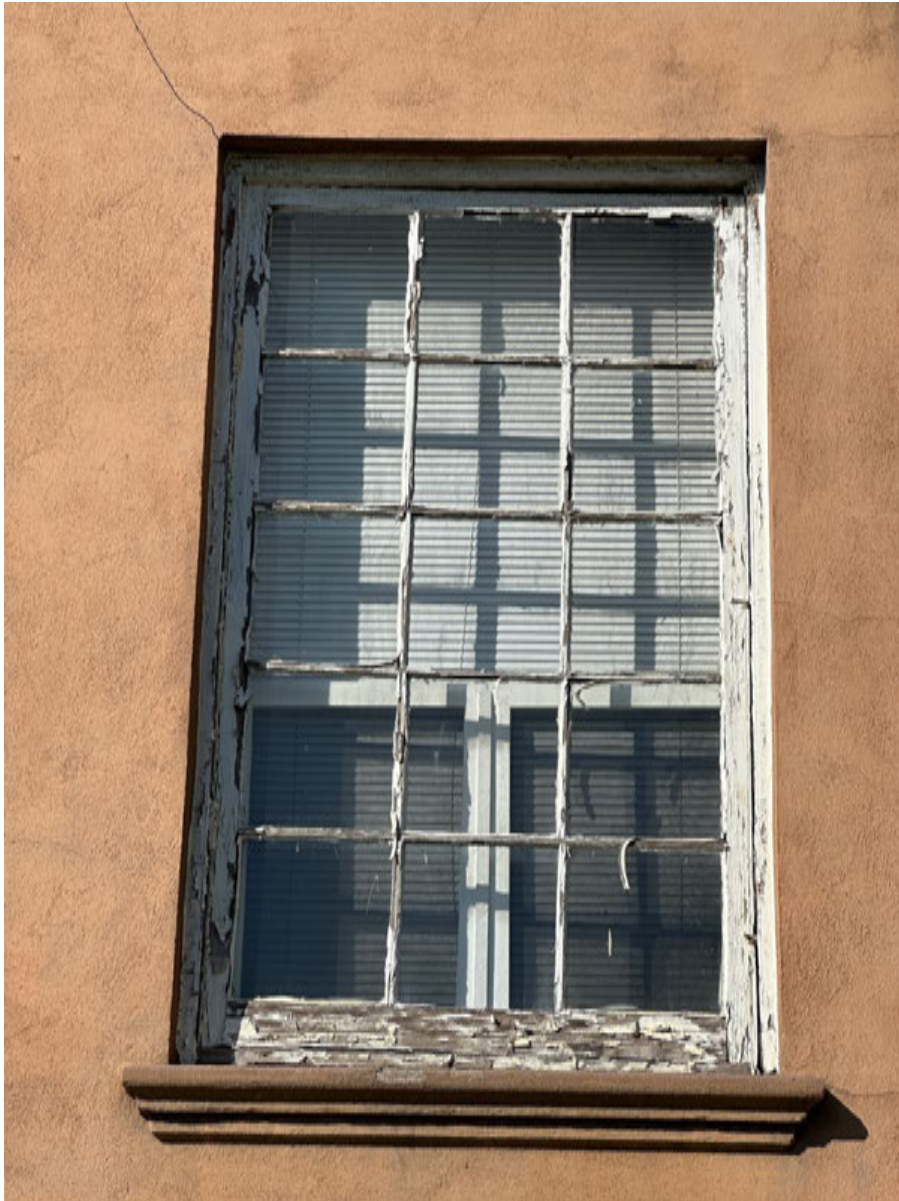
PHOTO: 7 E1 — East Elevation

REMARKS:
Window repairs.

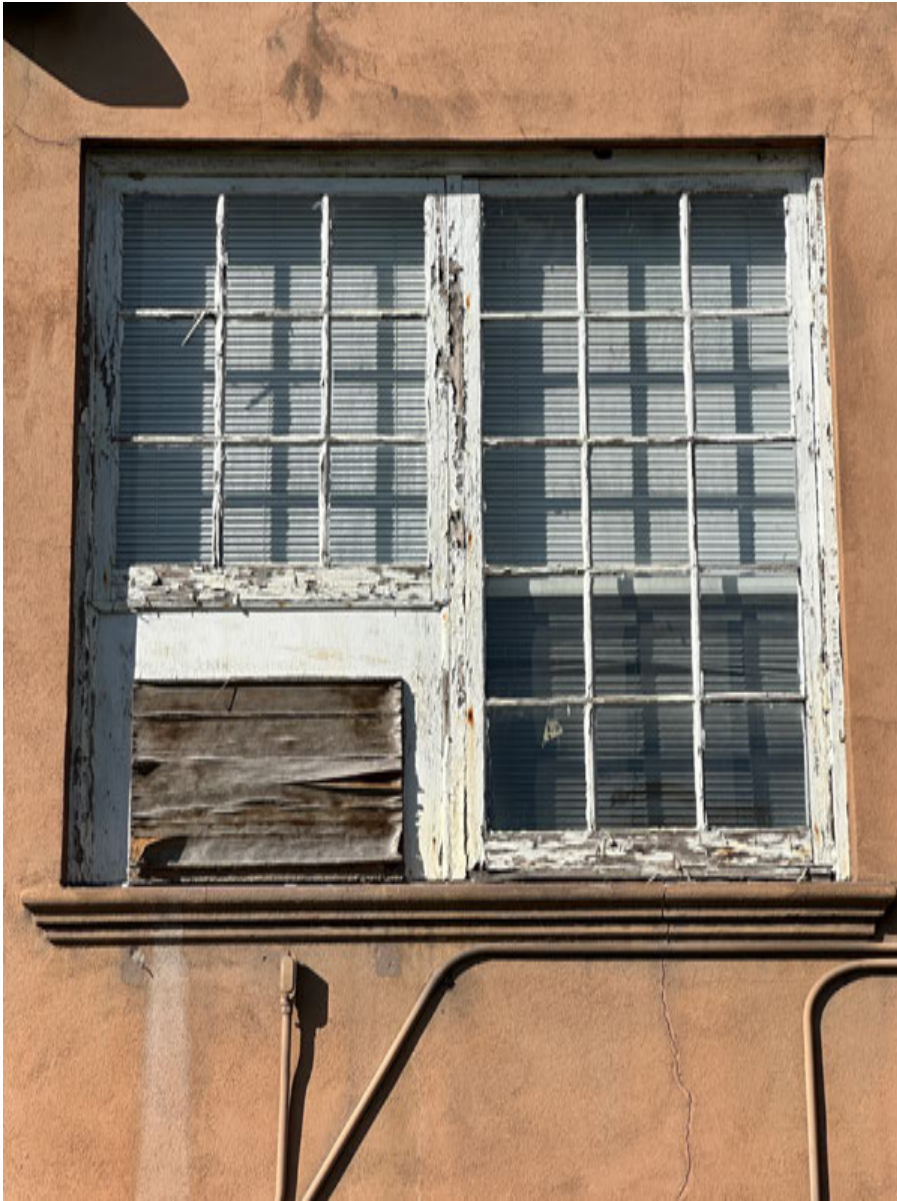
PHOTO: 7 E3 — East Elevation

REMARKS:
Window repairs.

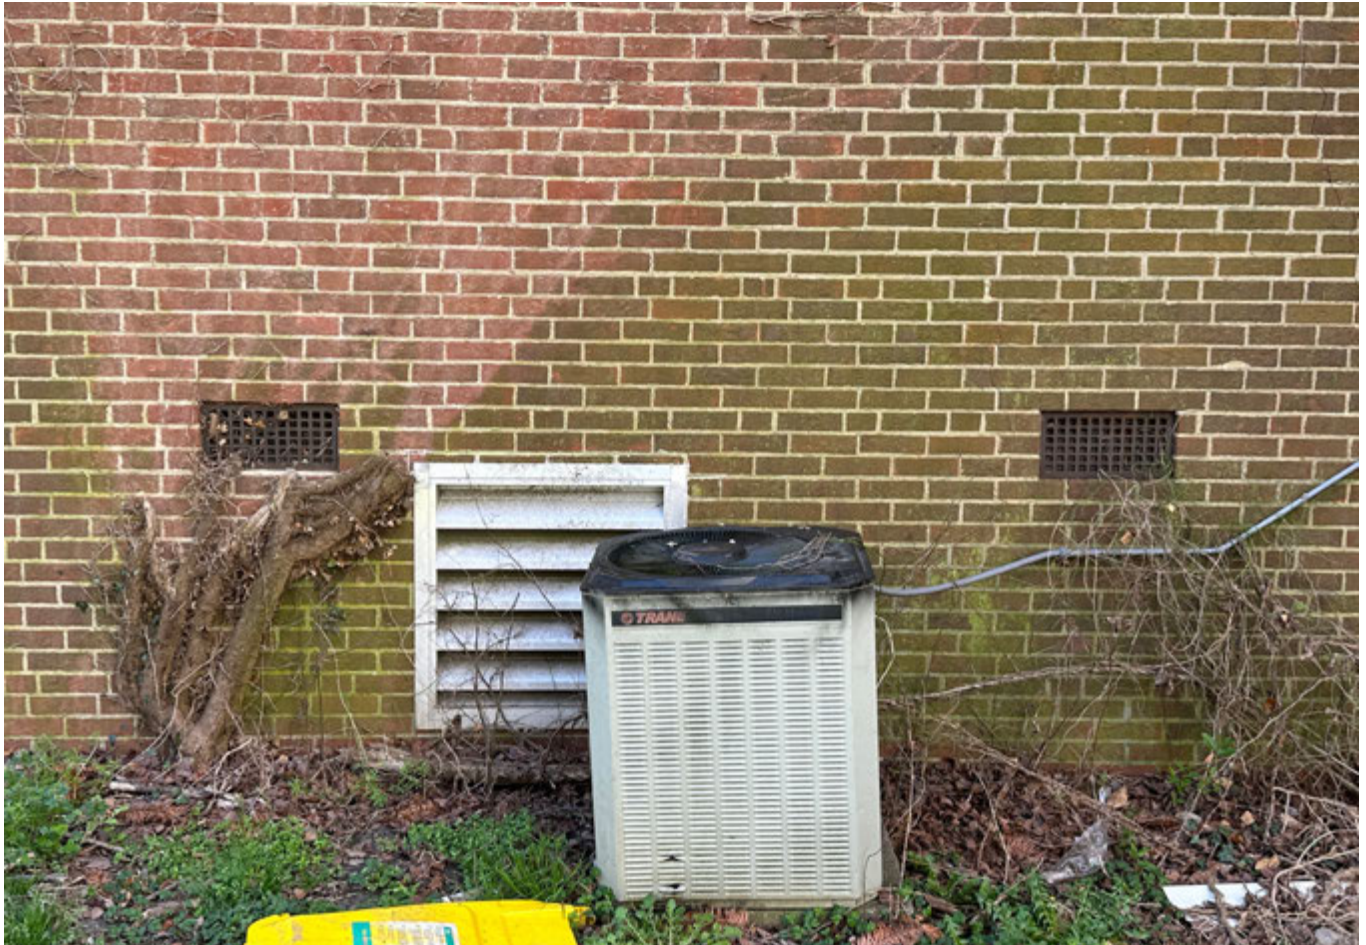
PHOTO: 10 N3 — North Elevation

REMARKS:
Crawlspace repairs.

- Remove shrubbery to ensure it does not damage brick or foundation.

10 N3
- Ensure any screens are removed and replaced

- Replace louver for any new mechanical equipment.

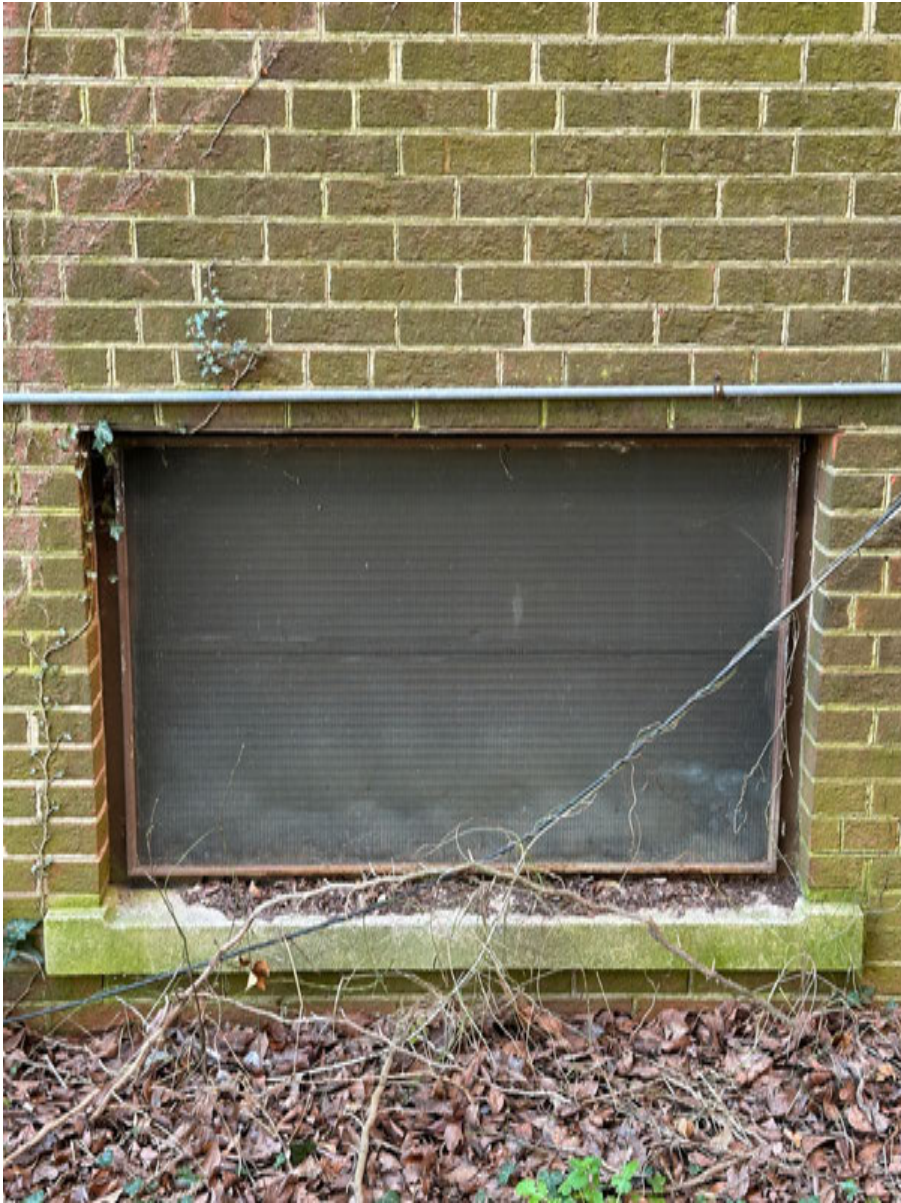
PHOTO: 10 N6 — North Elevation

REMARKS:
Window infill
